NATIONAL TRANSPORTATION SAFETY BOARD

RAILROAD ACCIDENT REPORT

REAR END COLLISION AND DERAILMENT
OF TWO UNION PACIFIC FREIGHT TRAINS
NEAR NORTH PLATTE, NEBRASKA
ON JULY 10, 1986

NTSB/RAR-87/03

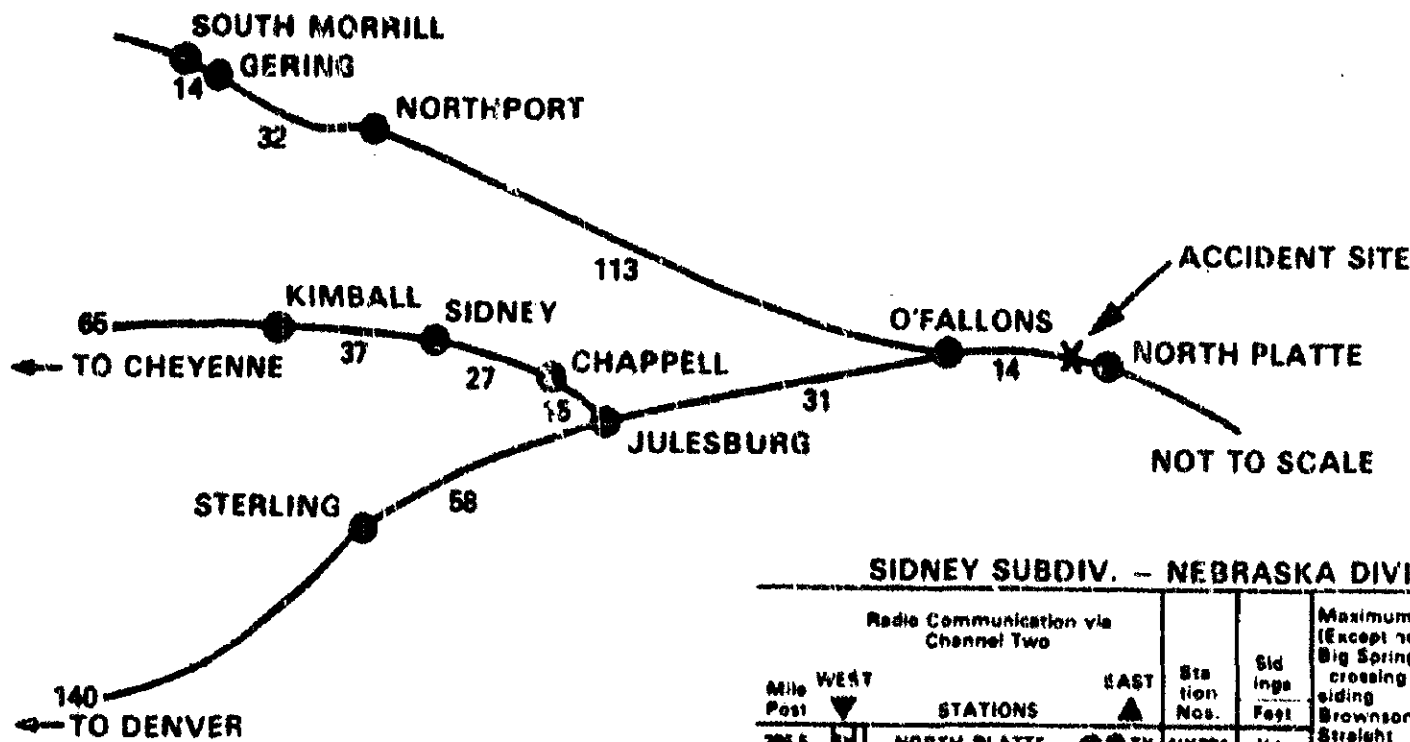
Figure 1.--Sketch of the North Platte and Sidney Subdivisions.

At 5:45 a.m., train No. CHLS-09 was switched to the number 1 main track at O'Fallons and continued east. (See figure 1.)
