NATIONAL TRANSPORTATION SAFETY BOARD

RAILROAD ACCIDENT REPORT

**REAR-END COLLISION OF
AMTRAK PASSENGER TRAIN 94, THE COLONIAL
AND CONSOLIDATED RAIL CORPORATION
FREIGHT TRAIN ENS-121,
ON THE NORTHEAST CORRIDOR
CHASE, MARYLAND
JANUARY 4, 1987**

NTSB/RAR-88/01

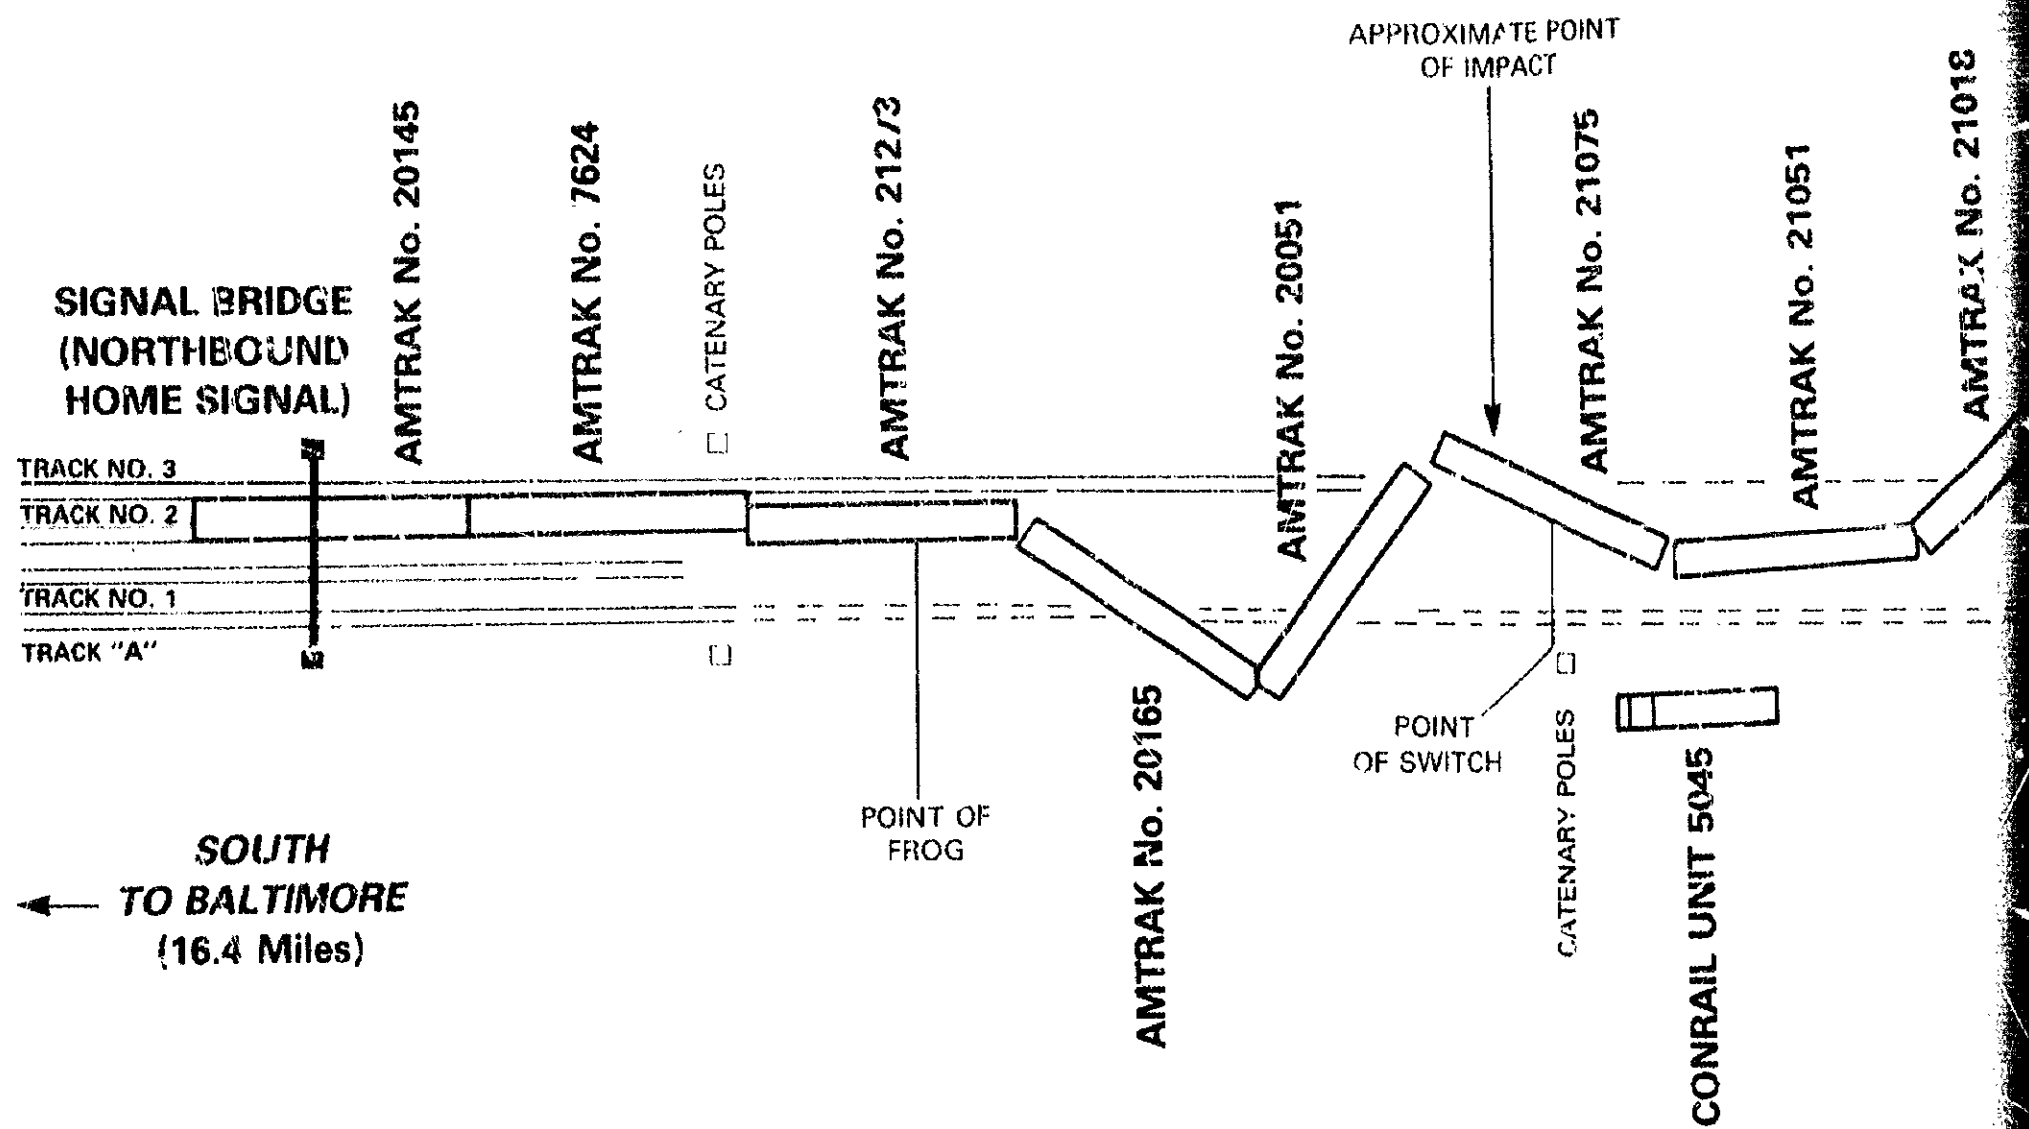
Figure 4. Wreckage Diagram.

The rear Conrail unit was virtually disintegrated with parts scattered across the tracks and property east of the tracks. The largest piece of wreckage came to rest about 150 feet northeast of the collision point. The rear of the middle Conrail unit was crushed by the rear unit. Uncoupled from the lead unit, it was propelled forward on track 2 for about 700 feet. Only the rear truck of this unit derailed. The lead Conrail unit sustained relatively superficial damage, although driven forward about 900 feet, it was the only piece of equipment in the two trains that was not derailed.

The forward cab and superstructure of the lead Amtrak locomotive unit was crushed downward and inward to the underframe. Separated from the trucks, the remains of the car body came to rest west of the tracks about 400 feet north of the collision point. The trailing Amtrak unit remained in line with the track, although separated from its trucks, and came to rest leaning about 45° to the right at a point about 450 feet north of the collision point (see figure 3).

The head car of the passenger train, an unoccupied food service car, came to rest behind the trailing Amtrak locomotive. After passing over the food service car, the second car came to rest on its side on top of the rear of the trailing Amtrak locomotive unit. It was more or less perpendicular to the track, badly deformed and bent or crimped downward in the middle at an angle of about 30° (see figure 4). The third car stopped diagonally to the track, leaning to one side, on top of the crushed food service car. One end was crushed between the second and fourth cars. The fourth car stopped diagonally to the track, upright and with the car body essentially intact. The 5th through 12th cars remained coupled and upright, although the 5th, 7th, 8th, and 9th cars had jackknifed and stopped diagonally to the track. The other derailed cars remained in line with the track (see figure 5).

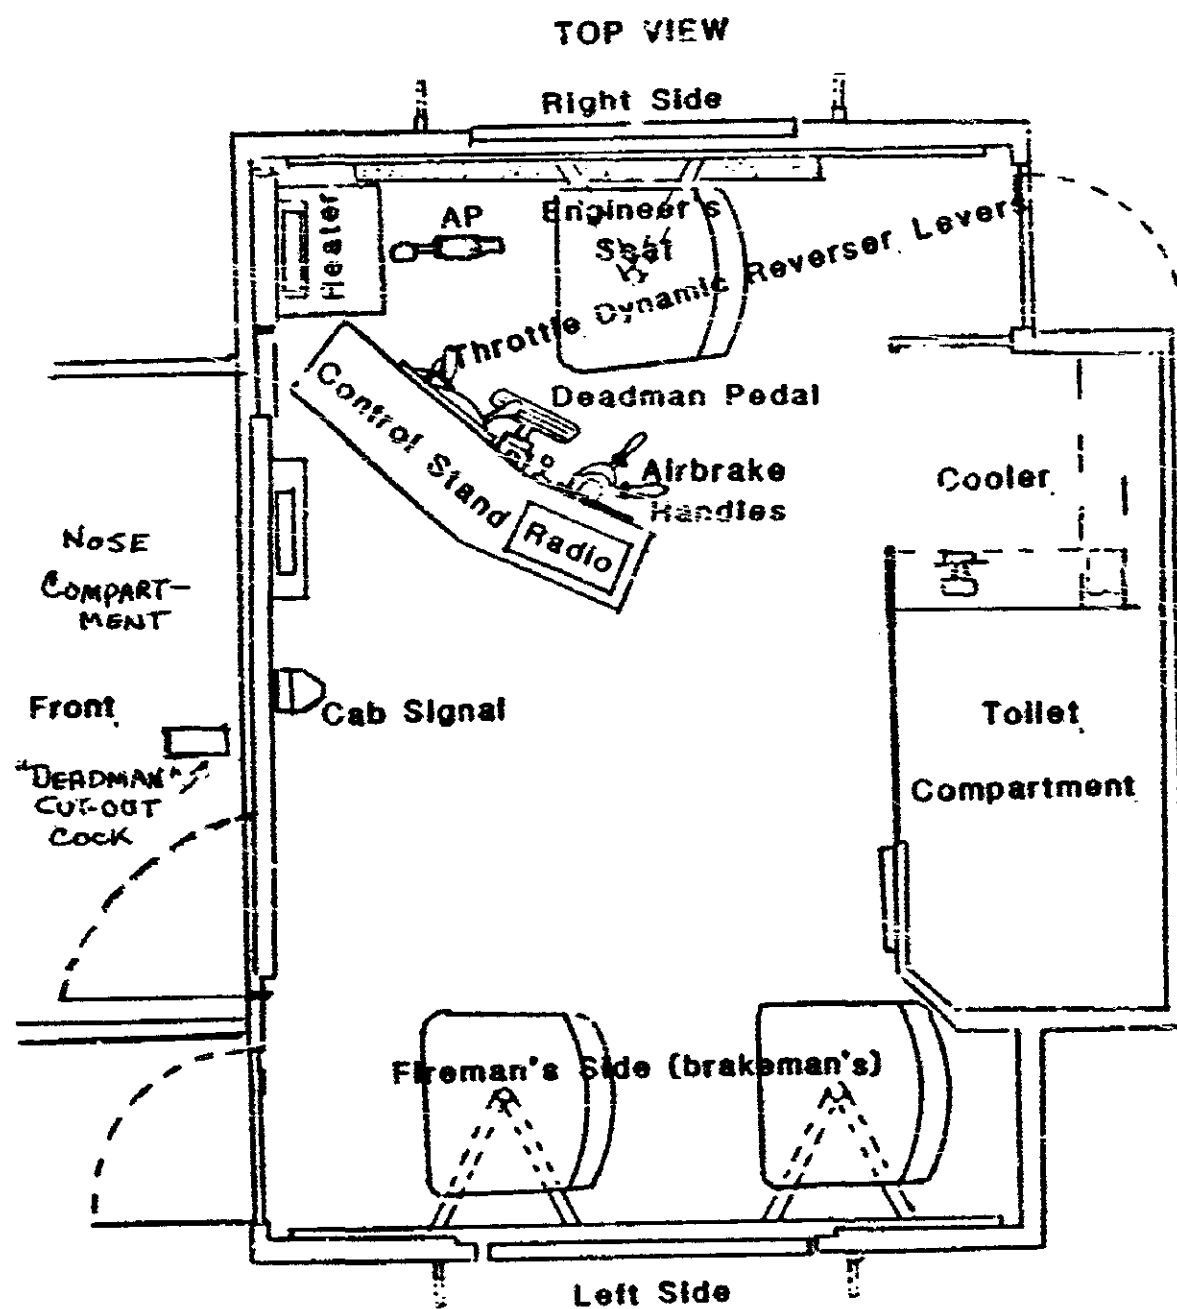
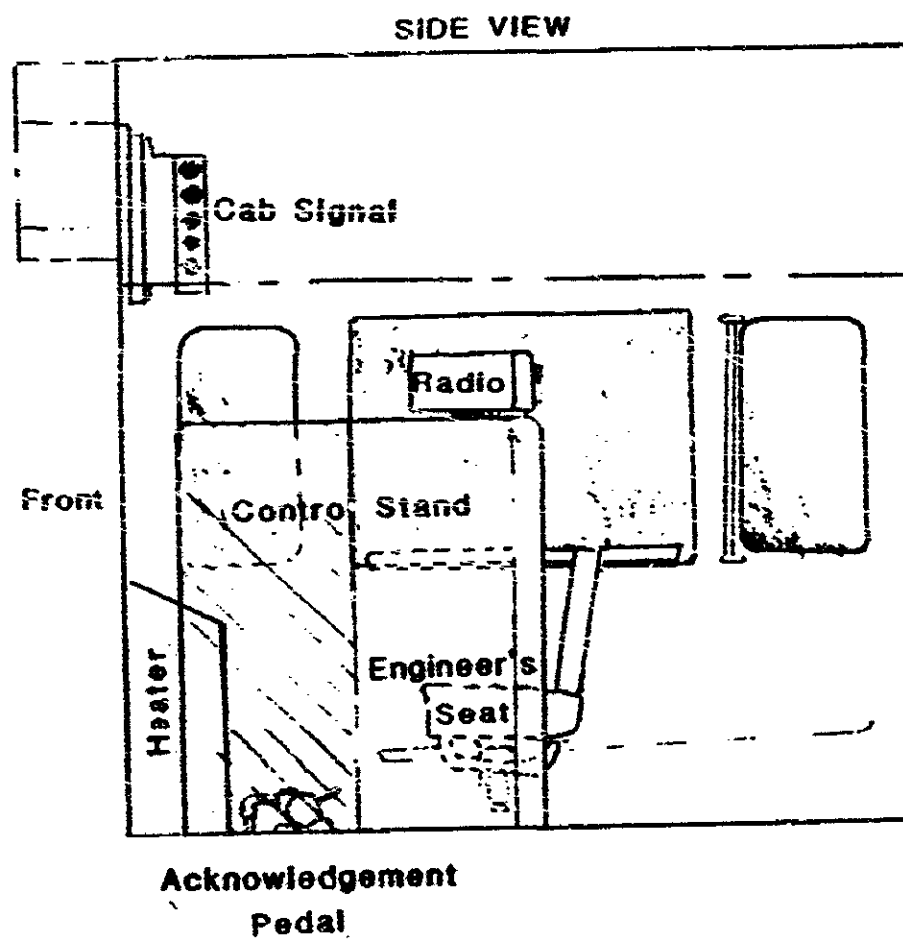
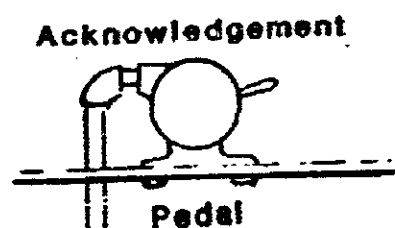
Figure 12. Floor plan and side elevation of the cab of Conrail locomotive unit 5044.

The control and airbrake stands were in the right side of the cab, and the throttle, dynamic brake, and reverser levers were in front of the engineer's seat with the airbrake handles and radio handset to the left of the seat (see figure 12). An emergency brake valve was located on the left side of the cab.

An elongated safety control or "deadman" foot pedal was on the floor in front of the control stand, forward and to the left of the engineer's seat. This pedal had to be kept depressed to prevent a "penalty" full-service airbrake application. The penalty airbrake application could also be prevented by cutting the deadman feature out of the airbrake system. A cut-out cock for this purpose was located inside the nose compartment and could be accessed without leaving the cab (see figure 12). According to Conrail, the deadman cut-out cocks are kept sealed in the "in" or operative position. After the accident, the deadman cut-out cock of unit 5044 was found unsealed and in the "out" position.

The four-aspect cab signal of unit 5044 was of the same configuration as the Amtrak AEM-7 locomotives; it was mounted in the middle of the forward cab bulkhead at the top of the windshield. The hinged cover had two sets of aspect ports set at oblique angles so that one could be viewed from each side of the cab. The top port was the "clear" aspect, the next two below were the "approach medium" aspect, the next below was the "approach" aspect, and the bottom port was the "restricting" aspect. There were screw-in receptacles in the signal box for four small white bulbs--one for each aspect. An examination of the signal box after the accident revealed that the bulb for the "approach" aspect was missing (see figure 13). All the other aspects had operative bulbs that were properly inserted.
