RAILROAD ACCIDENT REPORT

HEAD-END COLLISION
OF CONSOLIDATED RAIL CORPORATION
FREIGHT TRAINS UBT-506 AND TV-61
NEAR THOMPSONTOWN, PENNSYLVANIA
JANUARY 14, 1988

NTSB/RAR-89/02

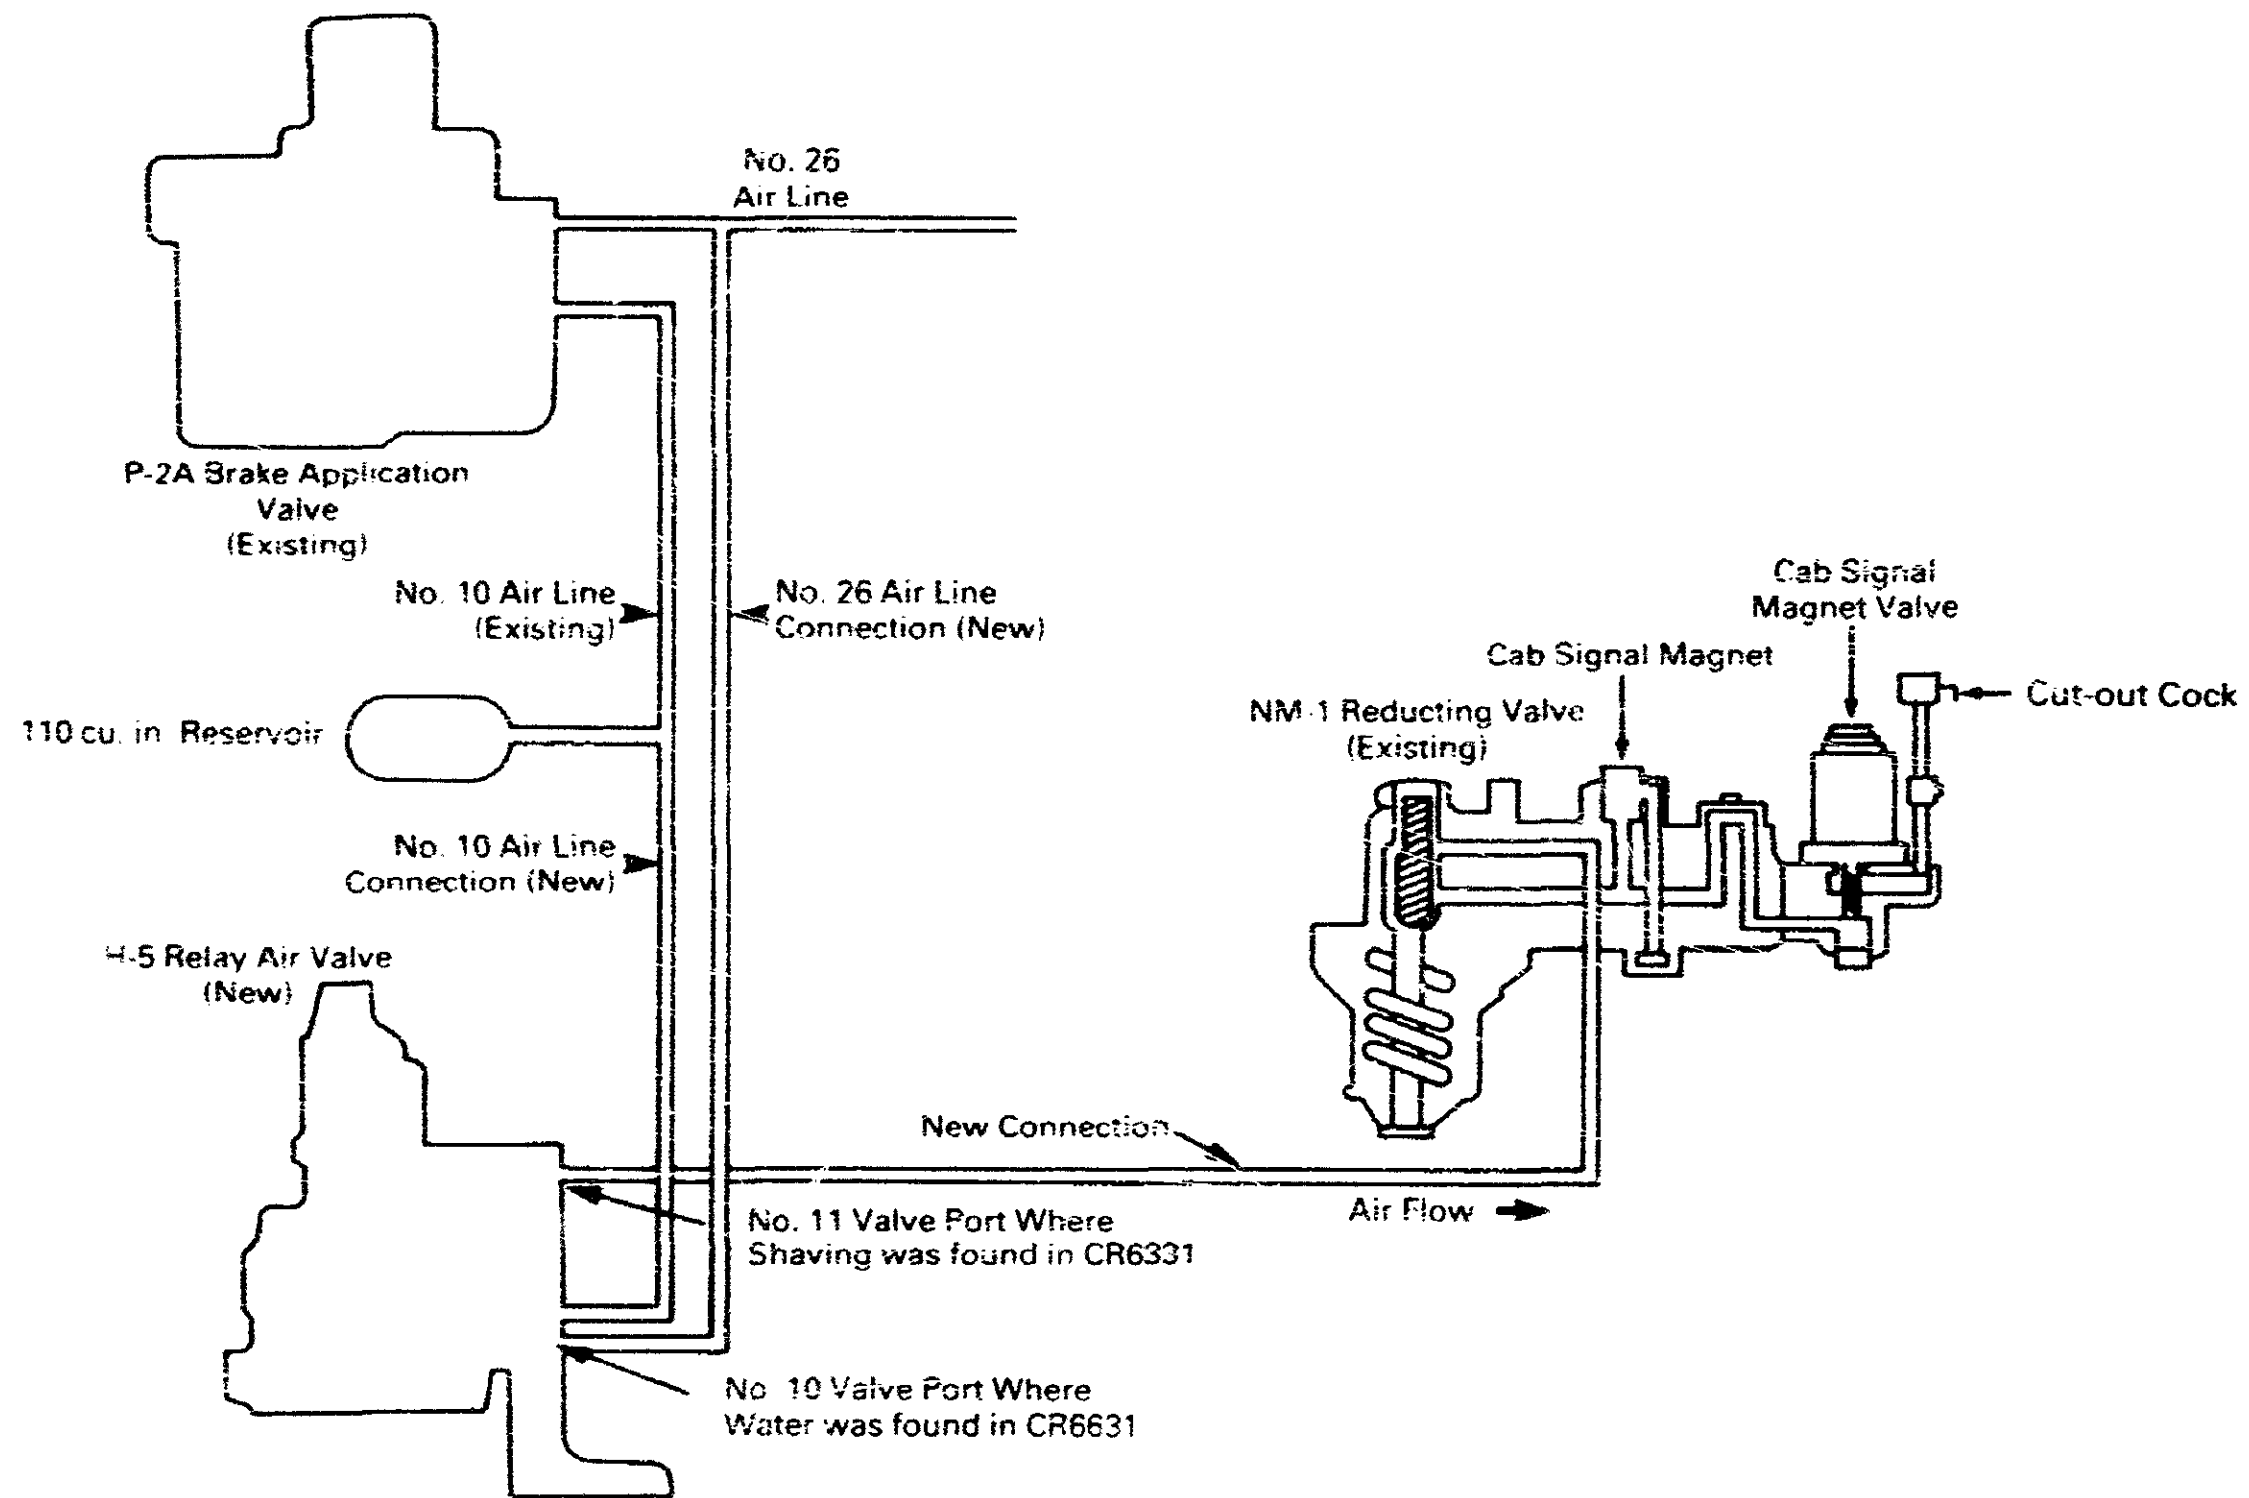
Figure 10.—Schematic diagram showing additions and modifications to the ACS system of Conrail locomotives in adding the ATS feature

The modification adding the ATS backup feature to the ACS system of Conrail locomotive units involved the installation of a H-5 relay air valve and 3/8-inch outside diameter (o.d.) copper tube air lines connecting the H-5 valve to the existing NM-1 reducing valve of the ACS system, as well as to the existing No. 10 air line (connecting the 110-cubic inch reservoir to the P-2-A brake application valve of the automatic air brake system) and the No. 26 air line (connecting the automatic brake valve with the P-2-A valve). (See figure 10.) The newly installed H-5 valve and the copper tubing connections were located in a noninsulated compartment under the floor of the operating compartment.
