NATIONAL TRANSPORTATION SAFETY BOARD

RAILROAD ACCIDENT REPORT

DERAILMENT OF
NATIONAL RAILROAD PASSENGER CORPORATION
TRAIN 7
ON BURLINGTON NORTHERN RAILROAD
NEAR SACO, MONTANA
AUGUST 5, 1988

NTSB/RAR-89/03

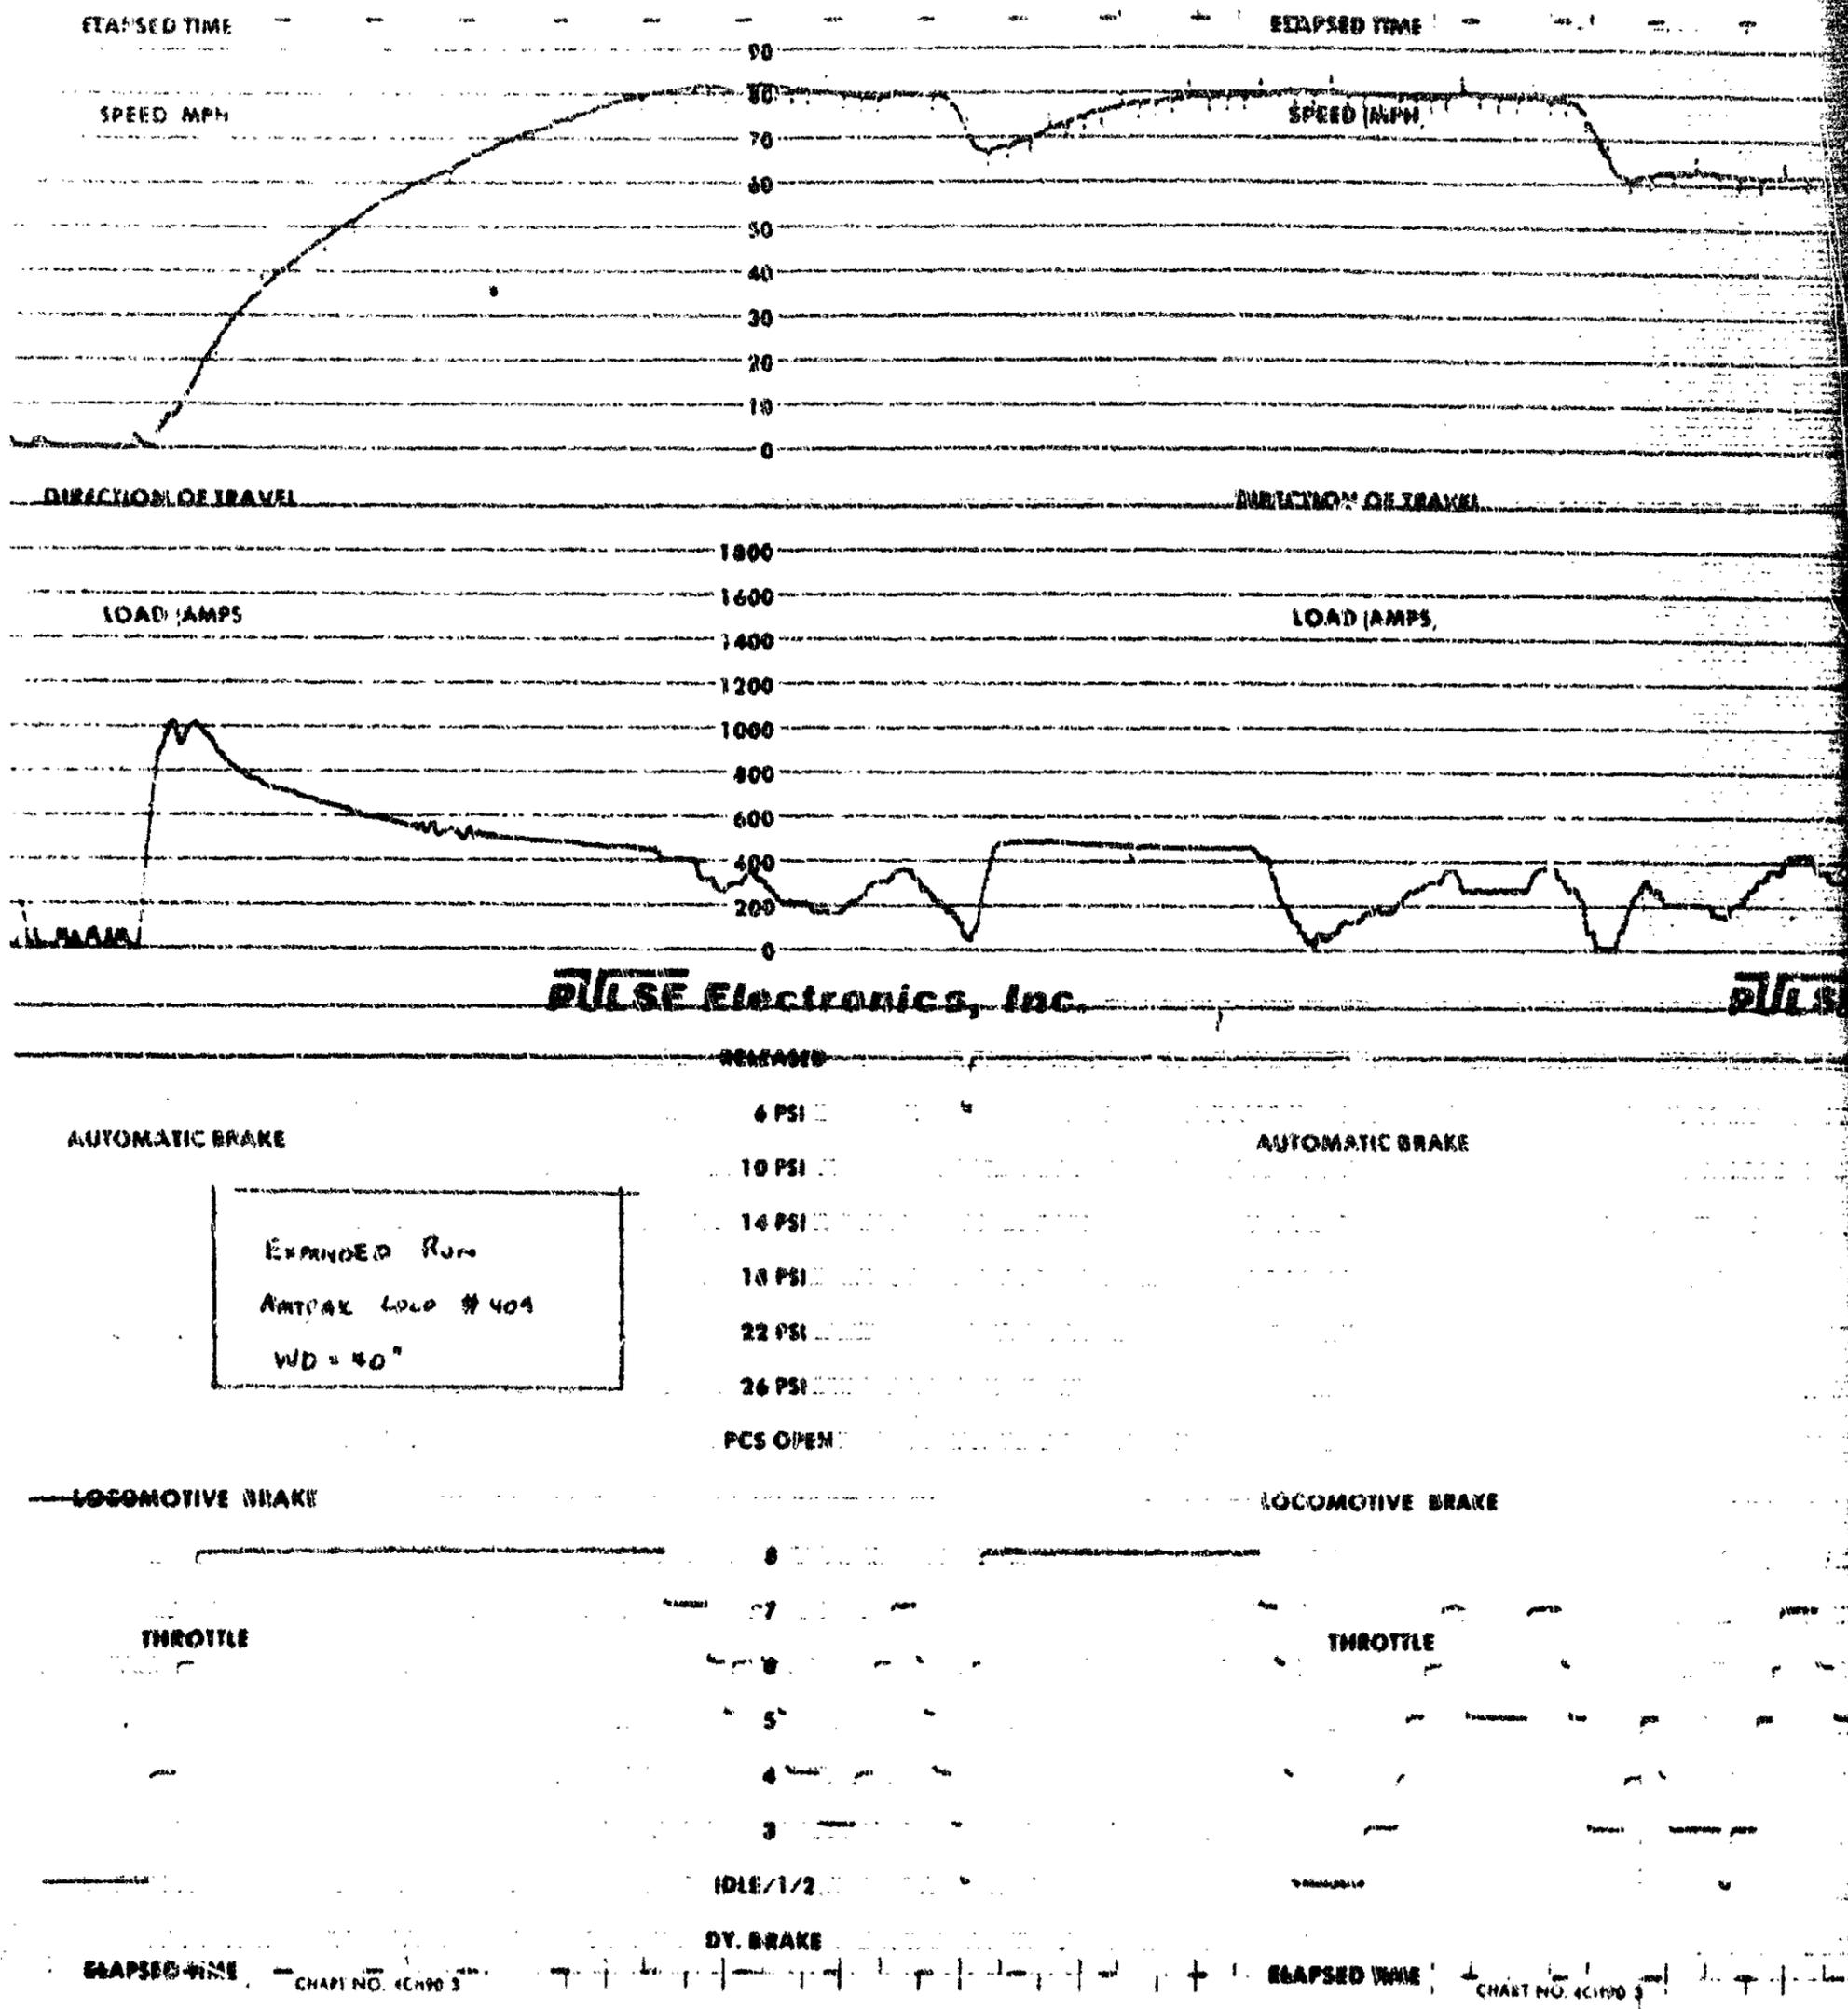
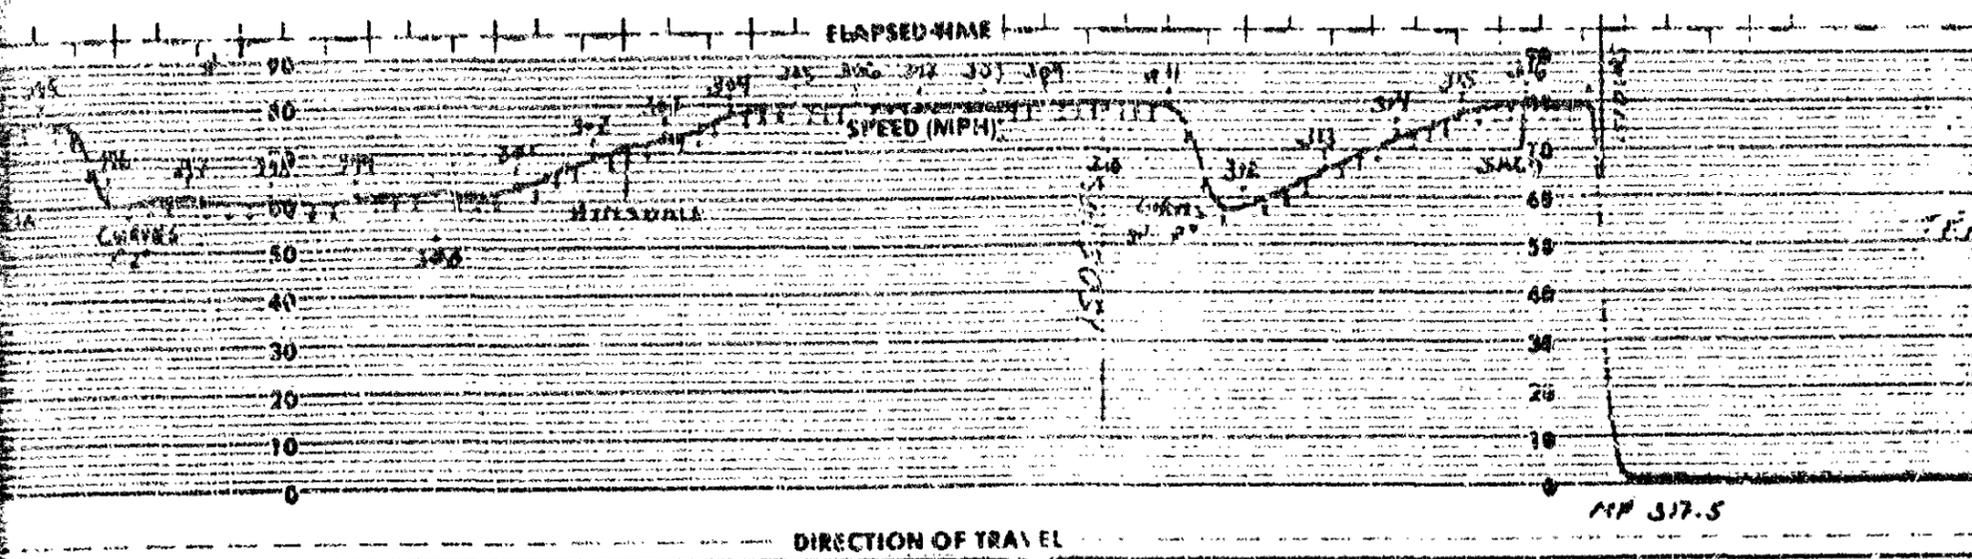
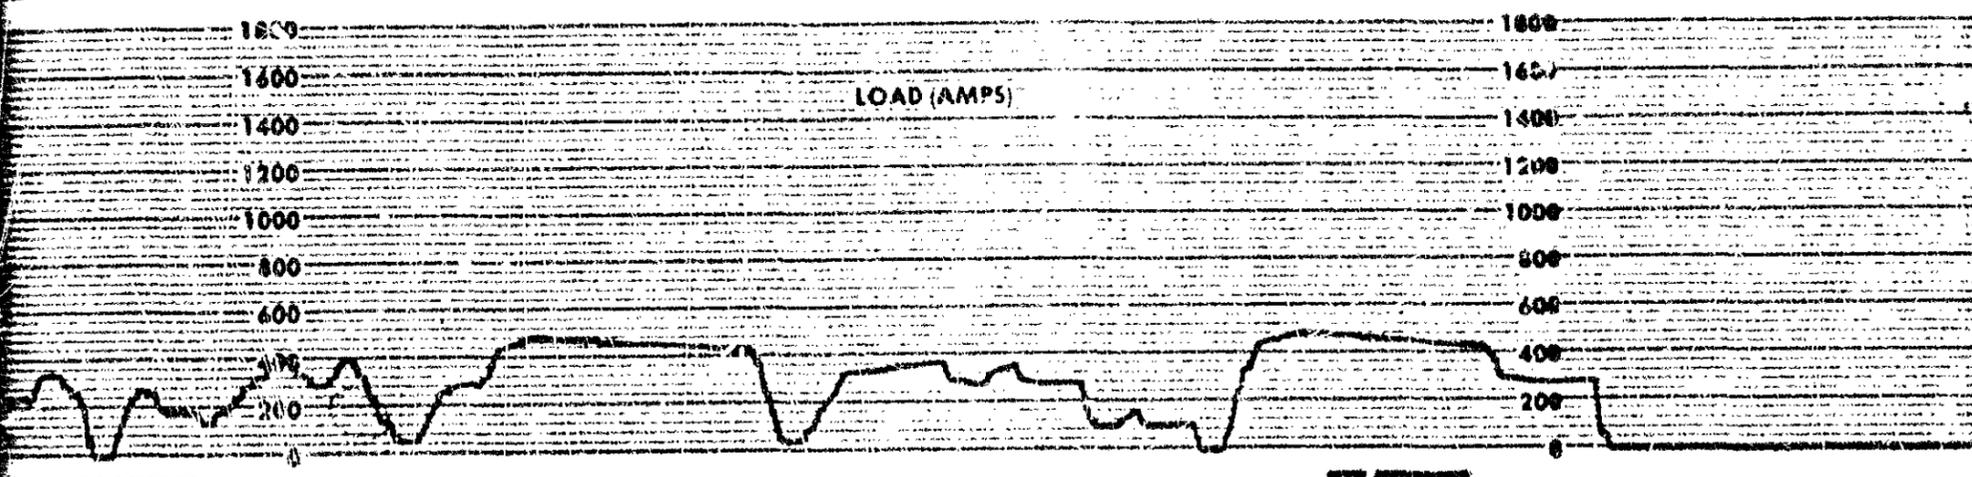
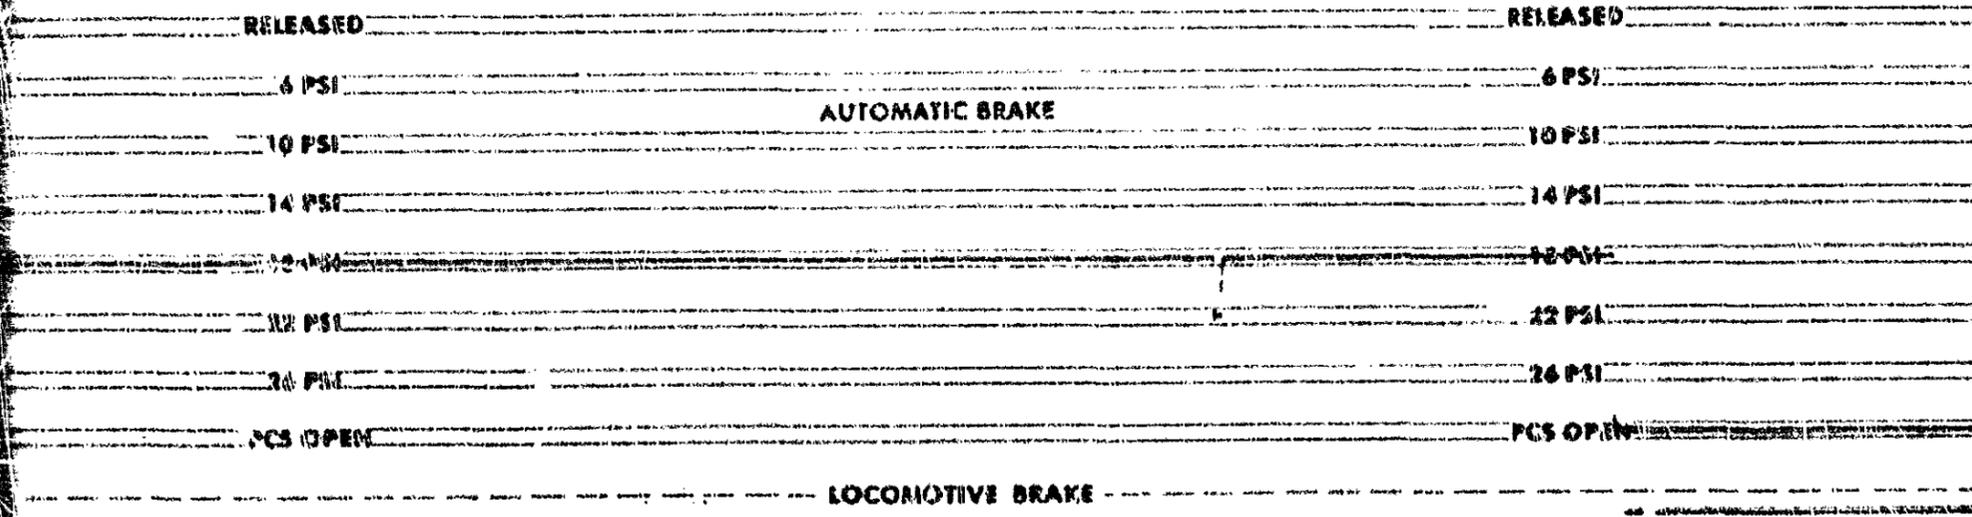
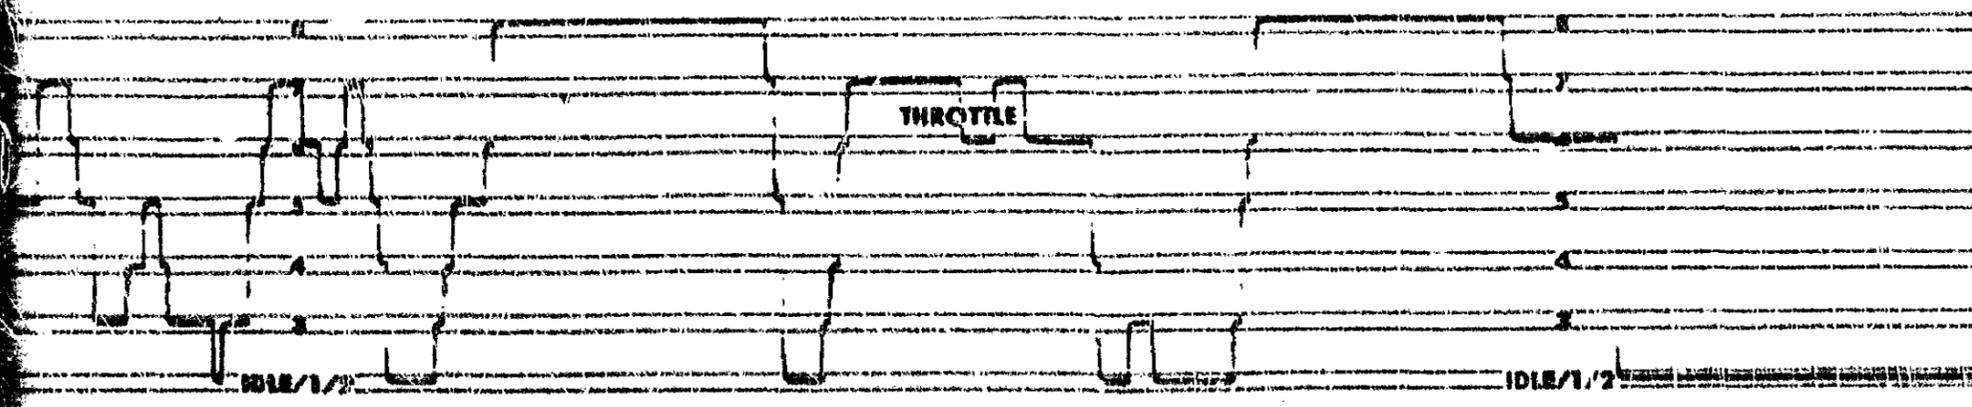
Figure 5. - - Safety Board event

The multi-event recorder cassette was removed from AMT 409 at 5:10 p.m. on August 5 by a BN operating officer while the locomotive was still at the accident site. (See appendix D.) BN personnel used a Pulse Electronics, Inc., desk-top playback system to prepare a paper printout from the information contained in the cassette. (See figure 4.) The printout indicated a continuous 18-psi automatic air brake application with further reductions to 22 psi. The cassette was taken to the Safety Board's laboratory to determine why the brake pipe reduction did not appear to correspond with the other data recorded at the same time on the cassette. Before beginning any detailed laboratory analysis of the cassette, the Safety Board prepared a paper printout using a Pulse Electronics, Inc., playback system similar to that used by the BN. The brake pipe reduction did not appear in the Safety Board's printout. (See figure 5.)

BN's assistant superintendent/locomotive shops testified that he had calibrated the playback system before preparing the paper printout on the night of the accident and that he had observed the brake pipe anomaly at the time he prepared the original printout. He stated, "I've seen this happen before. Occasionally, I've had it happen where we've had a bad air manifold on a locomotive." He did not recalibrate the playback system before releasing the paper printout. The assistant superintendent/locomotive shops testified that he had been formally trained on separate occasions by two major manufacturers of event recording devices in the preparation and interpretation of the paper printouts.

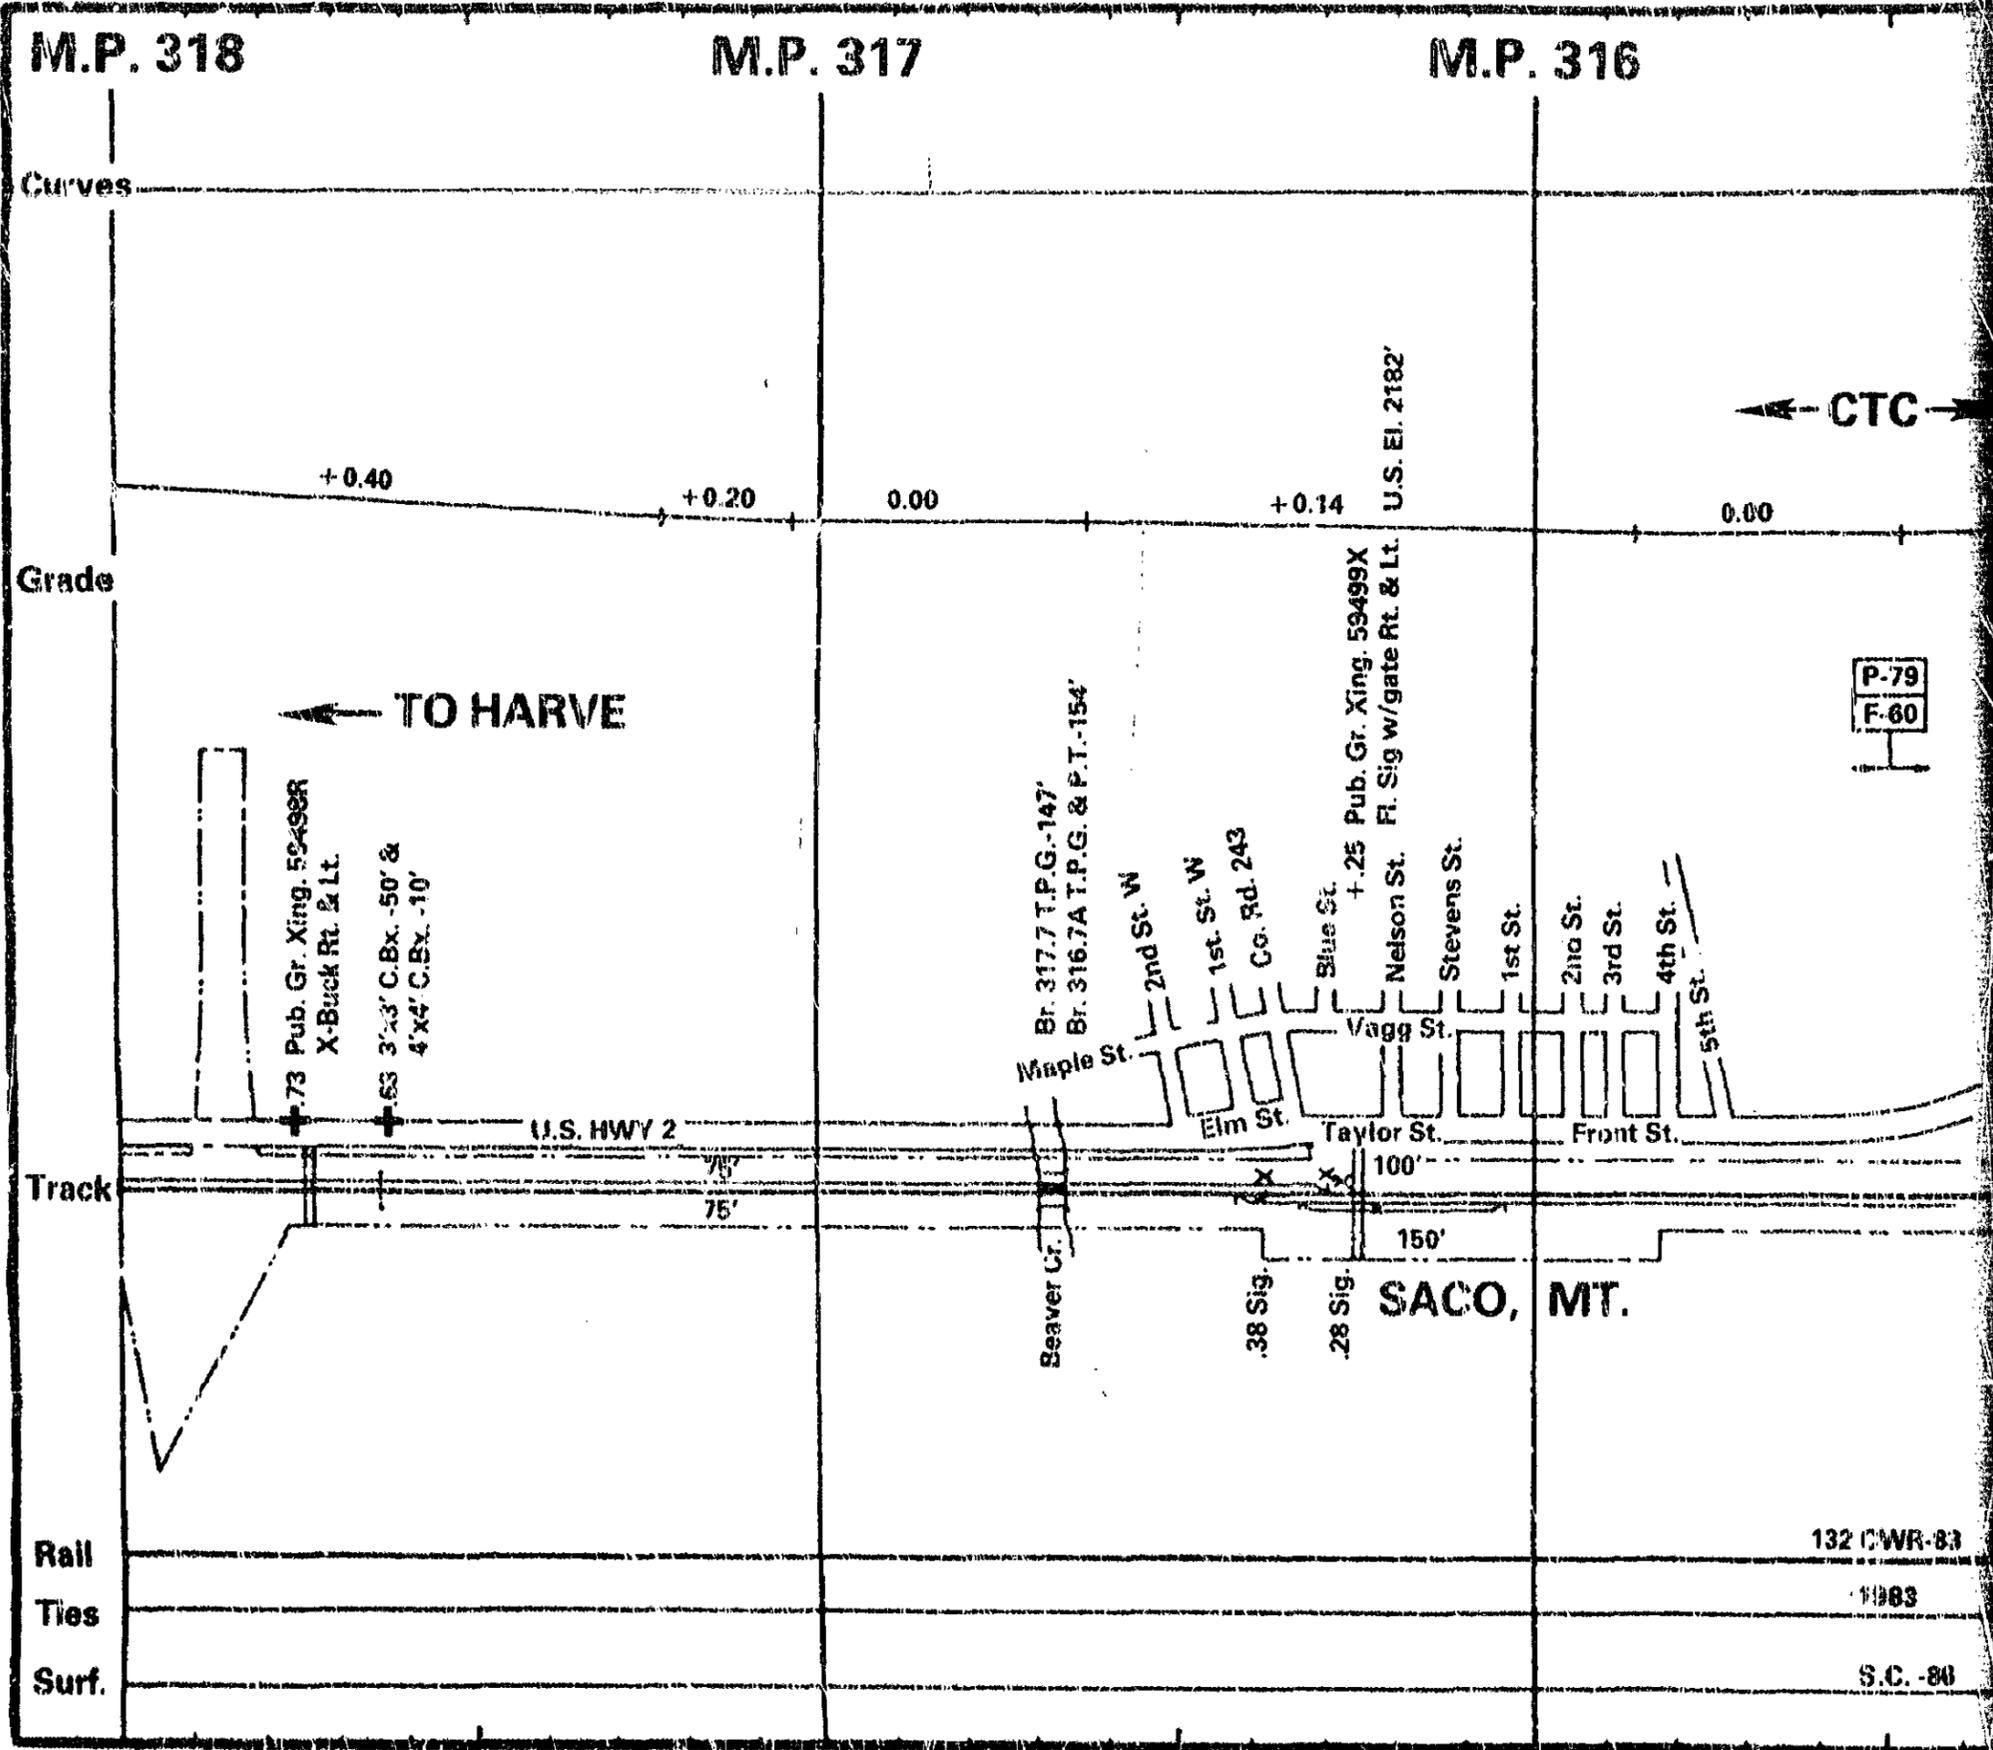
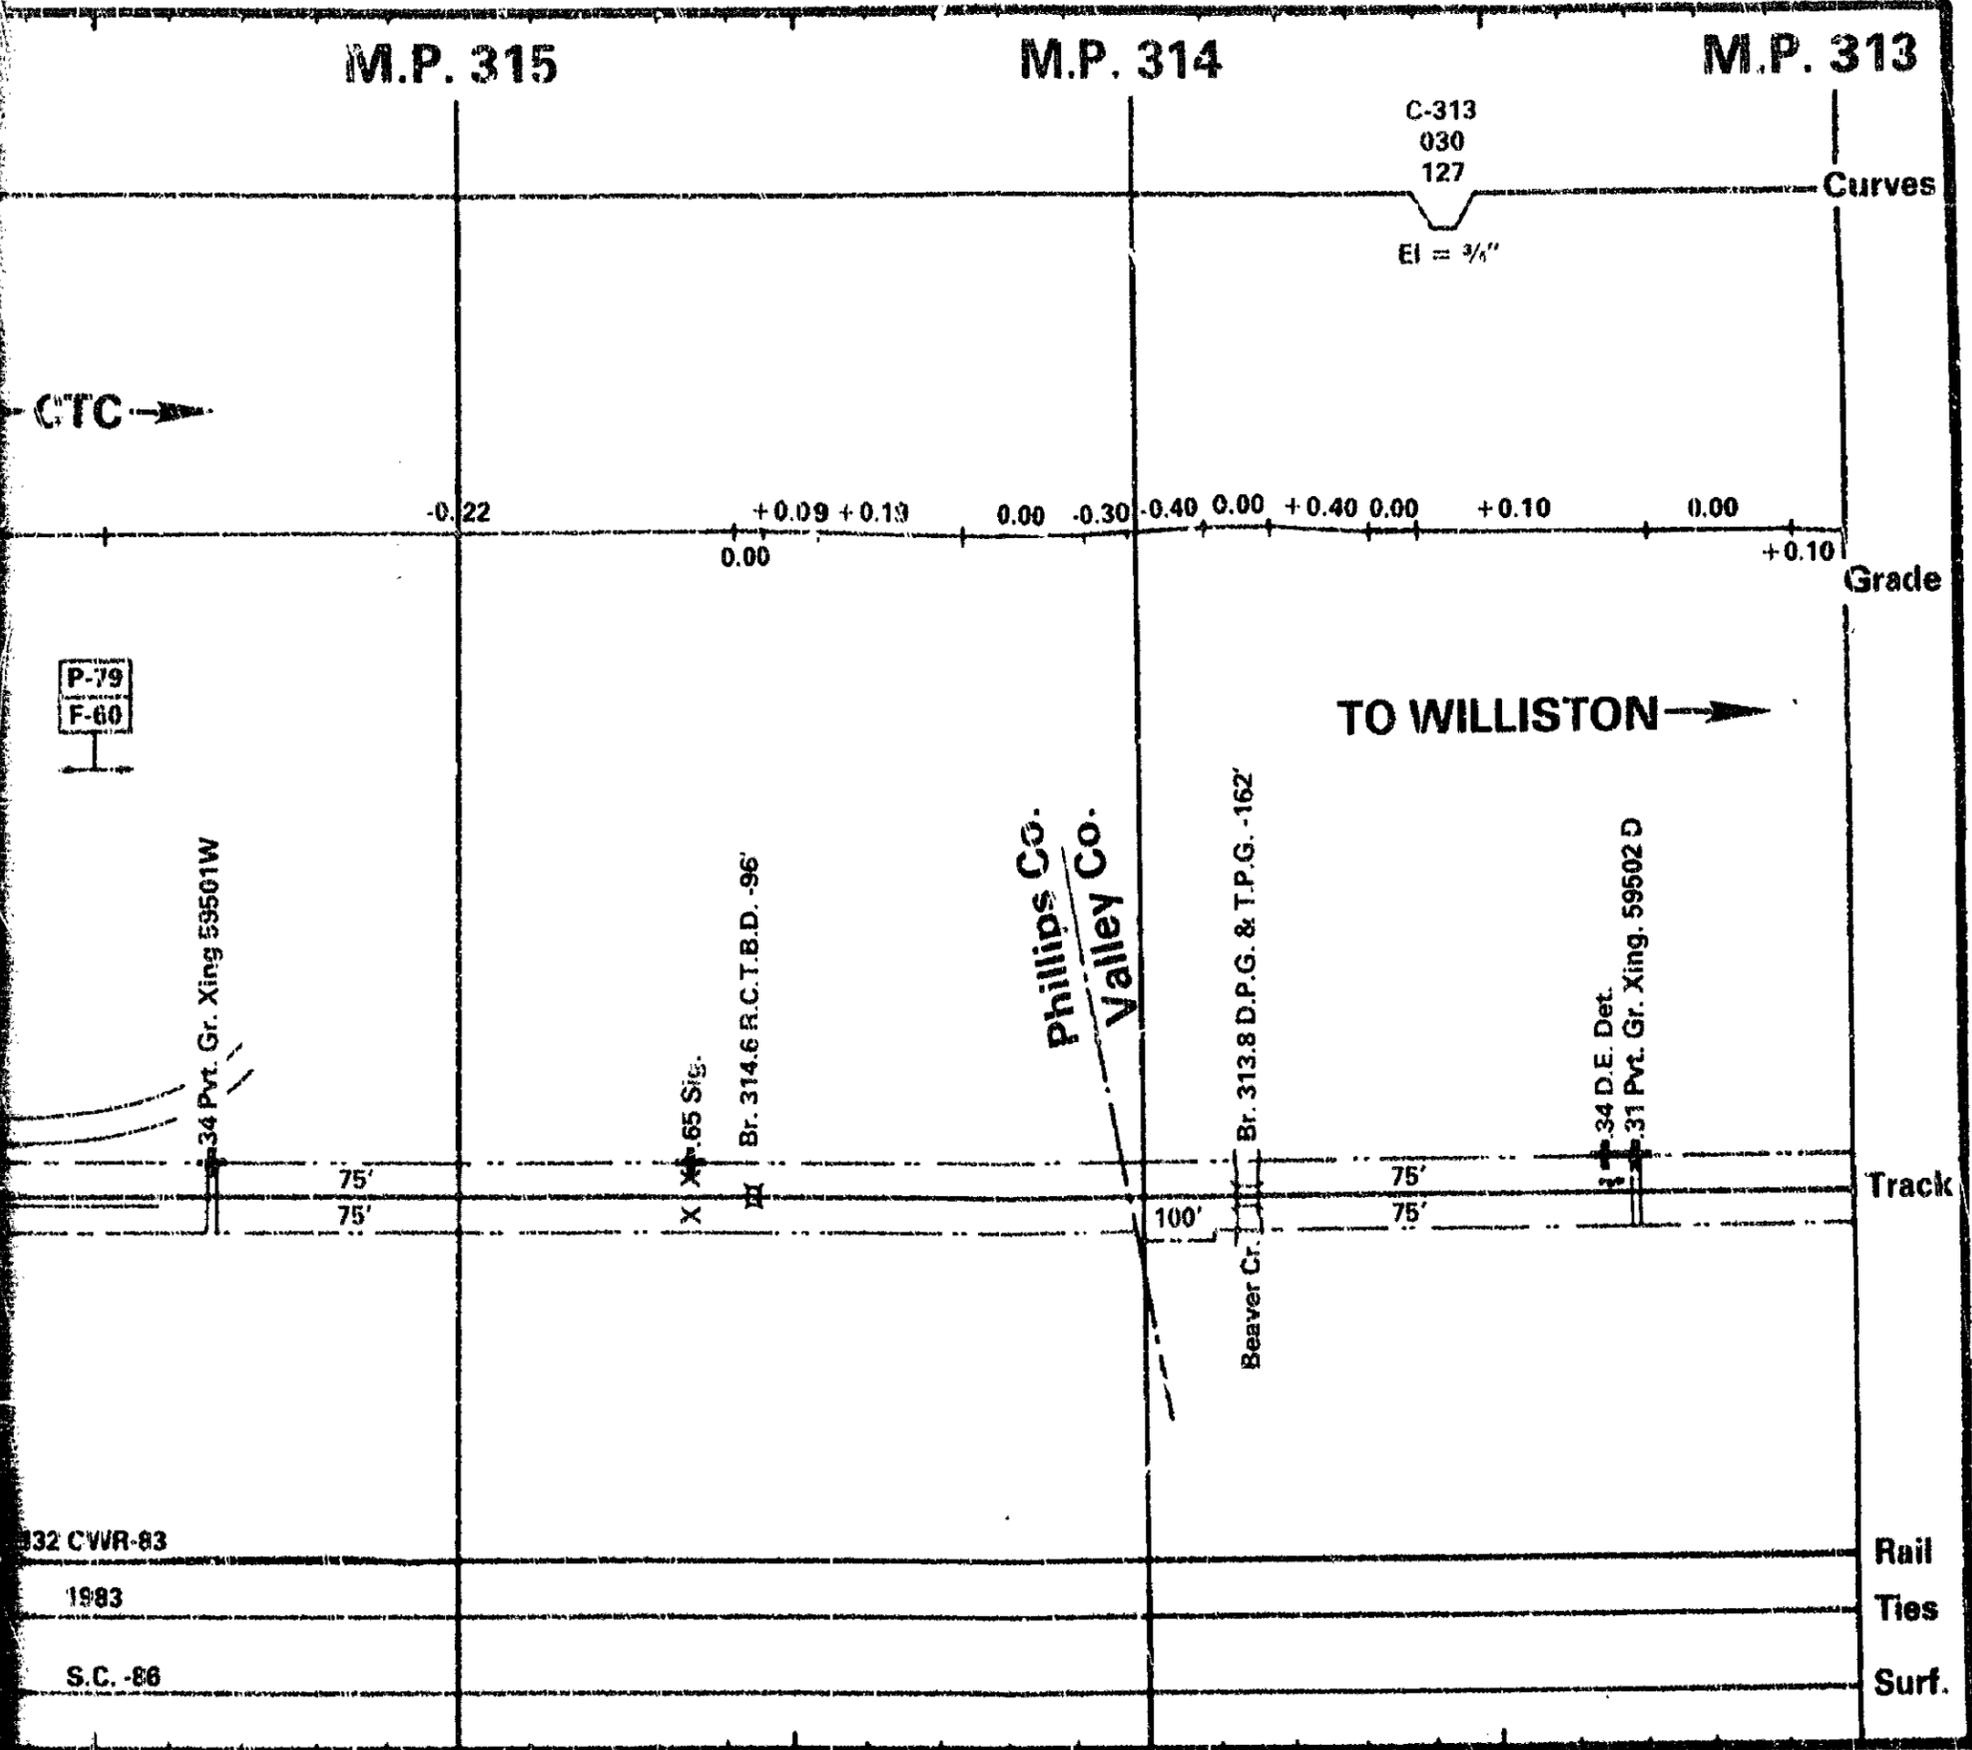
Figure 9. - - BN conso

General.--Train 7 derailed on BN's Montana Division, First Subdivision, in the area of mp 316.94. The track structure in the accident area consists of a single main track and a single passing track. (See figure 9.)
