PB91-916301
NTSB/RAR-91/01

RAILROAD ACCIDENT REPORT

**DERAILMENT OF
SOUTHEASTERN PENNSYLVANIA
TRANSPORTATION AUTHORITY (SEPTA)
COMMUTER TRAIN 61
PHILADELPHIA, PENNSYLVANIA
MARCH 7, 1990**

Abstract: This report explains the derailment of Southeastern Pennsylvania Transportation Authority (SEPTA) commuter train 61 in Philadelphia, Pennsylvania, on March 7, 1990. The safety issues discussed in the report are mechanical inspection procedures and maintenance practice oversight, supervision and training of SEPTA employees responsible for transit equipment, failure of the motor support bolt assembly, Federal and State regulatory requirements for mass transit operating practices and mechanical equipment inspectors, effectiveness of SEPTA's drug and alcohol testing program, and emergency communication between operating crews, tower personnel, and emergency response personnel. Recommendations concerning these issues were made to SEPTA, the Governor of Pennsylvania, the Transport Workers Union, and the City of Philadelphia Fire Department.

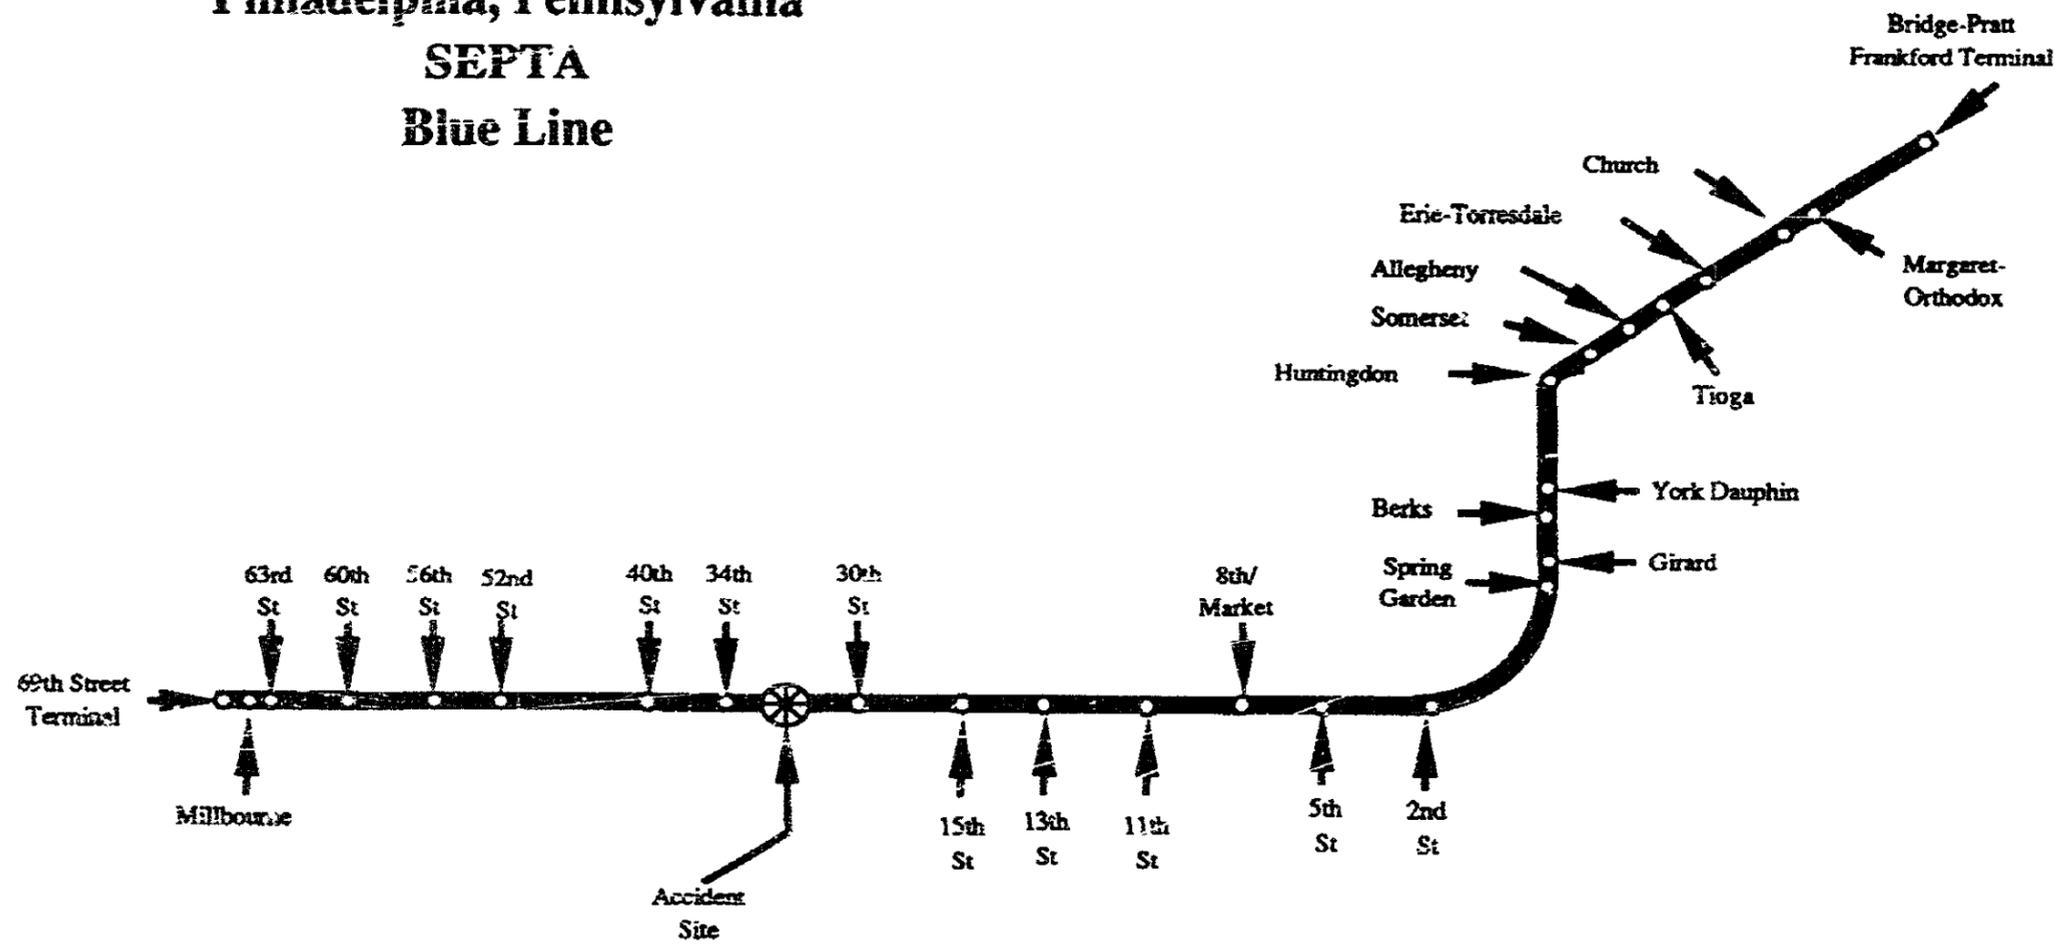
Philadelphia, Pennsylvania
SEPTA
Blue Line

While the train was going east it passed the Bridge-Pratt dragging equipment detector without tripping it. The detector is 9.2 miles from the accident site; it is a mechanical device that is pushed over if objects are being dragged along beneath the cars. If triggered, it activates an alarm in the tower, causing the tower personnel to notify the train operator. The towerman on duty at the Bridge-Pratt station at the time of the accident verified that the detector had not sounded as the train passed over it. The train completed the crossover from the eastbound to the westbound track behind the station tower. The motorman "changed ends" by moving the controls from what was now the last car to what was now the first car (from car 725 to car 769). He returned the train to the platform for the return trip to the 69th Street terminal. The train departed about 0754. According to the crewmembers, the trip to the 30th Street station was uneventful. The line supervisor

9.2 Miles Bridge-Pratt To Accident Site
 West of 30th Street Station

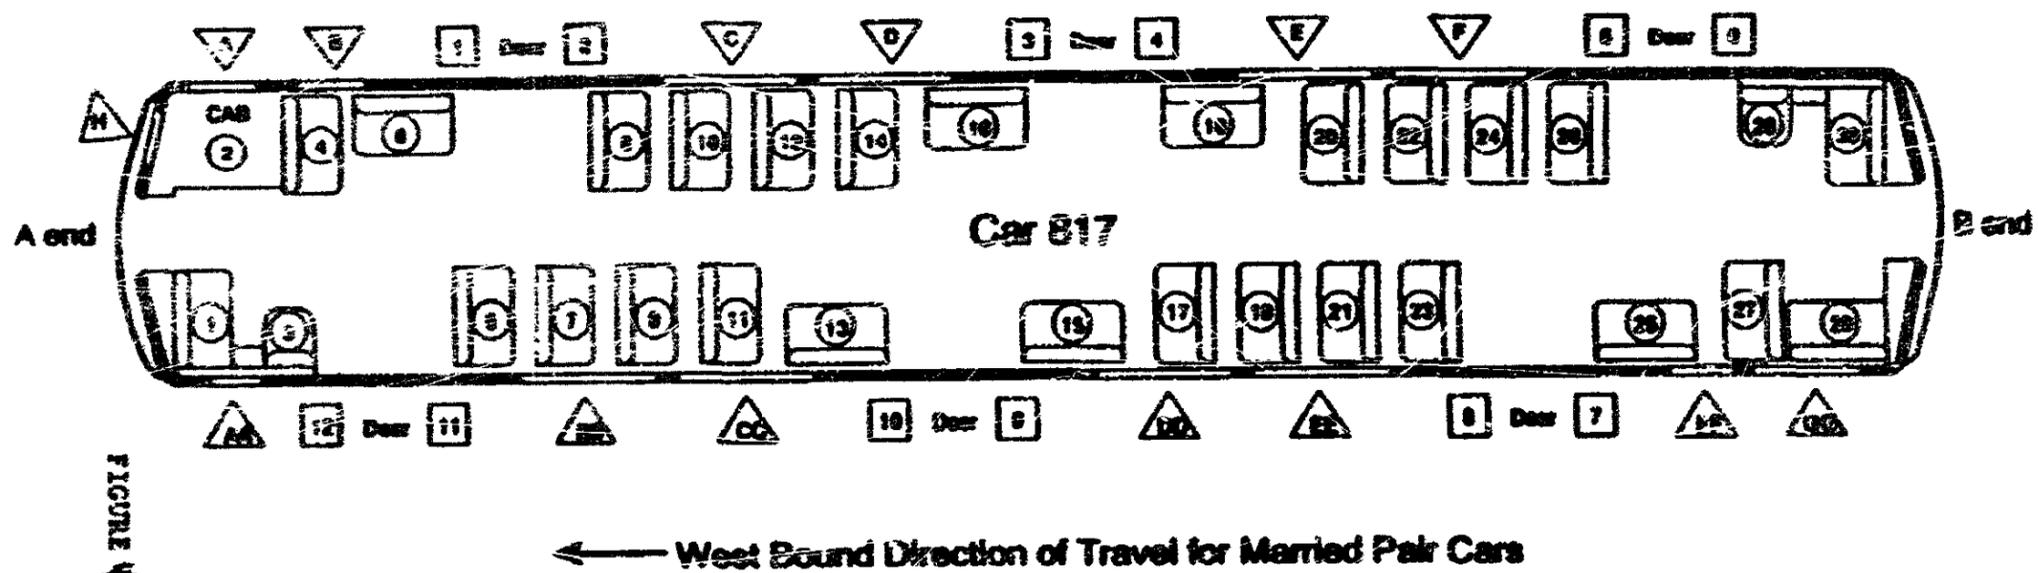
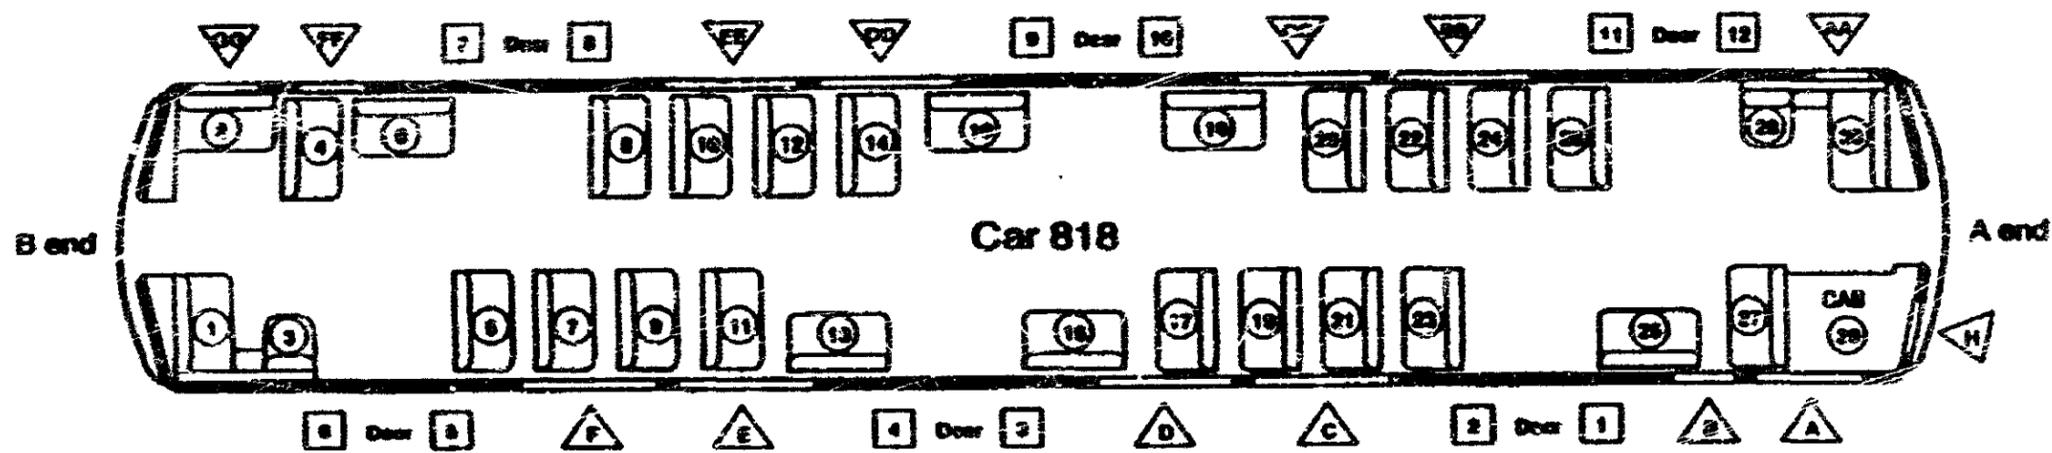
FIGURE 3

Figure 3.--Postaccident number and lettering system for seats, windows, and doors of SEPTA cars 817 and 818.

The seats in all the cars were numbered 1 through 30 from the A end. The six biparting automatic sliding doors were numbered 1 through 12 clockwise, starting with the right A end door. The windows were lettered A through F on the cab side and AA through GG on the opposite side. Windows A and H were the cab windows. (See figure 3.)
