PB91-916305  
NTSB/RAR-91/05

**RAILROAD ACCIDENT REPORT**

**DERAILMENT OF AMTRAK TRAIN NO. 6  
ON THE BURLINGTON NORTHERN RAILROAD  
BATAVIA, IOWA  
APRIL 23, 1990**

**Abstract:** This report explains the derailment of Amtrak Train No. 6 on the Burlington Northern Railroad at Batavia, Iowa, on April 23, 1990. The safety issues discussed in this report are: the lack of consistency, continuity, and comprehensiveness in Burlington Northern's Maintenance of Way Standard Practice Circulars; the efficacy of the rail expansion and contraction tables in Burlington Northern's Maintenance of Way Rules for in-track electric flash butt-welding operations; the propriety of conducting in-track electric flash butt-welding operations and out of face maintenance operations in cold weather; the effectiveness of Burlington Northern's track buckling prevention seminar for the in-track electric flash butt-welding operation; the adequacy of Burlington Northern's supervision of in-track electric flash butt-welding operations and implementation of maintenance of way standards; the ambiguity of Burlington Northern's rail temperature record form; and the lack of temperature quality control measures such

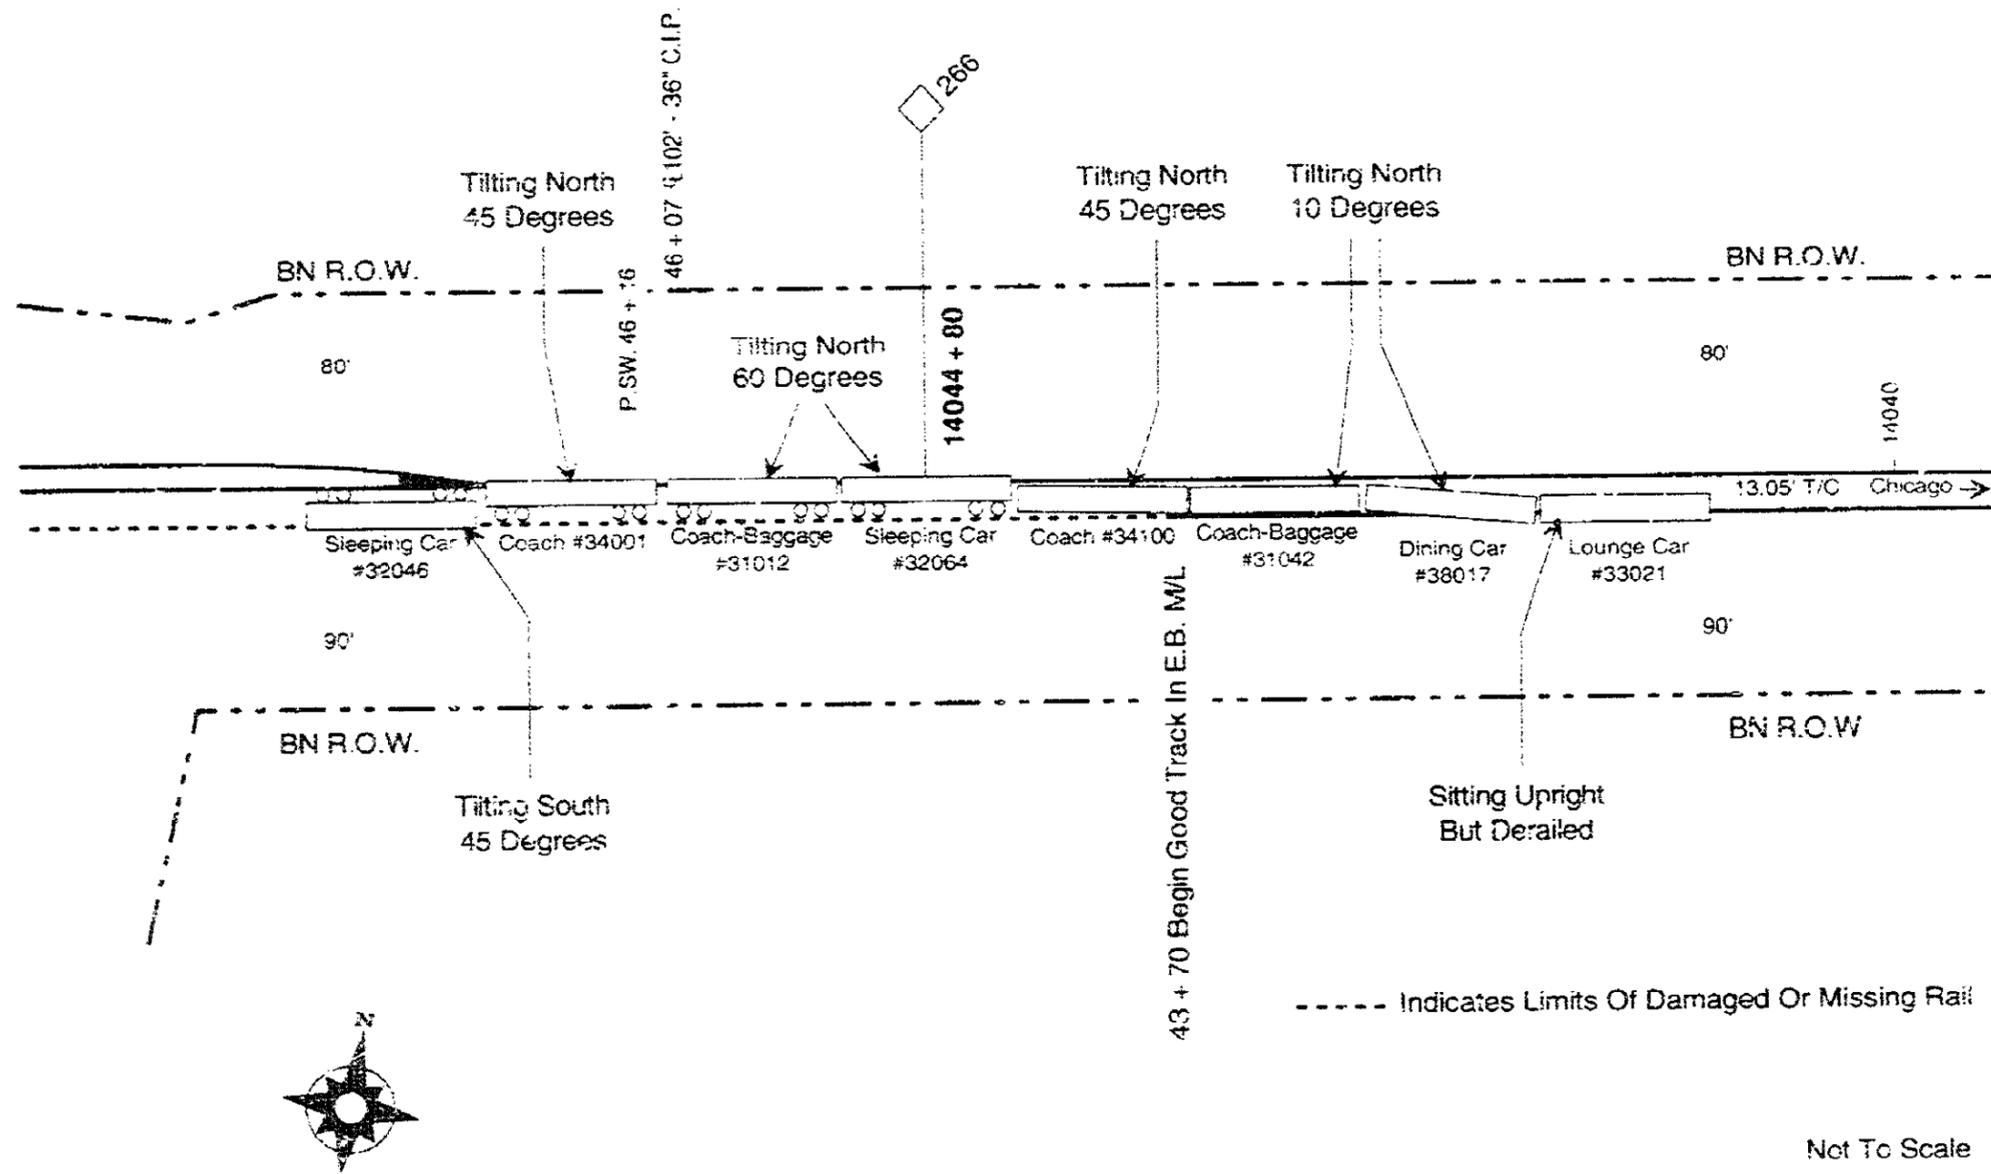
Figure 2.--Accident site diagram.

About 1:26 p.m., the last eight cars of train No. 6 derailed on the BN mainline track near MP 266 at Batavia, Iowa. The first derailed car, lounge car No. 33021, remained upright. The other cars, except the last one, came to rest leaning to the north at various angles; the last car leaned toward the south. The eight cars came to rest in a very shallow arc. The lead derailed car was almost centered on the eastbound track and the last car was just south of the eastbound track. The last four derailed cars had struck and sideswiped a gondola<sup>6</sup> car parked on an adjacent siding. None of the derailed cars rolled over on their side, although several leaned severely. The train remained coupled throughout the derailment. (See figures 2 and 3.)

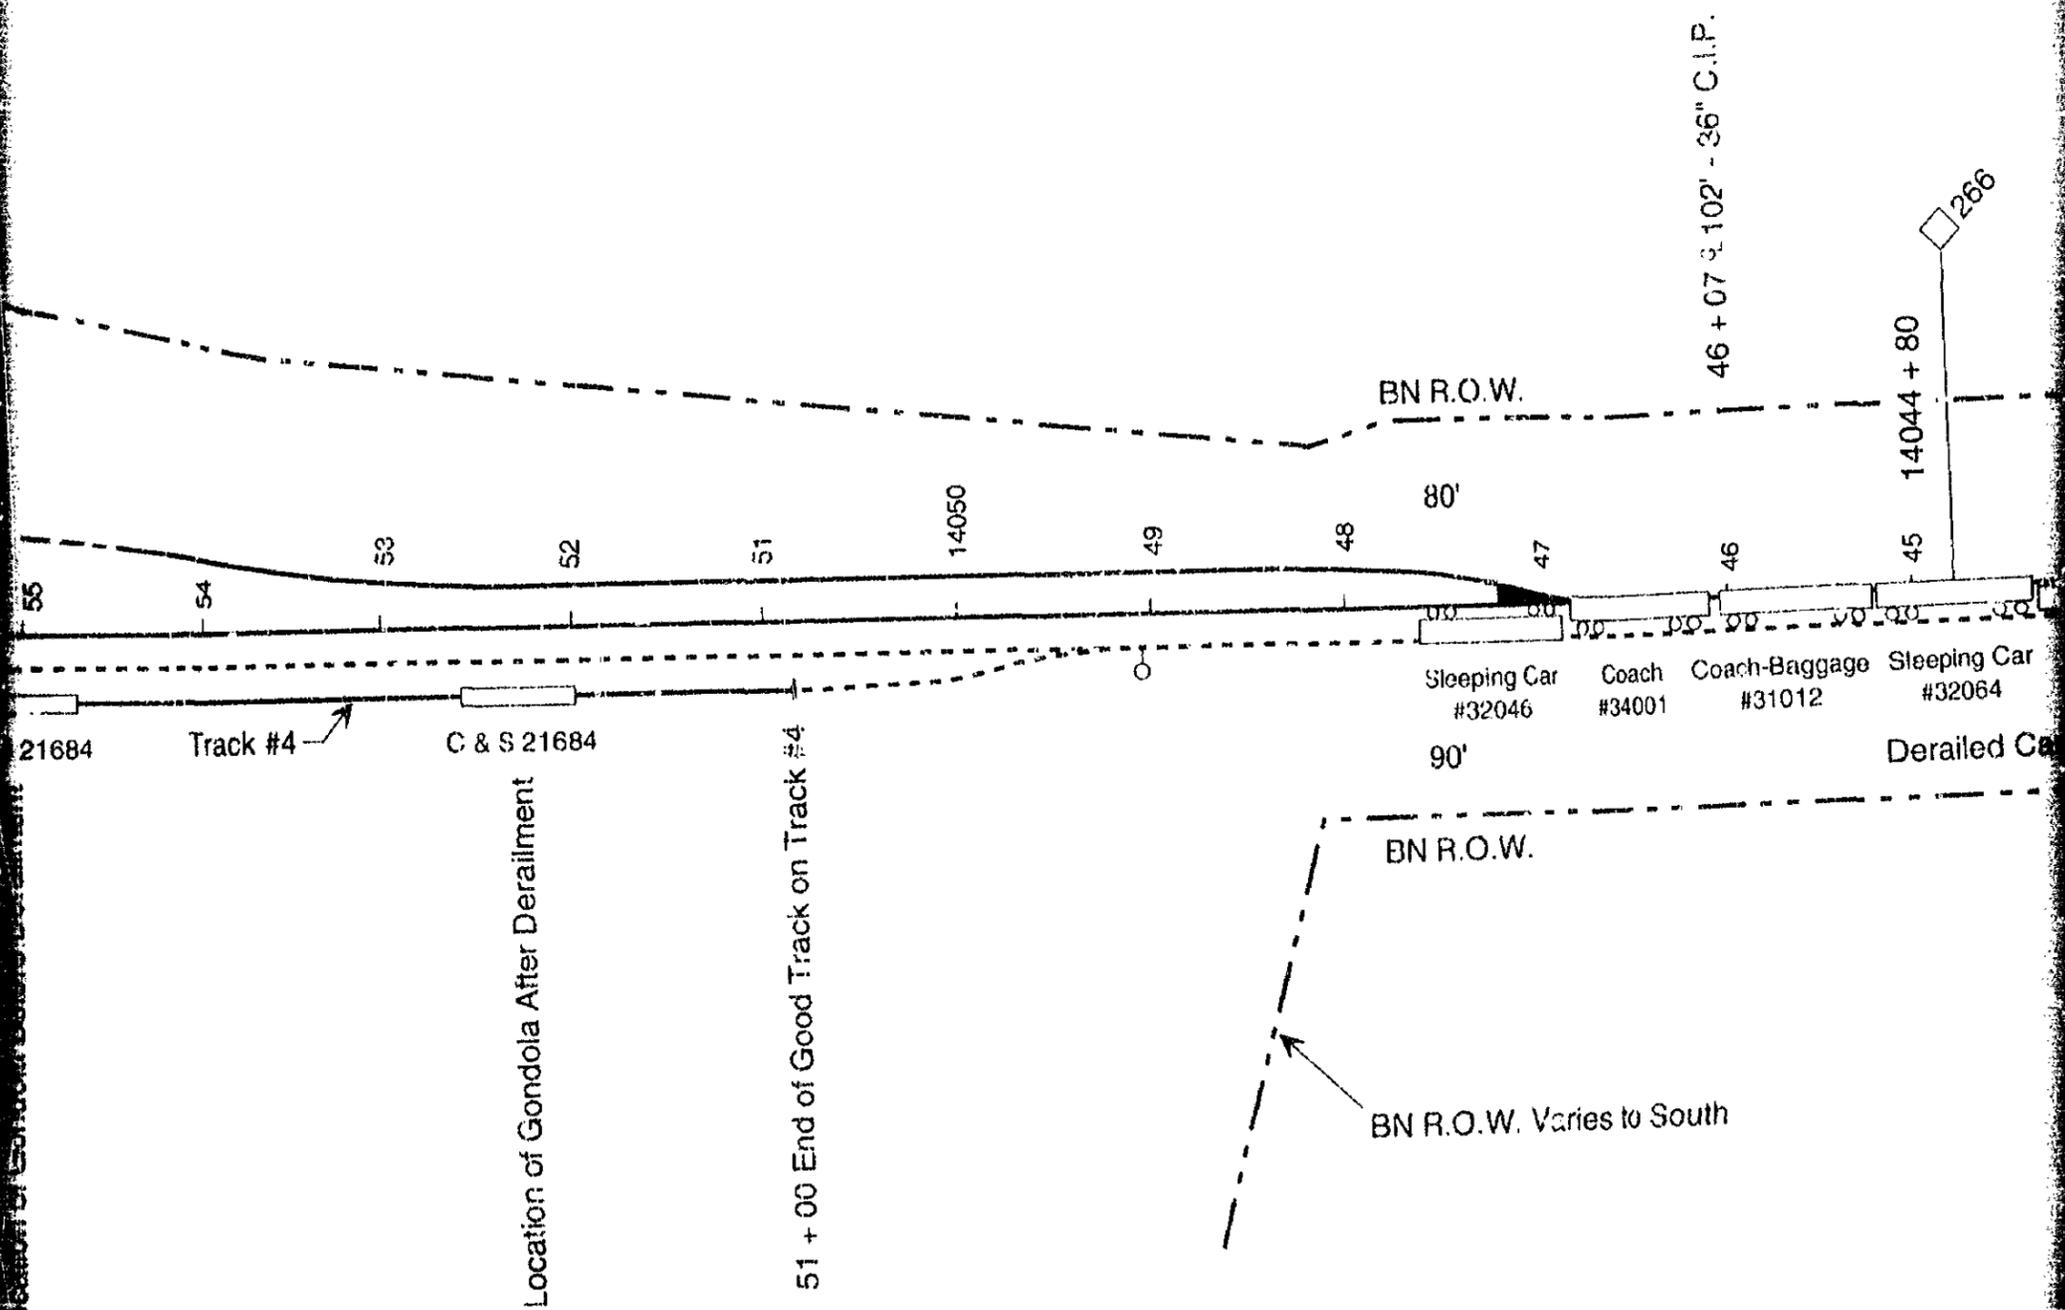
Figure 6. -- Batavia, Iowa, track arrangement.

County Road 43, a north-south public road, runs through Batavia and crosses the railroad at grade. The grade crossing has flashing warning lights. Just west of the road crossing, the railroad curves 1° 02' for about 1/4 mile, limiting sight distance east of the road crossing and through Batavia. A turnout for a track crossover from the eastbound No. 2 track to the westbound No. 1 track is about 400 feet east of the road crossing. Both railroad crossover turnouts are No. 11, 132-lb. R.E. rail with railbound manganese frogs<sup>12</sup>. A left hand turnout to a track siding is located at MP 266 and extends about 1/10 mile south and parallel to the eastbound No. 2 mainline track. (See figure 6.)
