PB93-916304
NTSB/RAR-93/03

RAILROAD ACCIDENT REPORT

COLLISION BETWEEN NORTHERN INDIANA
COMMUTER TRANSPORTATION DISTRICT
EASTBOUND TRAIN 7 AND WESTBOUND TRAIN 12
NEAR GARY, INDIANA, ON JANUARY 18, 1993

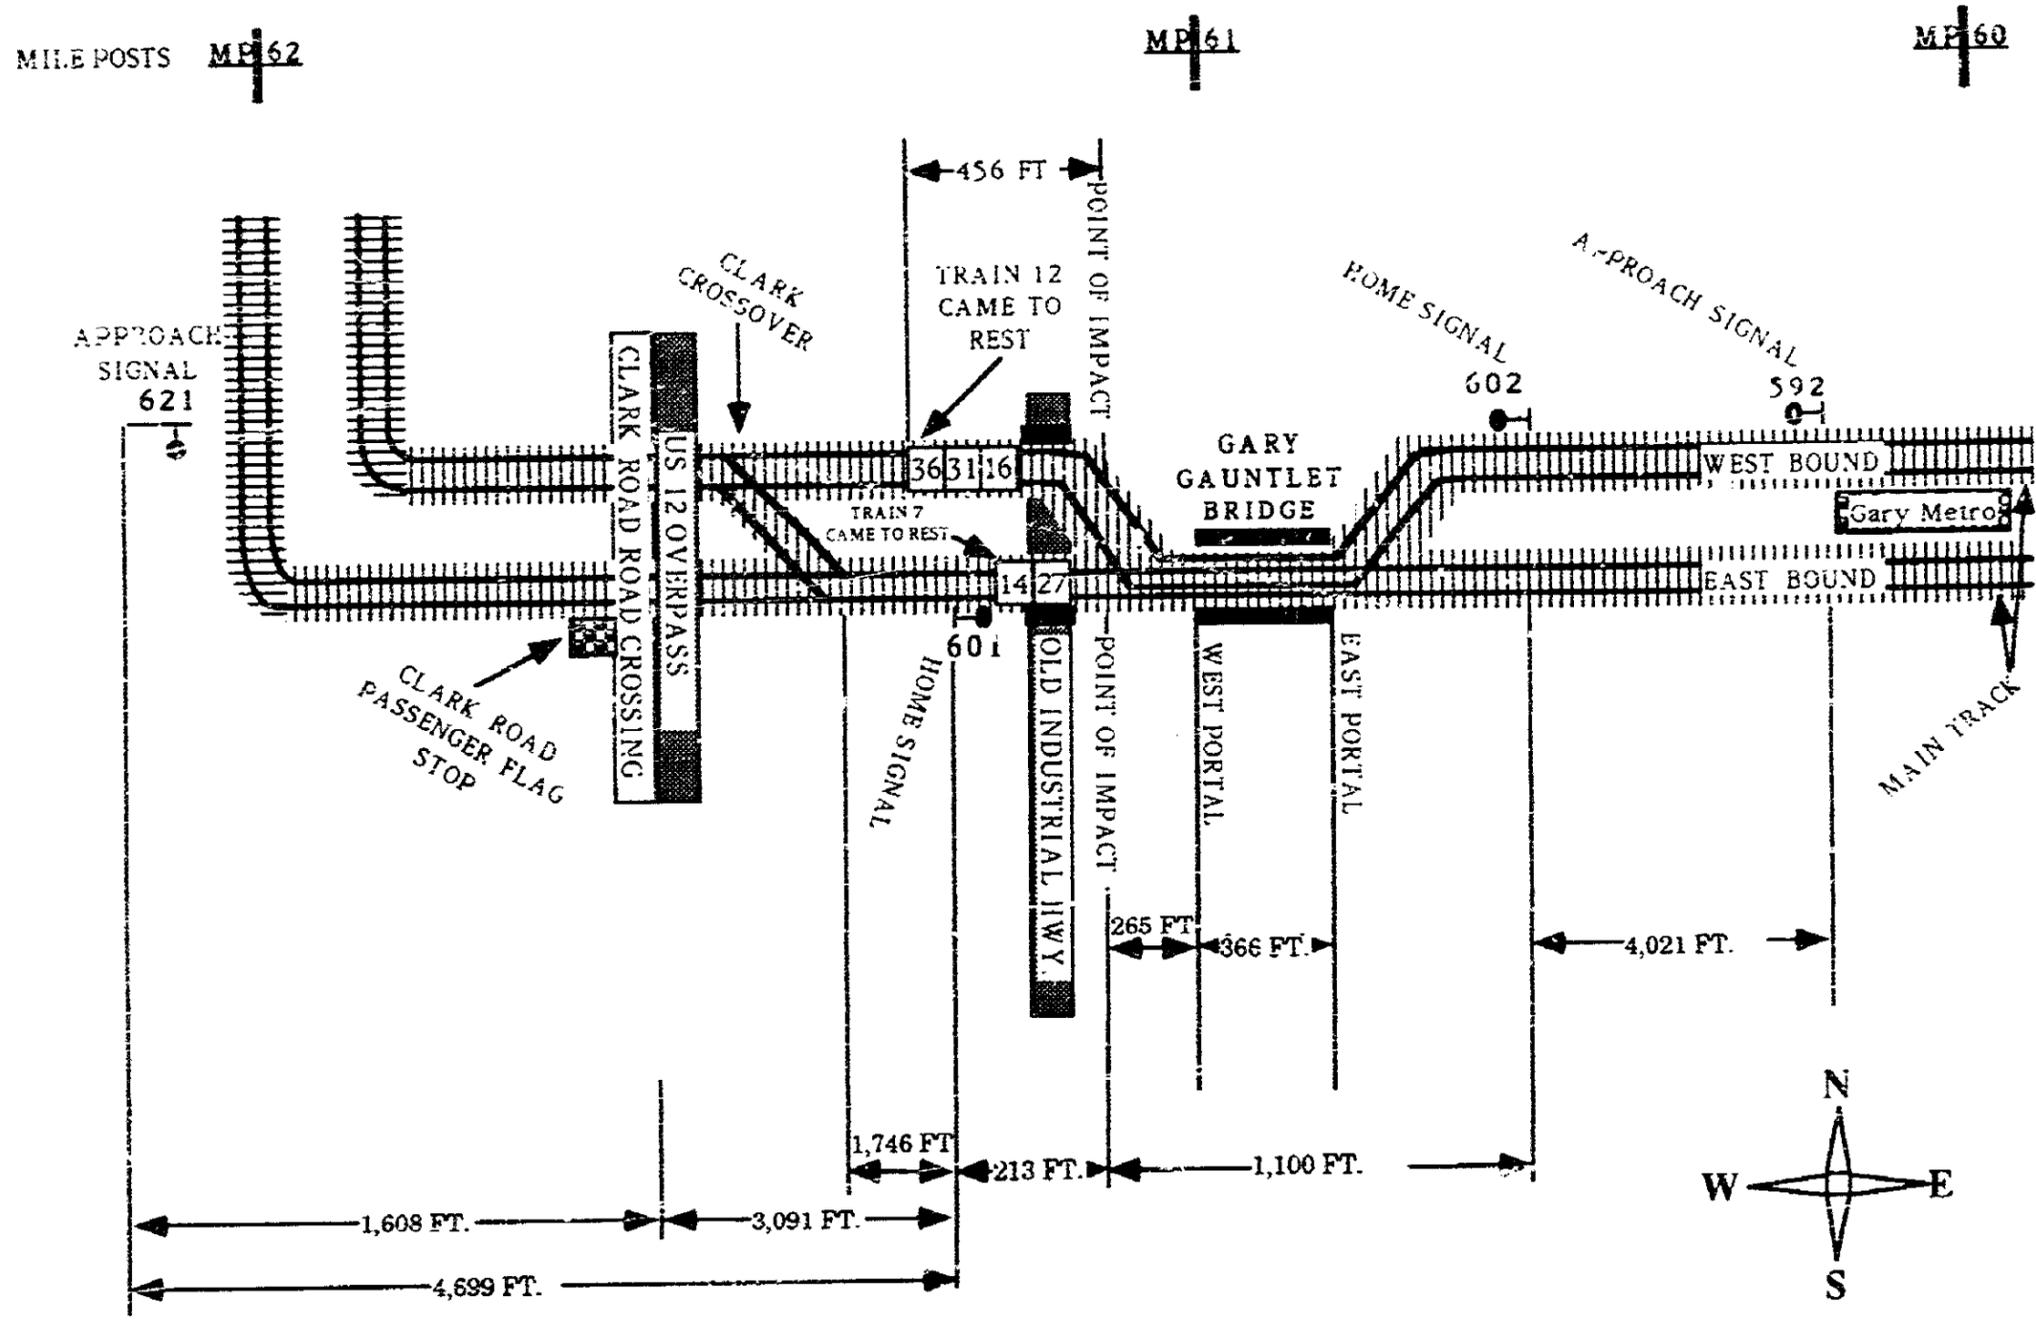
Figure 2.--Postaccident track diagram.

The engineer stated that after train 7 left the Hammond station and neared signal 621, he was operating the train at a speed of about 70 miles per hour (mph).¹ He said that as train 7 approached signal 621 (see figure 2), the signal indication changed from yellow (approach) to

The engineer of train 7 continued by saying that he recalled when the signal looked "dark," he then stood up to have a better view and saw the signal was "red." He added that the train was about 212 feet west of the signal when he saw it as "red" and that he immediately placed the train brakes in emergency application. Train 7 came to rest about 213 feet east of signal 601 and encroached the westbound track by 1 foot. (See figure 2.) The engineer said that once train 7 came to "rest," he could see train 12 on the bridge. This train collided with train 7, which pushed train 7 westward about 12 feet from the point of impact.

Track and Operations -- The accident occurred at milepost (MP) 61.1, west of the two-span 366-foot long Gary Gauntlet Bridge. The NICTD designates its track at MP 61 as class 3 in accordance with 49 Code of Federal Regulations (CFR) 213.9. The track met all applicable FRA standards. Two sets of track approach the bridge from the east and the west on a 2.5 percent grade. Because the bridge is narrow, a frog⁸ is used at each end of the structure to overlap the two tracks and form a gauntlet track. (See figure 2.) This particular track pattern allows only one direction of traffic on the bridge at a time.

Investigation disclosed that the point of impact was 265 feet west of the west end of the Gary Gauntlet Bridge (see figure 2). The engineer of train 12 stated that when he cleared the west end of the bridge he realized that train 7 was still moving and "everything happened too fast at that point." He further stated that he "was looking for a head-on collision at that particular time because of the fact that I was moving and, as far as I could tell, train 7 was still moving, and I could see us colliding on the straight track."
