NATIONAL TRANSPORTATION SAFETY BOARD

RAILROAD-MARINE ACCIDENT REPORT

**DERAILMENT OF AMTRAK TRAIN NO. 2
ON THE CSXT BIG BAYOU CANOT BRIDGE
NEAR MOBILE, ALABAMA
SEPTEMBER 22, 1993**

**Adopted: September 19, 1994
Notation 6167B**

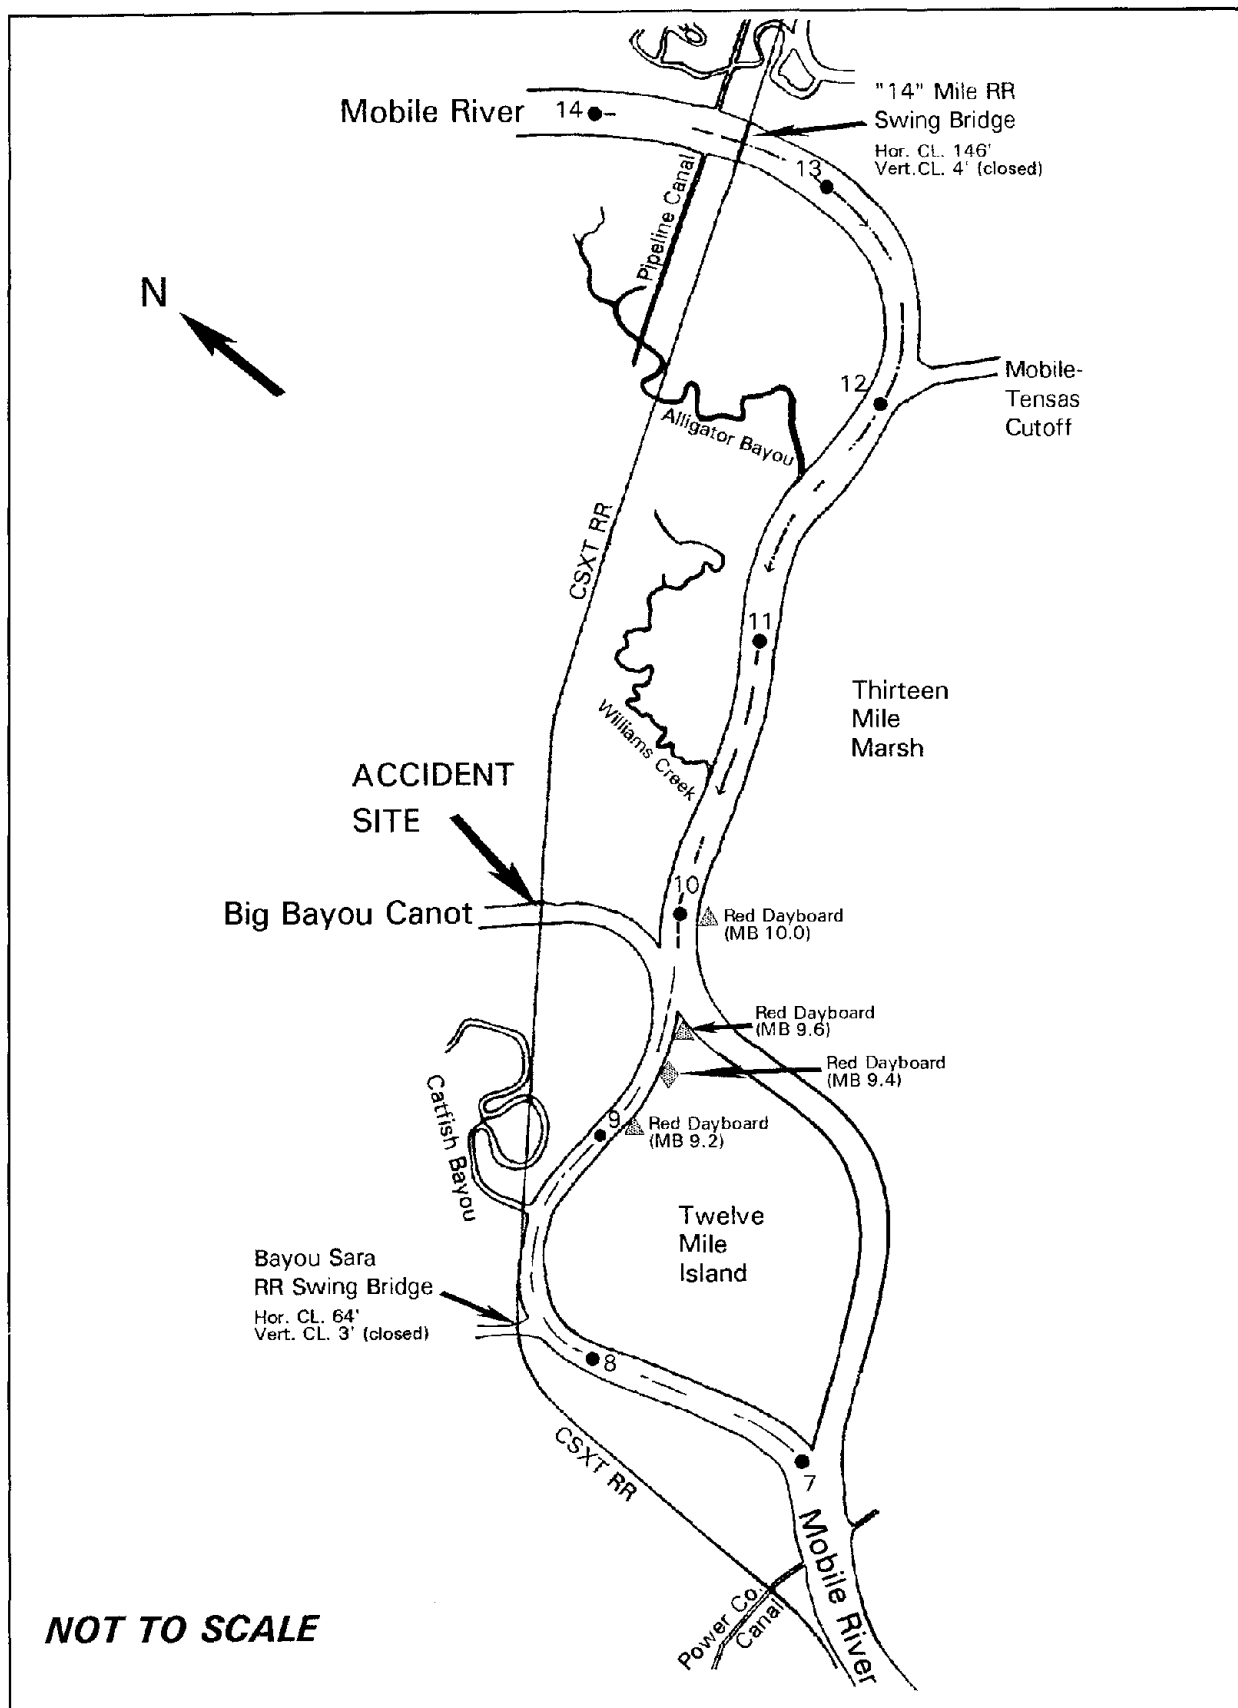
He stated that visibility was good³ and recalled learning from marine radio conversations shortly before he departed that conditions were foggy north of his position. He could see the THOMAS B. McCABE's stern lights until that vessel rounded a bend in the Mobile River at Bayou Sara (about mile 8.2). The MAUVILLA's position at the time, according to the pilot, was near the south end of Twelve Mile Island (mile 7), and he recalled visibility beginning to become "hazy" there (see figure 2).

Figure 2.--Mobile River chart.

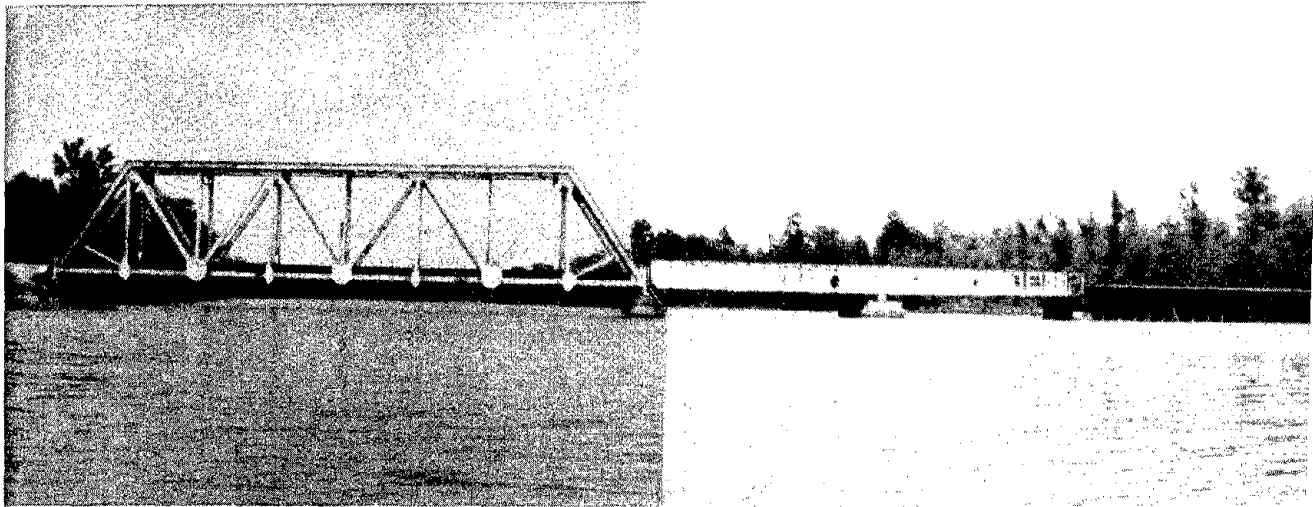
Figure 3.--Last inspection photograph of Big Bayou Canot railroad bridge before accident.

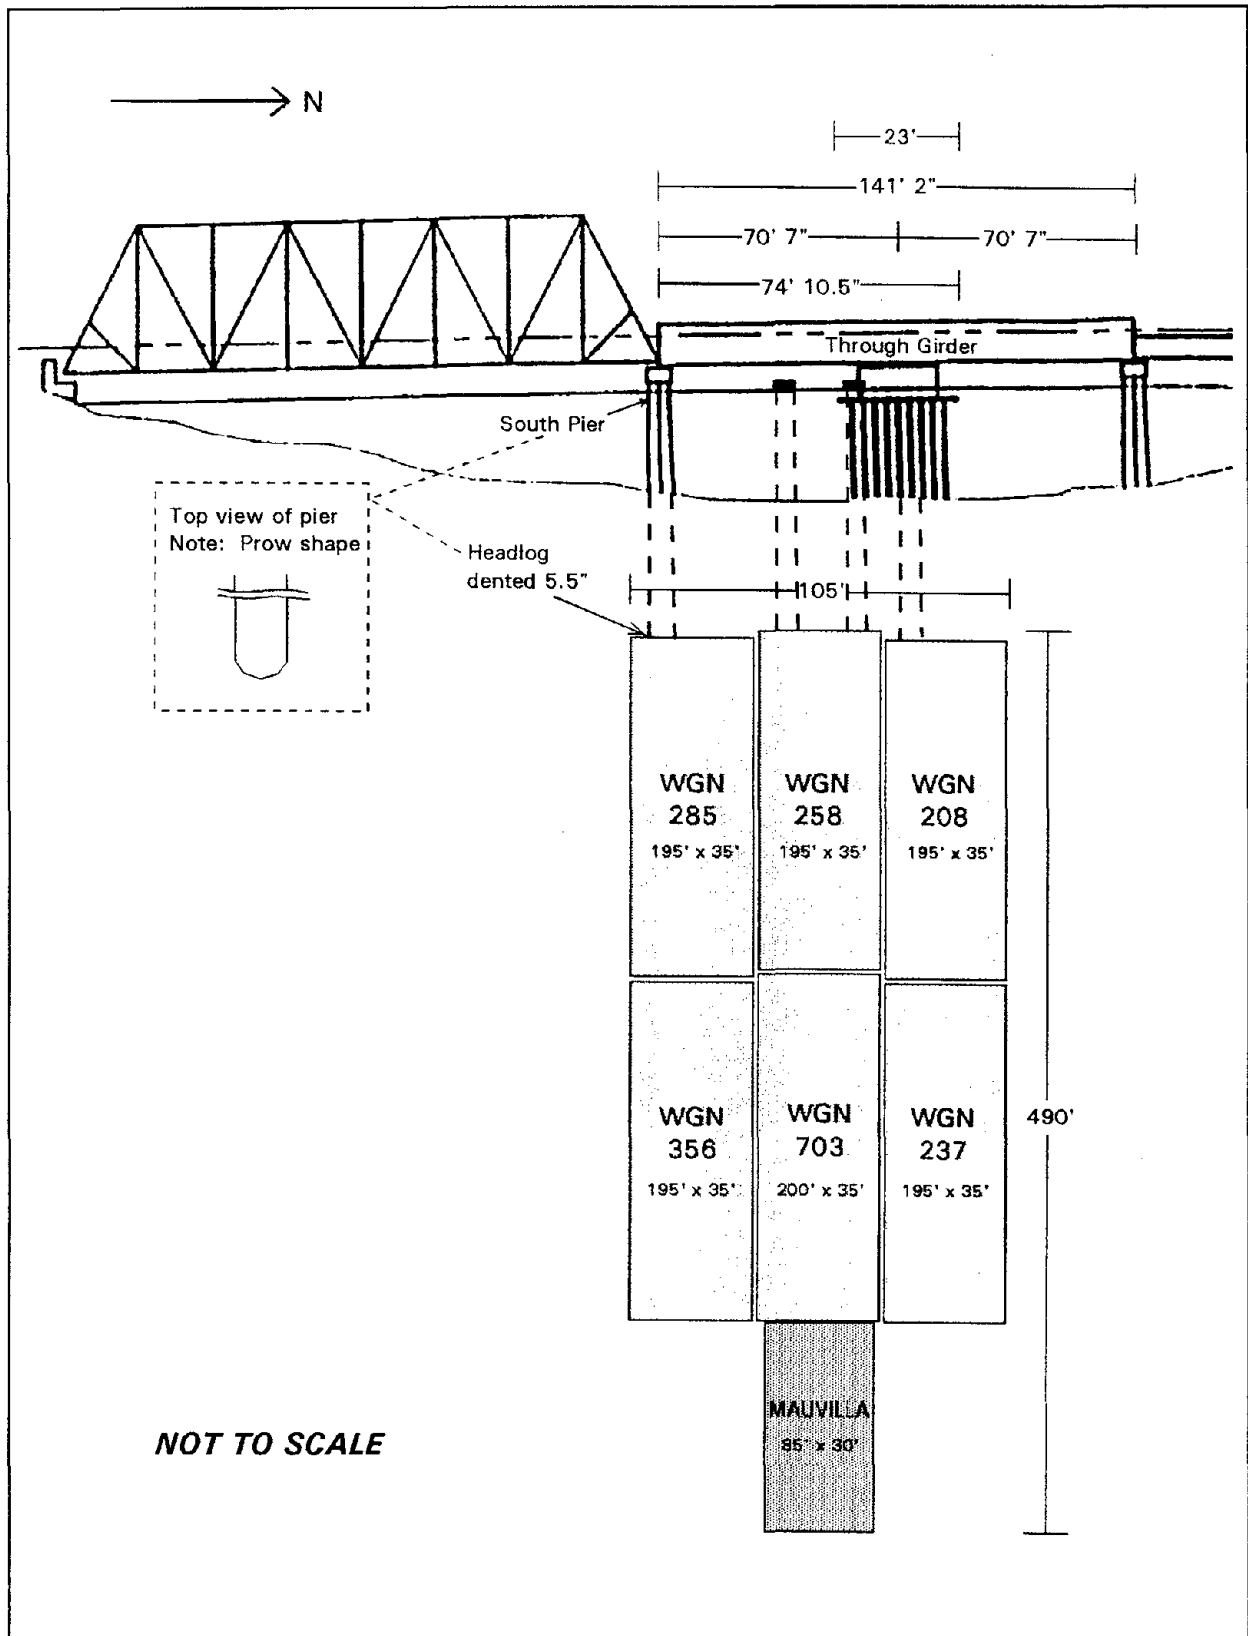
Figure 4.--MAUVILLA tow configuration and Big Bayou Canot bridge.

was drydocked at W&GN's yard on September 27, 1993, for a hull survey. The marine investigative group noted no apparent damage to the hull, rudders, or propellers. Inspection revealed no evidence of a wire or other item having been wrapped around the propellers or rudders. The lead port (WGN 285) and starboard (WGN 208) barges (see figure 8) were slightly dented where they struck the bridge's concrete piers, and the center lead barge (WGN 258) had six marks on its headlog where it struck the vertical stiffeners on the bridge span (see figure 4). The other three barges were undamaged.

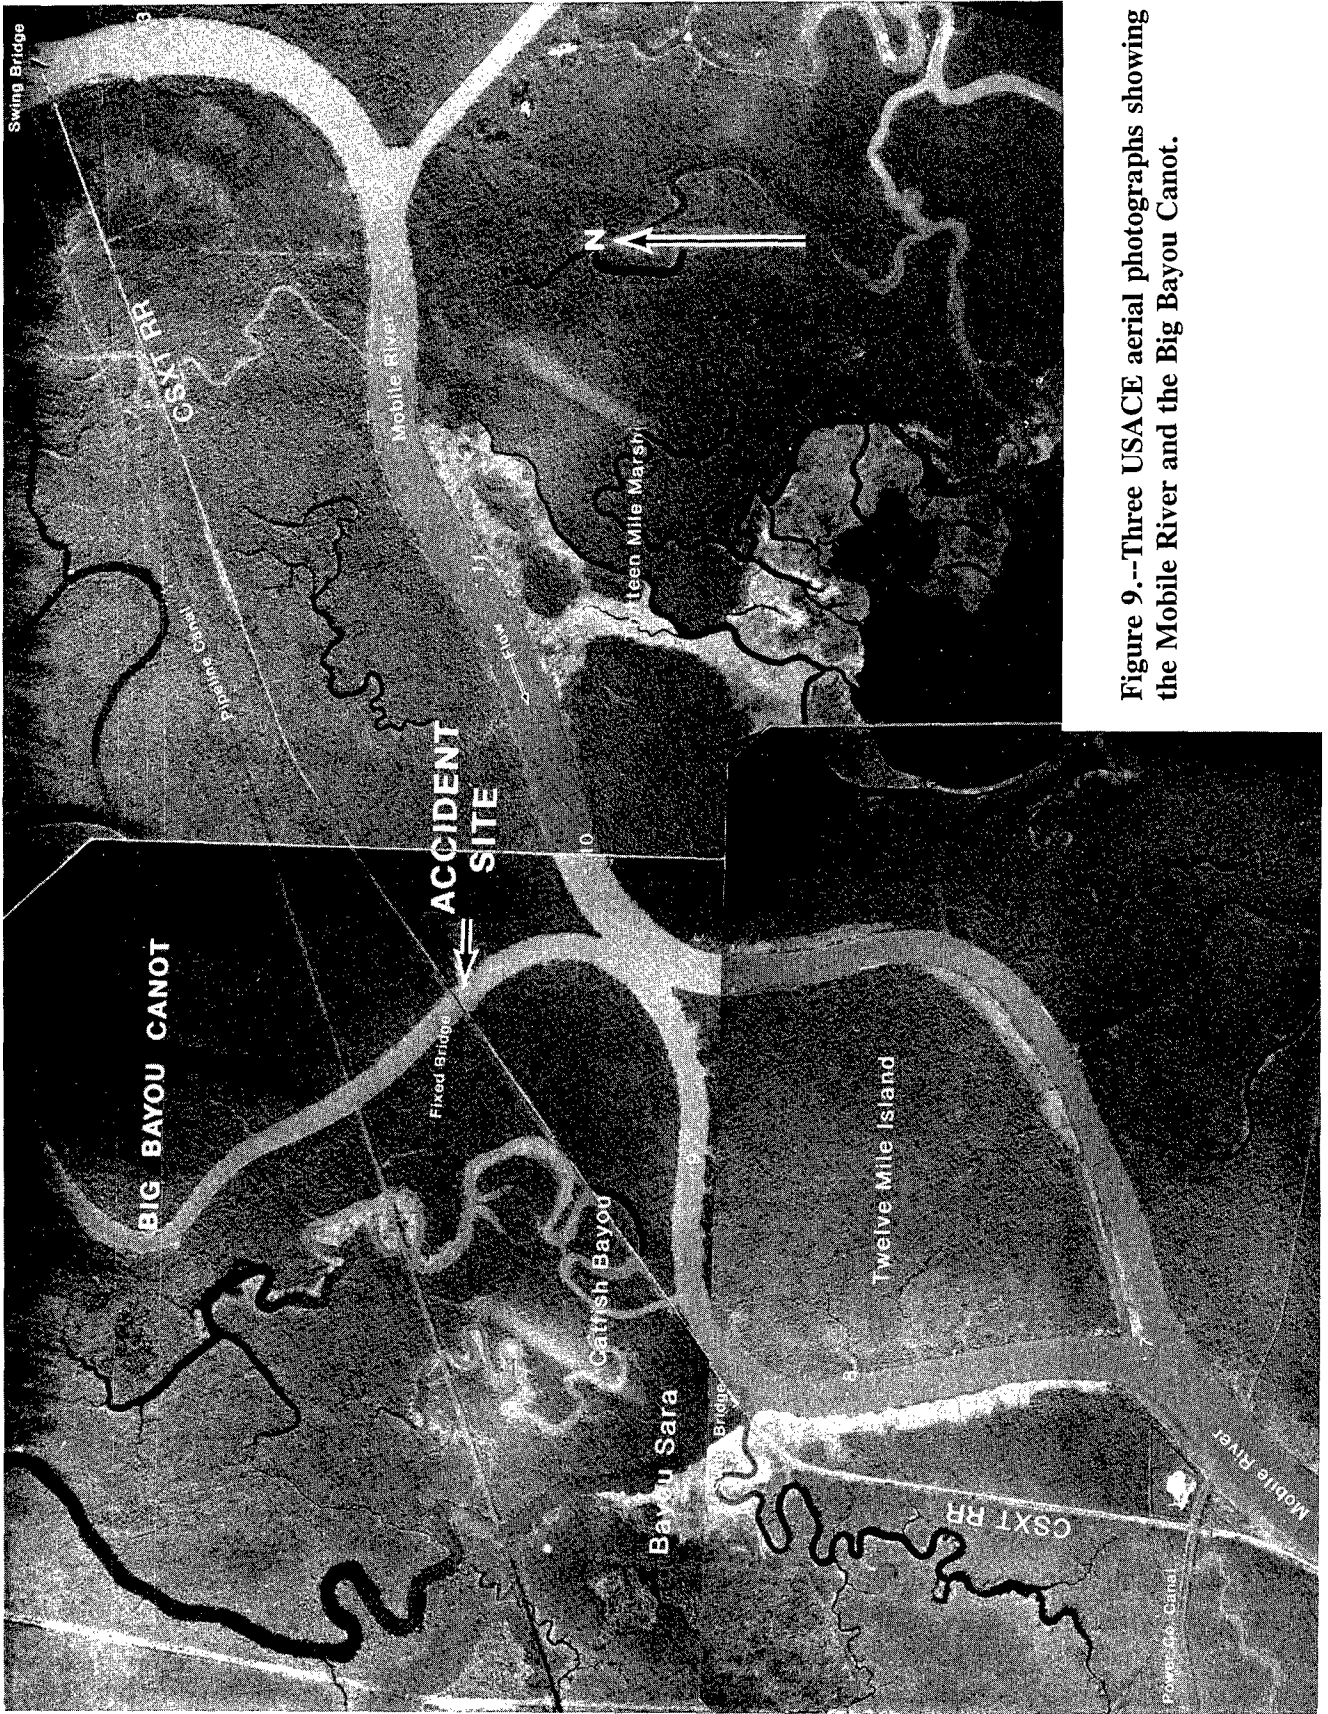
To continue upriver and avoid entering the Big Bayou Canot, a tow following the river curvature must stop its leftward movement (see figure 9). When the shorelines are visible, cues are available to guide an operator through the intersection. When the shorelines are obscured, an operator needs radar information to stay on the intended courses. He or she has to correlate the radar information with chart information or memory of the waterway's geography to determine the tow's location and choose the proper waterway.

Heading upriver about mile 9.1, the Mobile River begins curving to the left and spans an arc of about 95 degrees to the entrance of Big Bayou Canot, a distance of about 0.8 mile. Although the pilot said he did not see the intersection of the two waterways on the radar, it should have appeared on the radarscope about the time the tow passed mile 9.1 and should have remained there even after the MAUVILLA entered Big Bayou Canot if the radar was set to the 1/2-mile scale. Even if the radar was set to the 1/4-mile scale, the triangular point of land marking the north end of the intersection should have appeared on the radar shortly after the tow entered the intersection.

Figure 9.--Three USACE aerial photographs showing the Mobile River and the Big Bayou Canot.
