PB94-916302
NTSB/RAR-94/02

RAILROAD ACCIDENT REPORT

HEAD-ON COLLISION AND DERAILMENT OF
BURLINGTON NORTHERN FREIGHT TRAIN
WITH UNION PACIFIC FREIGHT TRAIN
KELSO, WASHINGTON
NOVEMBER 11, 1993

Adopted: November 15, 1994
Notation 6247A

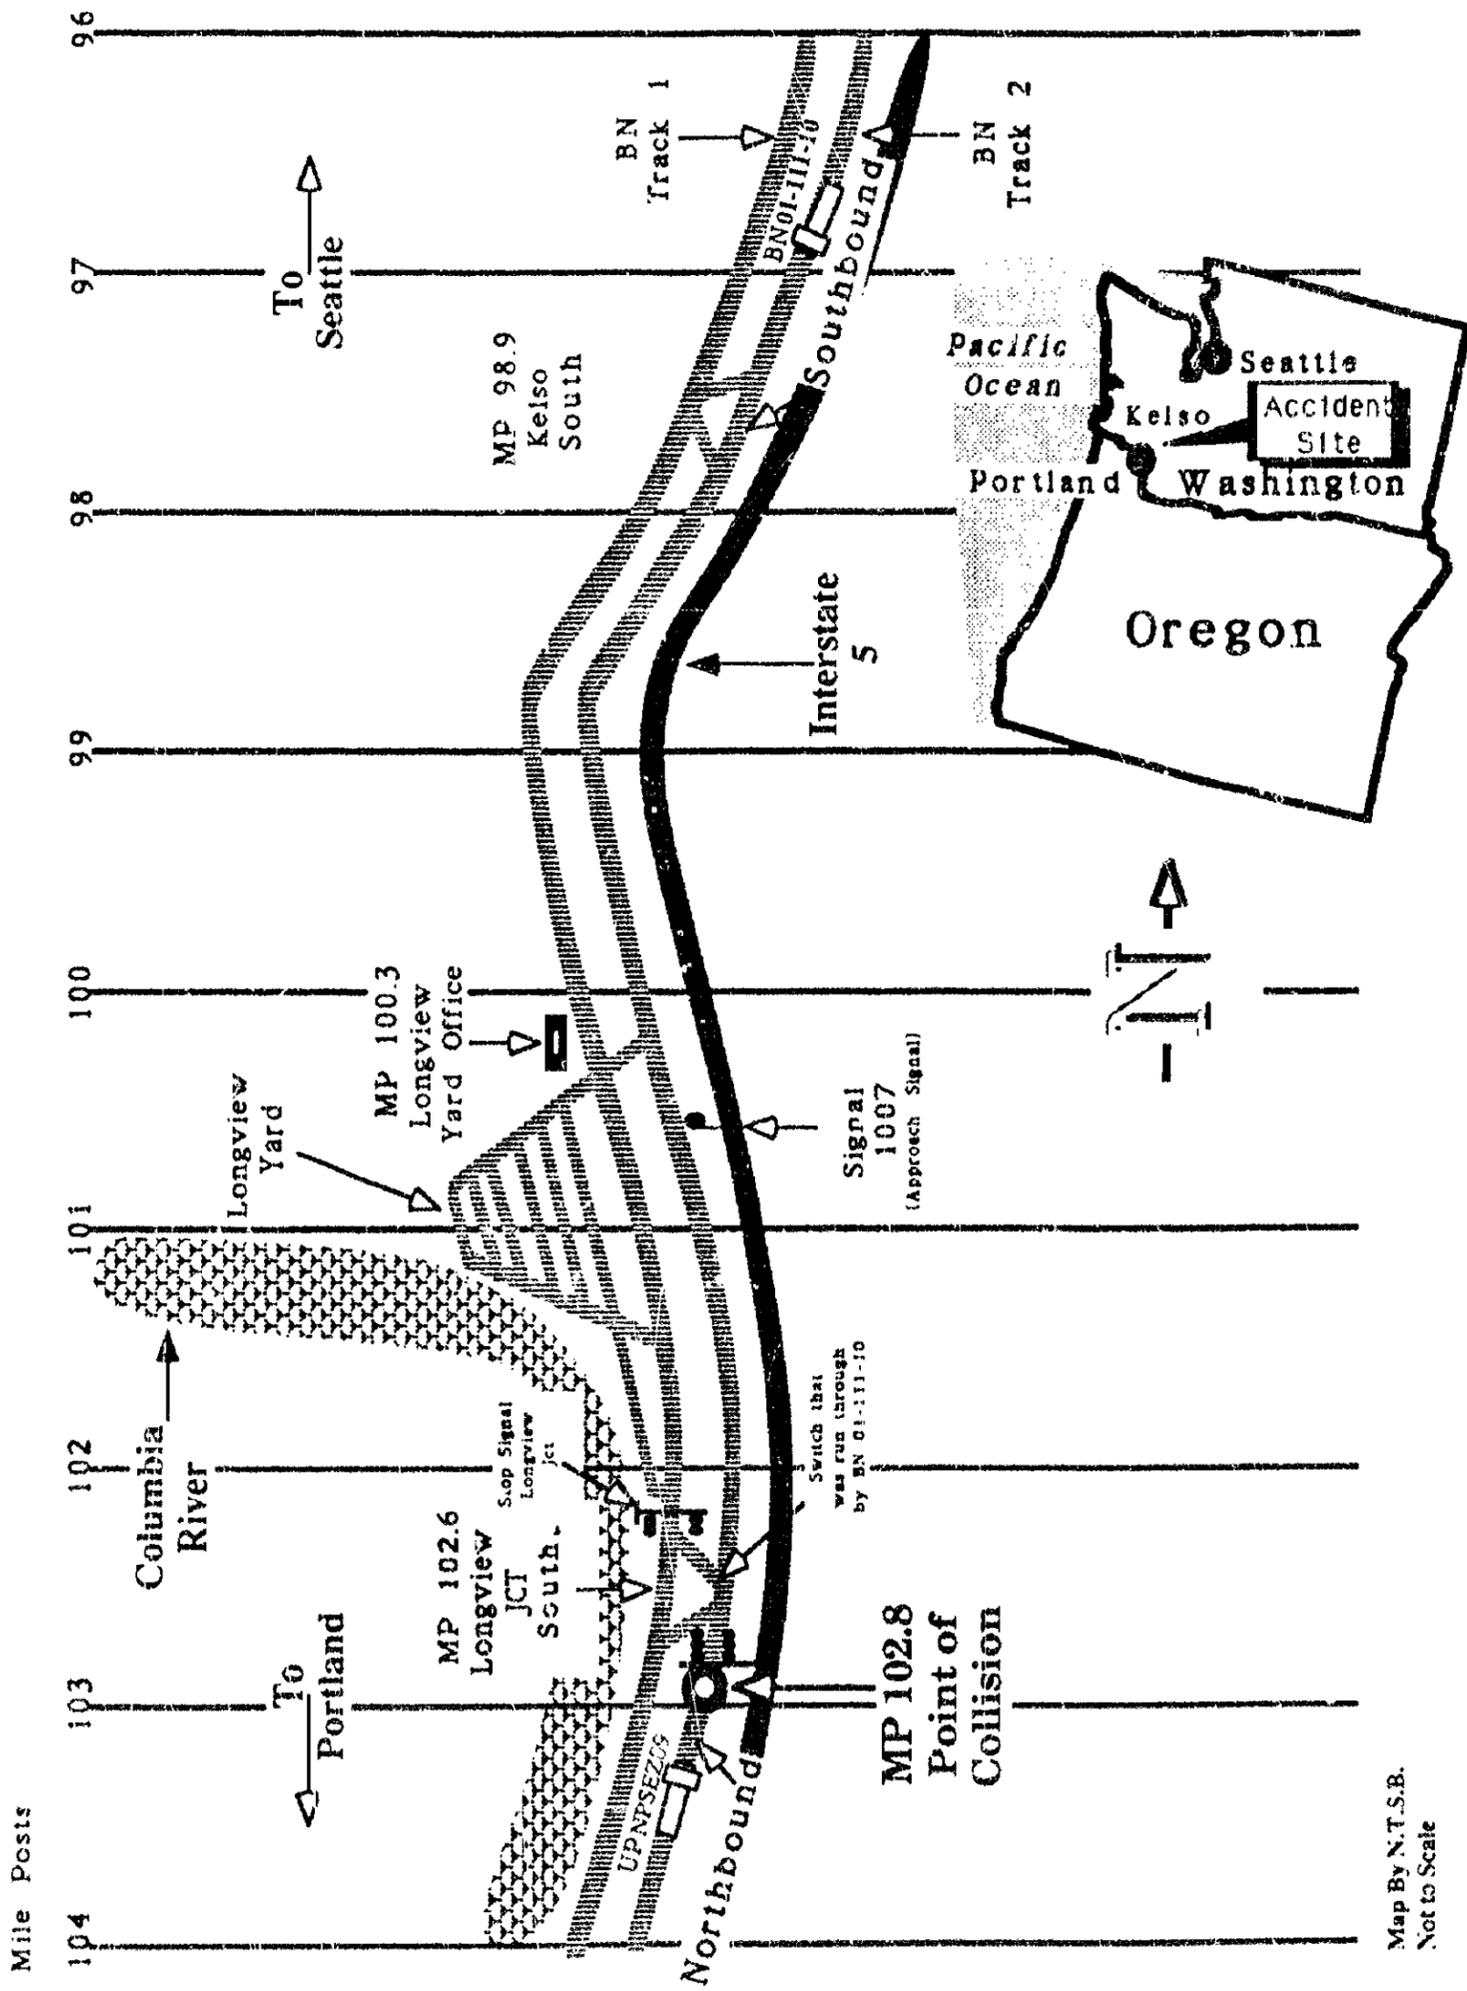
Figure 2.--Map of accident site.

BN dispatching records (see appendix D) indicate that train 111 passed the intermediate signal (MP 100.7) about 12:20 a.m. (See figure 2.) The intermediate signal is the approach signal to Longview Junction South interlocking. With the route that the dispatcher had lined up, the intermediate signal should have been displaying a yellow, or approach, indication. The dispatching record also indicates that about 12:24 a.m., the interlocking had a "power off" alarm.
