NTSB/RAR-95/03

# NATIONAL TRANSPORTATION SAFETY BOARD

## RAILROAD ACCIDENT REPORT

COLLISION AND DERAILMENT INVOLVING  
THREE BURLINGTON NORTHERN FREIGHT  
TRAINS NEAR THEDFORD, NEBRASKA  
JUNE 8, 1994

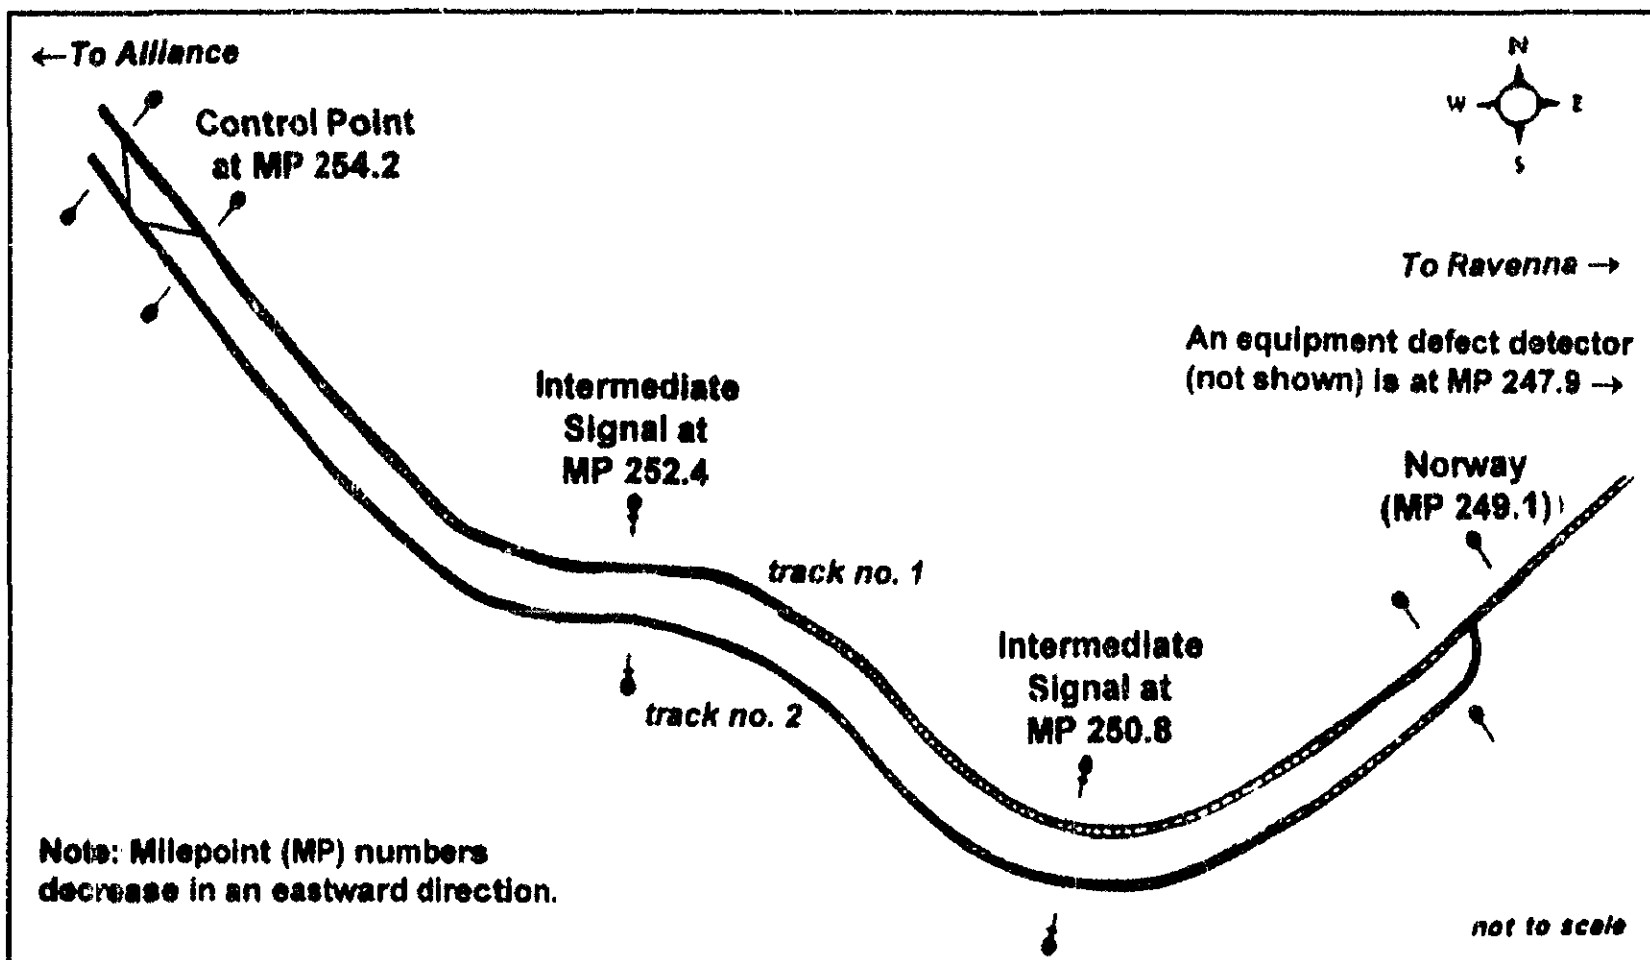
**Precollision Events** -- At 3:00:27 a.m., the BN dispatcher radioed the first eastbound train, KCS 735 East, that it would meet two westbound trains at Norway (MP 249.1), where the single main track from the east becomes a double main track (figure 2). According to the crew of BN 6782 East, shortly before the accident, they were following KCS 735 East on track no. 1 and were on an *approach* signal indication<sup>2</sup> when they received a *restricted proceed*<sup>3</sup> signal indication at the intermediate<sup>4</sup> signal at MP 250.8. Their signal indication was a result of KCS 735 East stopping in the block ahead. When he observed the end-of-train (EOT) device of KCS 735 East, the engineer of BN 6782 East stopped his train short of the signal at MP 250.8. The BN 6782 East conductor estimated that the rear end of KCS 735 East was about 550 feet east of the intermediate signal at MP 250.8 (figure 3).

Figure 2 – Layout of accident area showing signal locations.

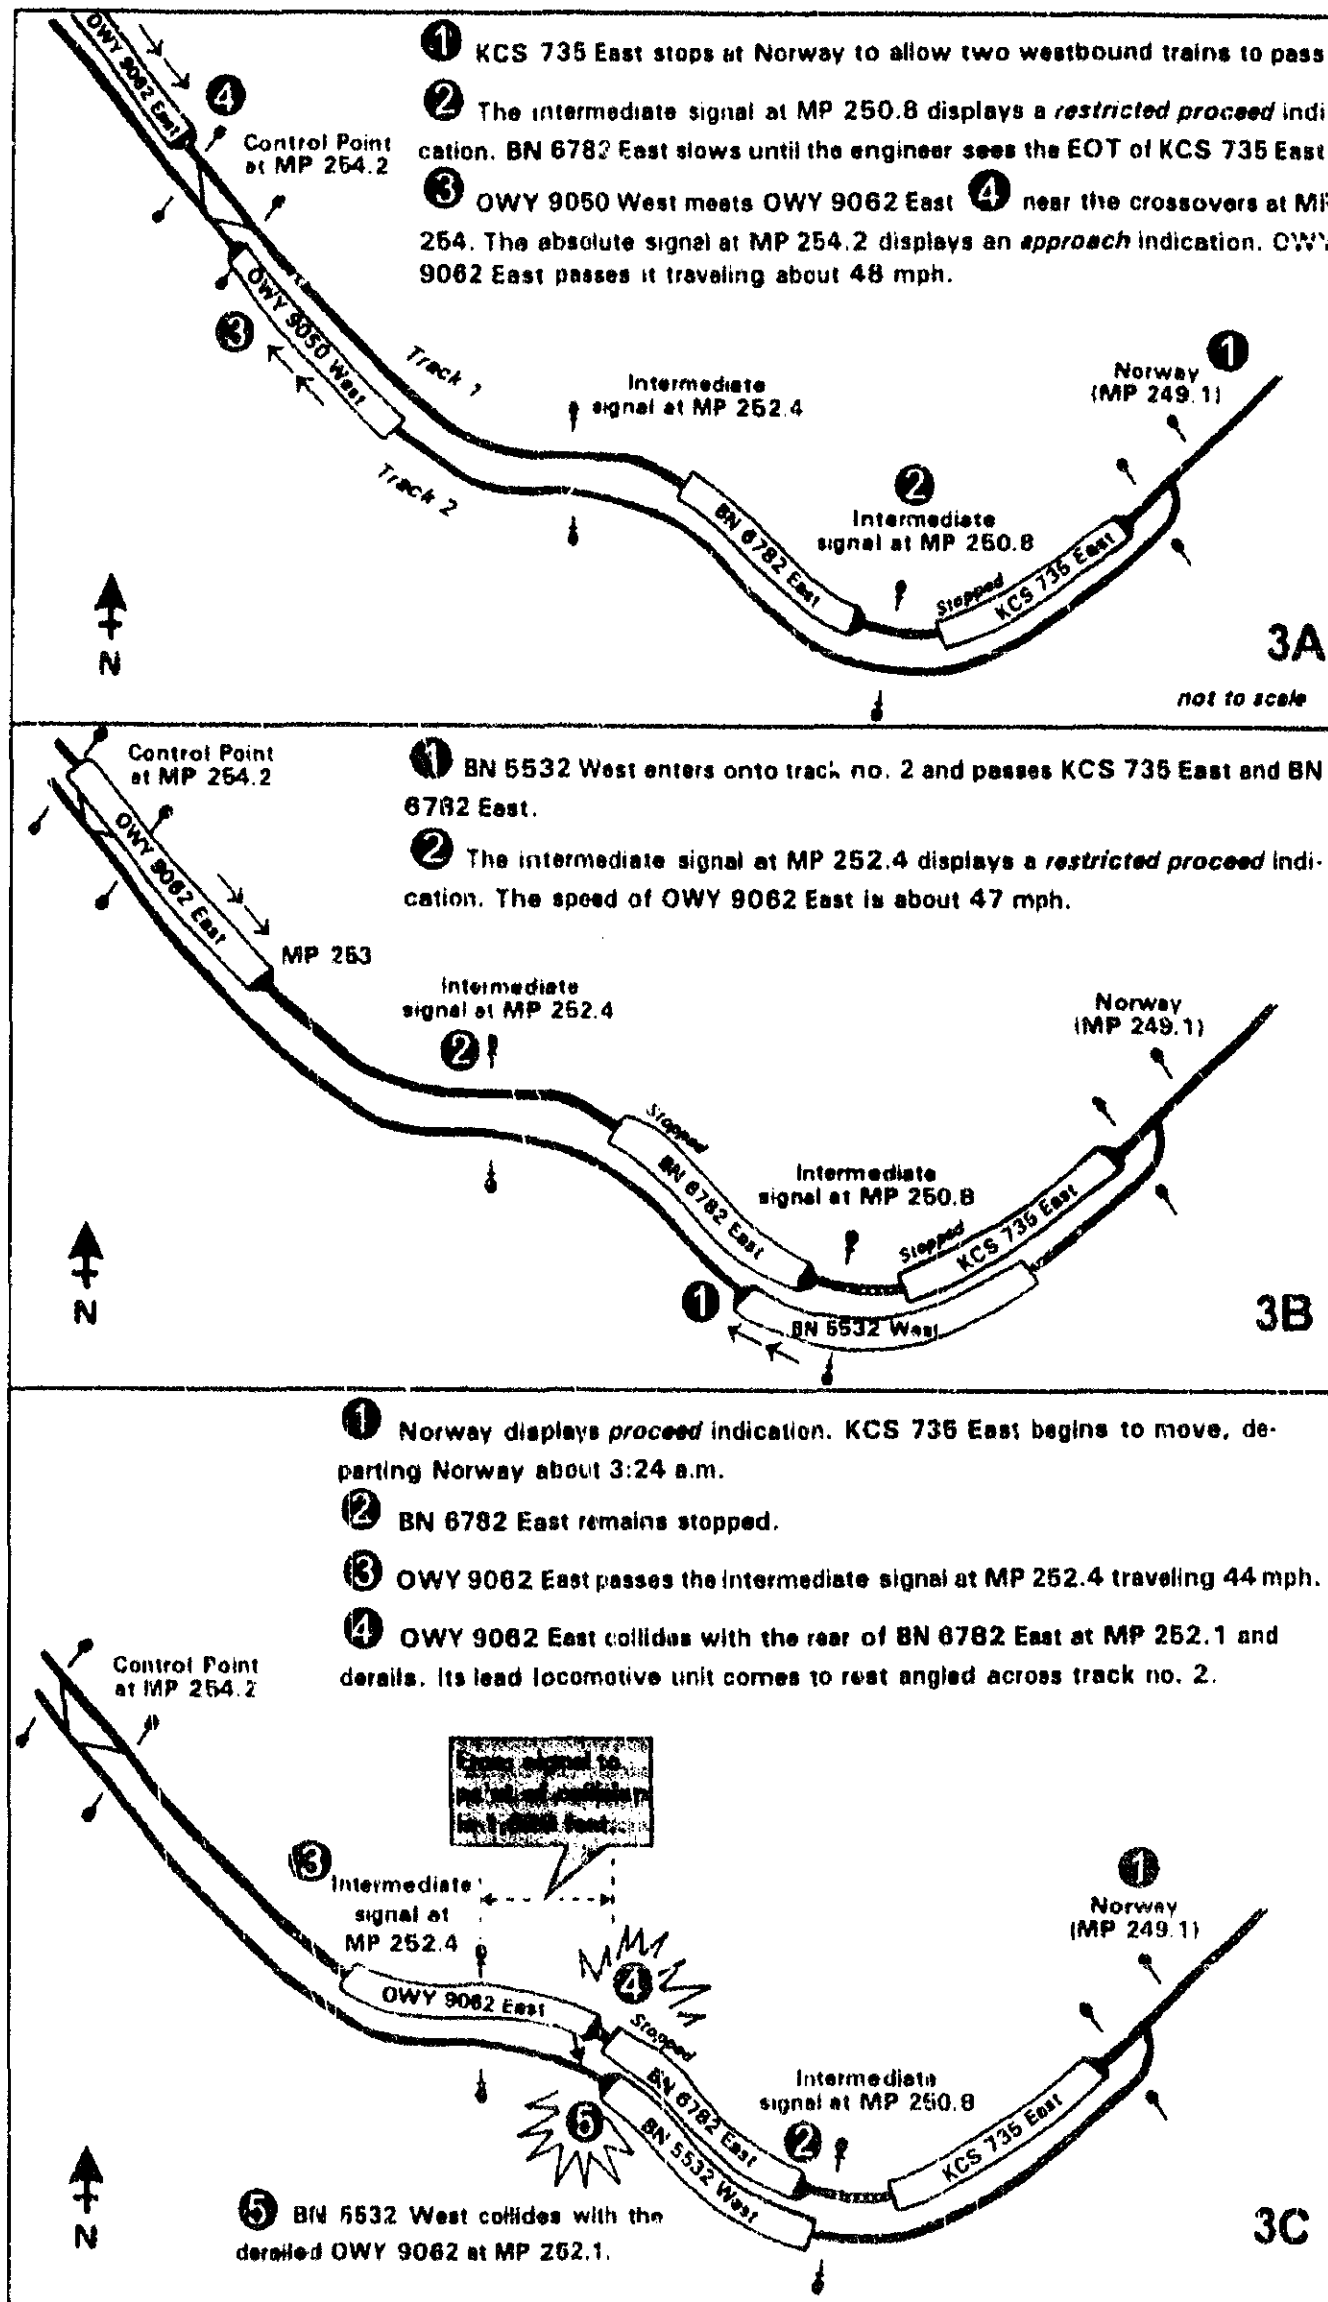
Figure 3 -- Sequence of Events

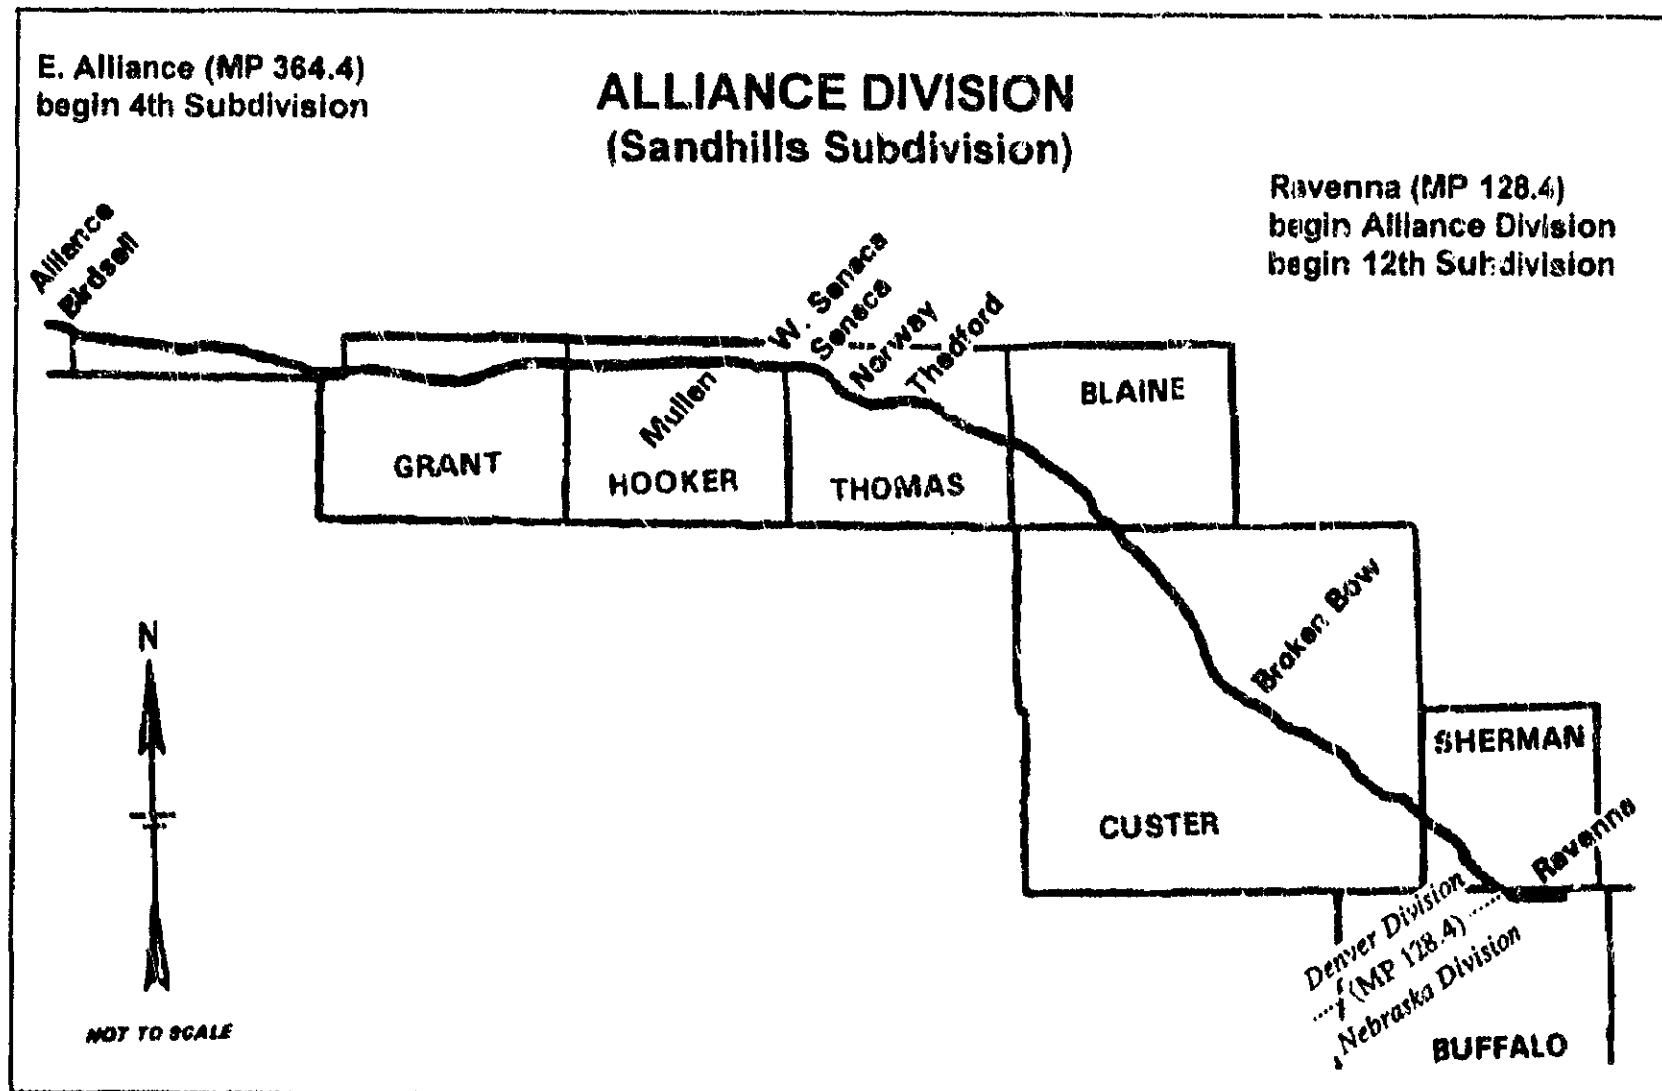
The three eastbound trains had departed Alliance between 10:45 p.m. and 11:20 p.m. on June 6, 1994. Train KCS 735 East had departed about 10:45 p.m., BN 6782 East had departed about 11 p.m., and OWY 9062 East had departed about 11:20 p.m. Train BN 5532 West had departed Ravenna at 10:15 p.m. (See figure 5.)

Figure 5 -- Route between Alliance and Ravenna.
