# **NATIONAL TRANSPORTATION SAFETY BOARD**

## **RAILROAD ACCIDENT REPORT**

**NEAR HEAD-ON COLLISION AND DERAILMENT OF  
TWO NEW JERSEY TRANSIT COMMUTER TRAINS  
NEAR SECAUCUS, NEW JERSEY  
FEBRUARY 9, 1996**

**Adopted: March 25, 1997  
Notation 6674A**

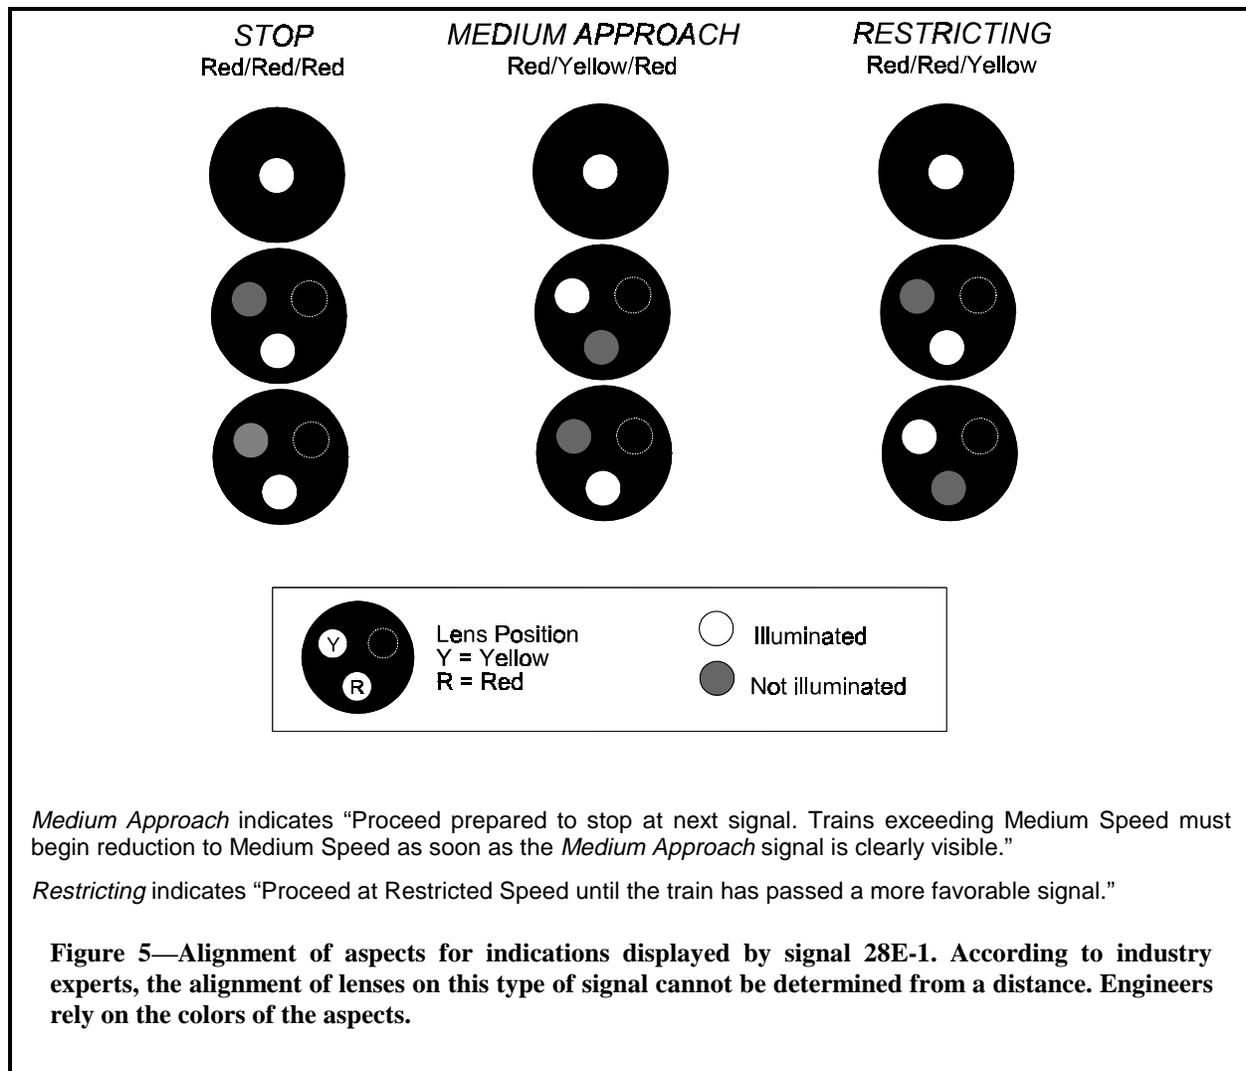
Figure 4—Type of light unit at Signal 28E-1.

The three main tracks comprising the West End interlocking have Transcontrol color light signals (figures 4 and 5), General Railway Signal (GRS) Company model 5G electric switch machines, and 100 Hz phase selective track circuits.

Safety Board investigators had all lamps illuminated at signals R6, 28E-1, and 24W, and recorded their voltages. No signal lamps were burned-out. After inspecting the lamps on scene, investigators had them removed and sent to the Safety Board's Washington, D.C., laboratory for further analysis and testing. Safety Board metallurgists inspected a total of 14 signal lamps and found that the filaments in all bulbs were intact, appeared to be in working order, and showed no evidence of damage, deformation, or separation.

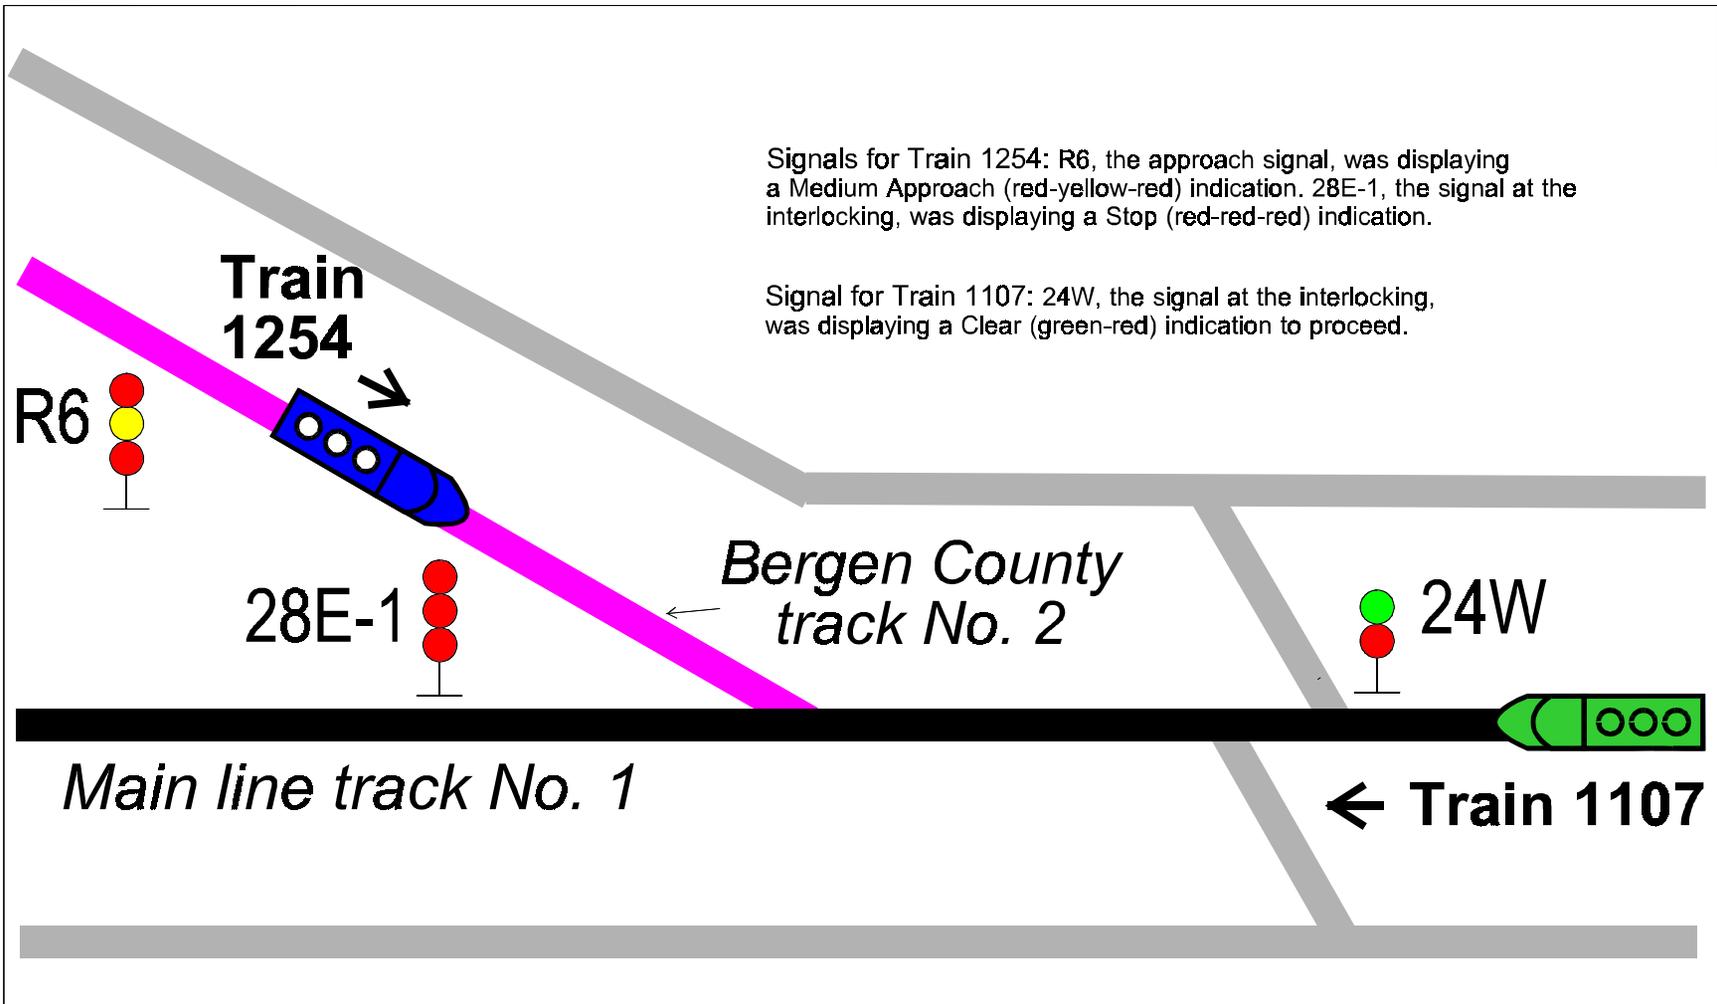
ing indicated that switches Nos. 37, 39, and 49 had been lined and locked in position and that signal 24W had been displaying an indication for a westbound train to proceed on track No. 1 (figure 6).

On February 11, 1996, investigators conducted “locking” tests of the electrical circuits to ensure that the signals and signal appliances, such as switches, operated properly, that is, did not change within the prescribed relay time interval. Investigators tested the relays, meggered all cables, and verified all track circuits in the routes. All tests revealed that the signal system functioned as designed, in accordance with FRA requirements.

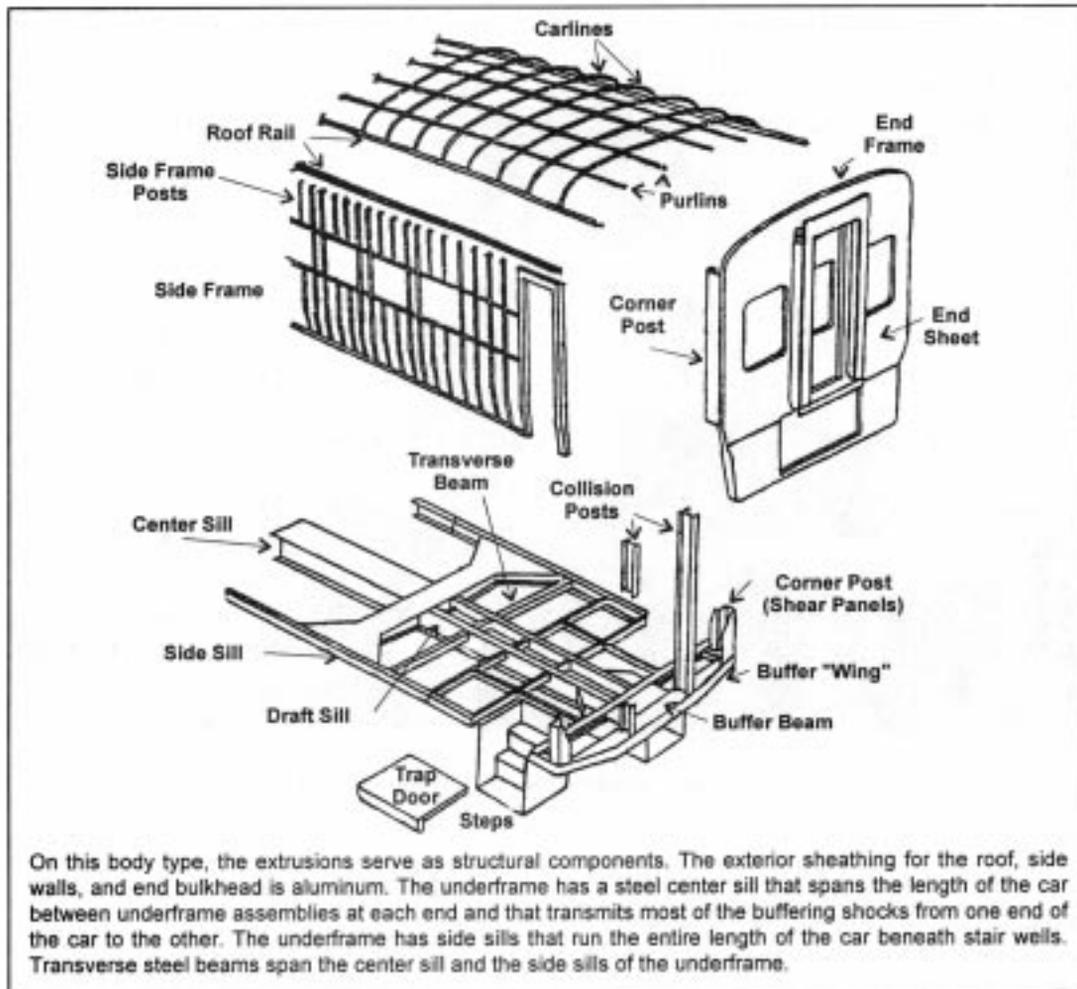
Figure 7—Comet II type car

**Train 1254**—All five cars sustained damages; the locomotive unit had no reported damages. The lead unit, cab car 5146, which was a Comet II type car (figure 7) with a body constructed primarily of aluminum extrusions and aluminum sheet metal, suffered major damage. The right<sup>11</sup> buffer wing, which is attached to the corner post stub, had separated from the car. The end sheet had separated from the car. The floor in the engineer's compartment had been sheared off. The trap door and stairwell were missing. The right side of the compartment roof, outboard of the collision post, had been sheared off. A 10-foot section of roof rail had broken off and lodged in the locomotive cab of train 1107. The interior bulkhead directly behind the engineer had been pushed rearward at the bottom and pulled down at the top. The engineer's seat had folded back into the bulkhead. The first two seats aft of the bulkhead, where the deceased passenger had been sitting, had been pushed rearward into the seats behind them. The space normally occupied by these seats was filled with debris.
