RAILROAD ACCIDENT REPORT

COLLISION AND DERAILMENT
OF MARYLAND RAIL COMMUTER MARC TRAIN 286 AND
NATIONAL RAILROAD PASSENGER CORPORATION
AMTRAK TRAIN 29
NEAR SILVER SPRING, MARYLAND
ON FEBRUARY 16, 1996

**Adopted: July 3, 1997
Notation 6664C**

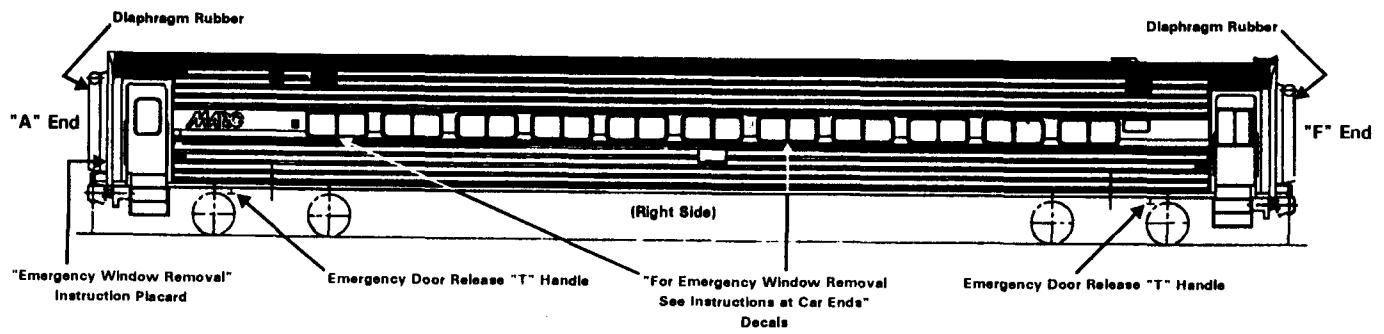
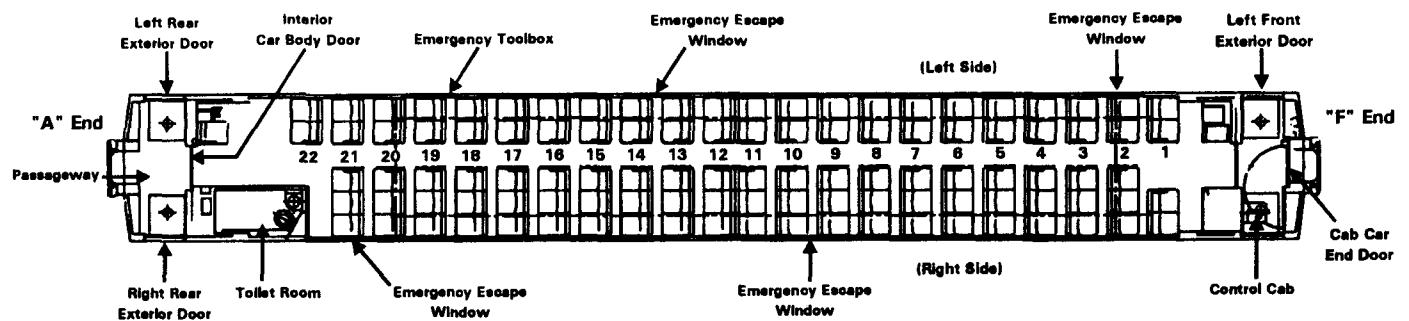
**Figure 5--a. Typical MARC II passenger coach cab control car.
b. Interior configuration of MARC passenger coach
cab control car 7752.**

MARC Train 286—The train consisted of passenger coach cab control car 7752, passenger coaches 7709 and 7720, and diesel electric locomotive (GP39-H2) unit 73. These cars were designated by MARC as MARC II type cars.⁹ (See figure 5a.) Neoprene diaphragms were attached to both ends of the cars, which provided a weather-resistant barrier between two coupled cars. All cars were equipped with a safety bar on both ends of the cars. The safety bar latched in both the horizontal and the stored vertical position.

MARC train 286 was configured to operate in the push mode with locomotive unit 73 at the rear of the train. Passenger coach cab control car 7752 was very similar in arrangement to the other passenger coaches in train 286 except that the leading "F" end had an operating cab with controls in the front right corner of the car. (See figure 5b.) This enabled the engineer to operate

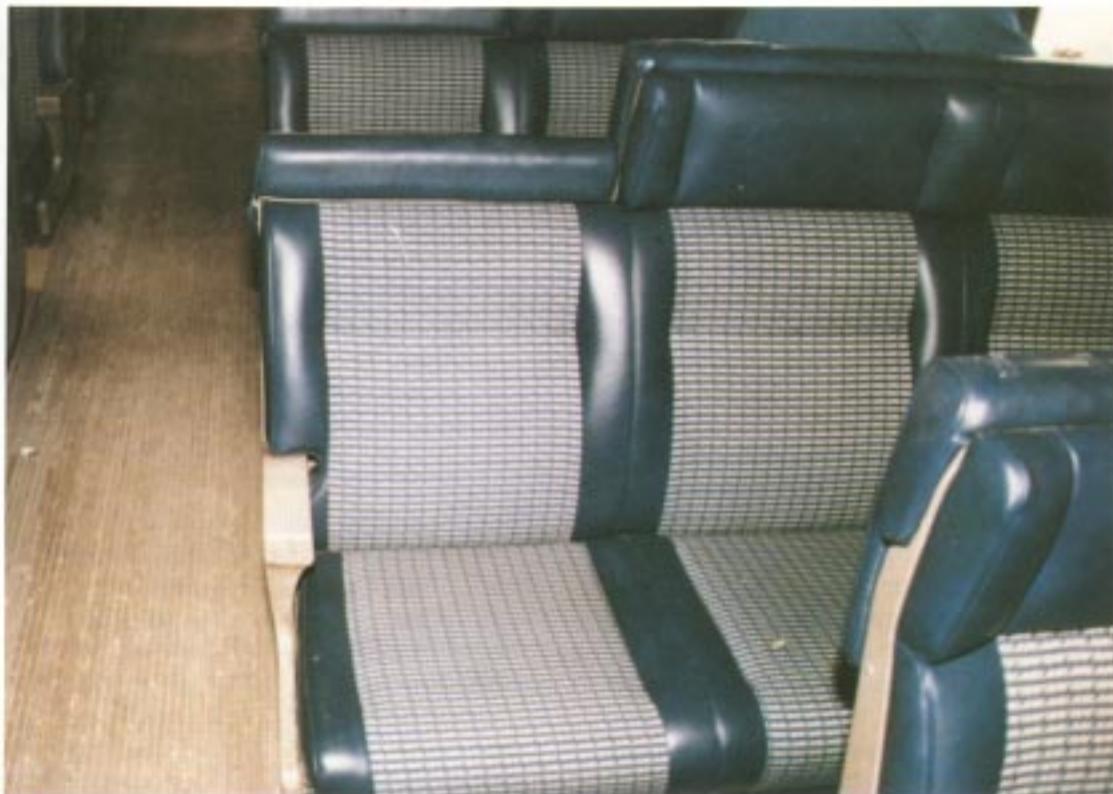
Figure 13--Photograph of typical seats in MARC passenger cars.

The tested materials, consisting of the major combustible items in the car, included the upholstered portion, but not the rigid plastic side-rail and back components, of the seats (see figure 13); the ceiling lining, which was similar, if not identical, to the other wall lining and partition materials; and the window mask material. The pad cushion materials of the seat passed the
