Railroad Investigation Report: NTSB/RIR-22-15

# Massachusetts Bay Transportation Authority Trolley Collision with Derailment

Brookline, Massachusetts  
July 30, 2021

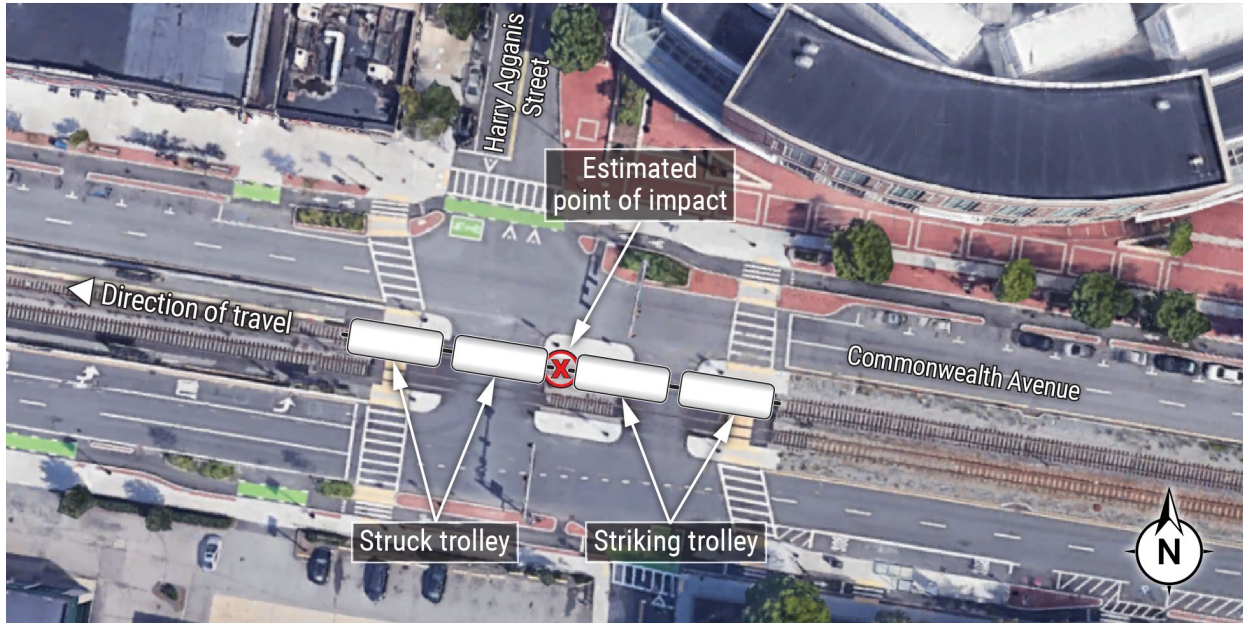
**Figure 1.** Overhead illustration of accident scene. (Source: Google Earth edit.)

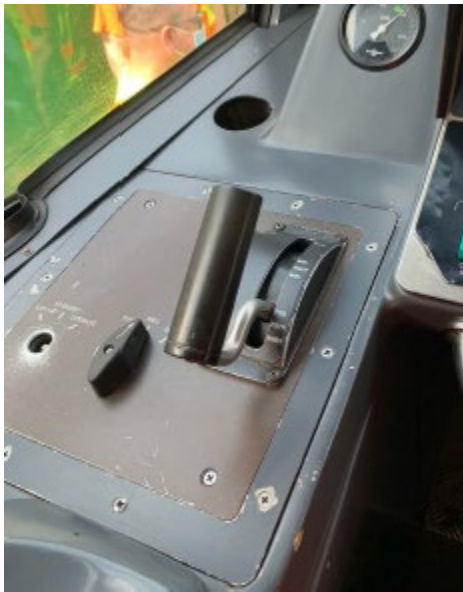
Each involved trolley consisted of a newer Type 8 railcar leading an older Type 7 railcar. Type 8 railcars are equipped with a single lever (a master controller) that controls both power and braking efforts. The master controller includes a failsafe (or deadman's switch) that requires the operator to rotate the controller handle 90 degrees and hold it in place. If released, the handle rotates back to its original position, and this activates the trolley's emergency brakes. (See figure 4 and figure 5.) Type 8 and Type 7 railcars do not have a forward collision avoidance feature to detect trolleys in the path of travel and automatically apply brakes.

**Figure 4.** Master controller with deadman's switch disengaged.

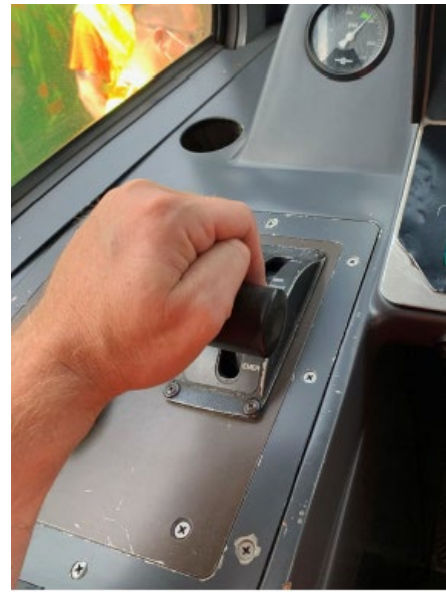
**Figure 5.** Master controller with deadman's switch engaged.

failsafe emergency brake system activated by the deadman's switch feature and found it functional.
