Railroad Investigation Report: RIR-26-02

# Metropolitan Atlanta Rapid Transit Authority Employee Injury

Atlanta, Georgia

October 19, 2024

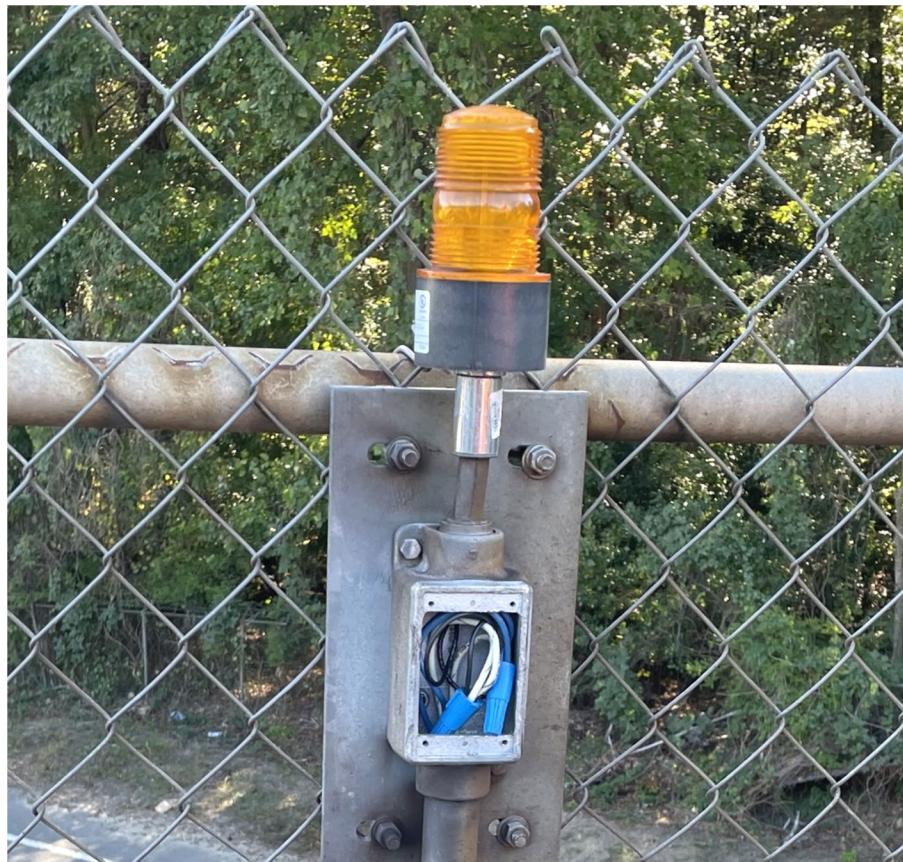
**Figure 2.** Example of a train approach light.

During the briefing, the tasks of each technician were discussed. Technician 3 was assigned to go to the train control room (TCR), which was located inside the tunnel. While in the TCR, technician 3 was to monitor train movements and provide warning via radio if a train was approaching their work area and to activate the train approach lights, causing them to flash so the nonfunctioning train approach lights could be identified by the other technicians of the work crew and then repaired. These other two technicians (technicians 1 and 4) were assigned to repair the train approach lights outside of the track envelope.<sup>5</sup> [Figure 2](#) is an exemplar train approach light.
