Railroad Investigation Report: RIR-26-10

# Port Authority Trans-Hudson Corporation Third Rail Feeder Cable Fire

| <b>Accident type</b> | Third rail fire |

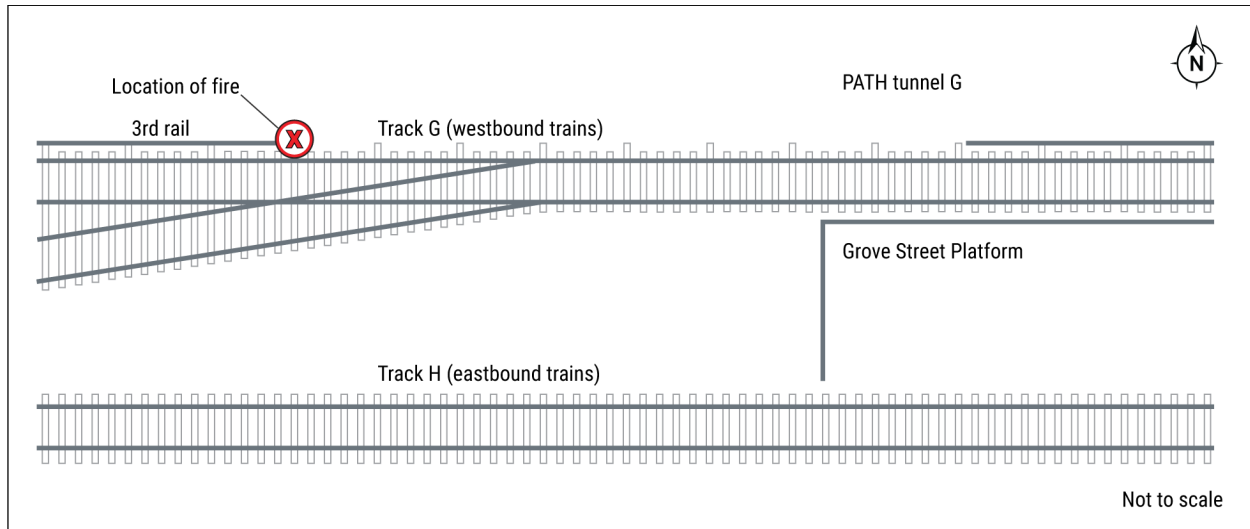
Nine minutes before the accident, about 7:25 a.m., an operator of eastbound PATH passenger train 719 on track H (opposite track G) called the control desk to report a flame on track G within the Grove Street Station interlocking limits.<sup>2</sup> (See figure 1.)

**Figure 1.** Accident location at Grove Street Station.
