Sinking of the US Cargo Vessel *El Faro*

Illustrated Digest

This digest of the National Transportation Safety Board's (NTSB's) Marine Accident Report **NTSB/MAR-17/01** contains a description of the accident and safety issues, and summarizes some of the safety recommendations intended to prevent such an accident from happening again. The full report and docket can be found at www.ntsb.gov.

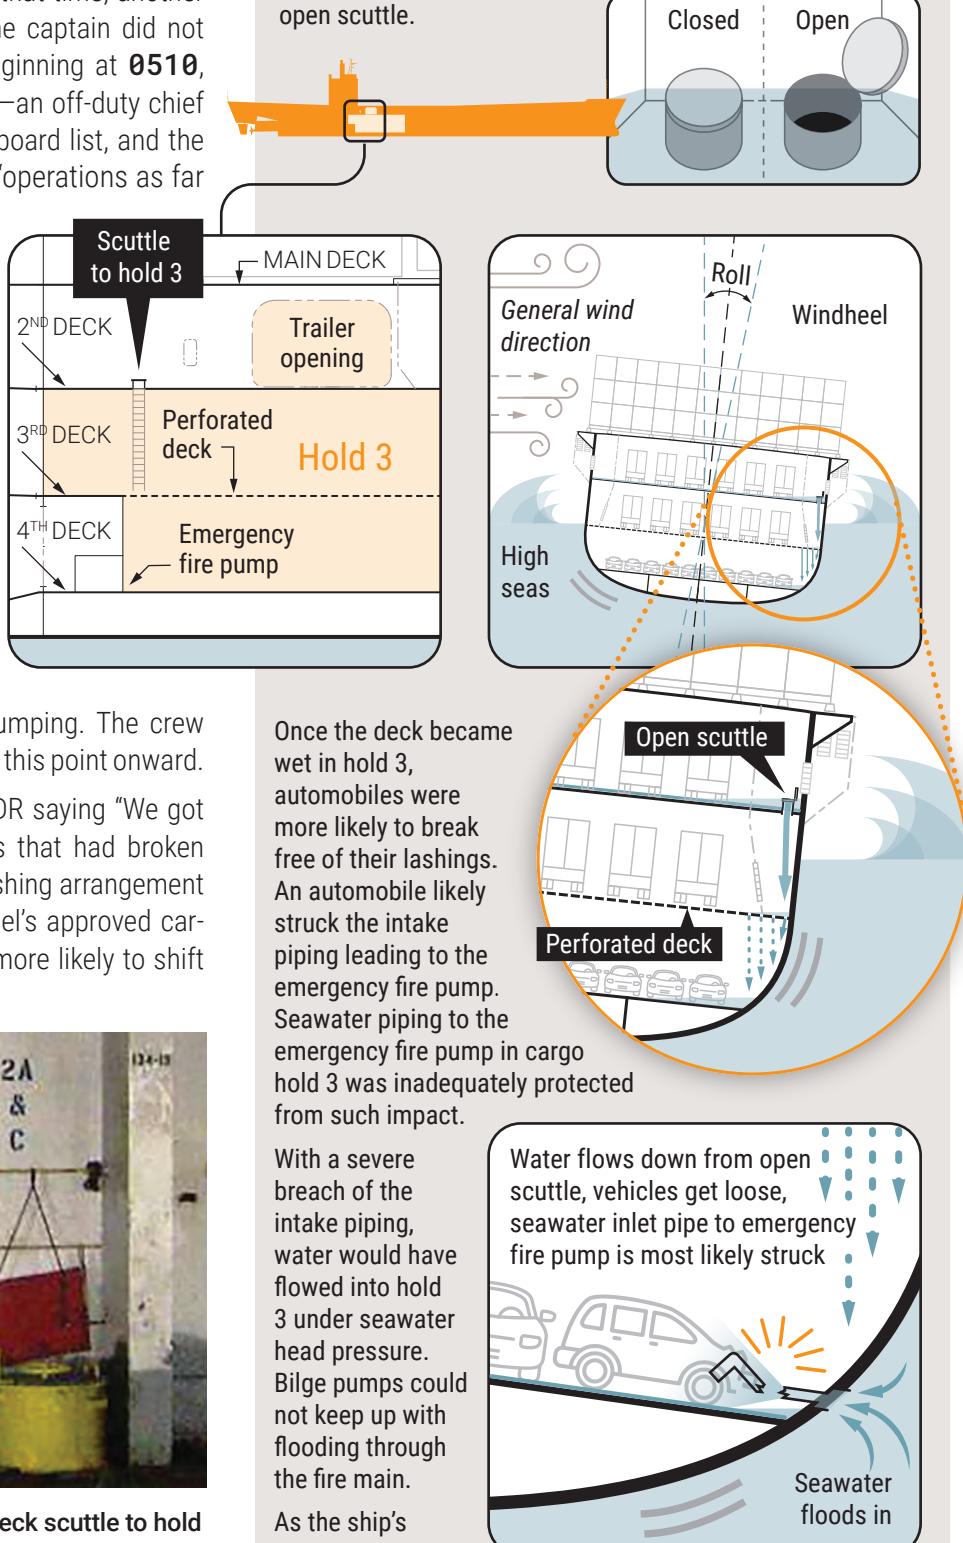
How the water got in

The crew found that a scuttle (small watertight hatch) on the second deck, starboard side, was open and seawater on deck was flowing over it and down into cargo hold 3. The ship's list to starboard was causing seawater to pool near the scuttle located on the starboard side. The captain told an engineer to begin transferring ballast water from the starboard ramp tank to the port ramp tank.

El Faro's partially enclosed second deck had a number of scuttles that had to be closed and fastened ("dogged"). Flooding began through an open scuttle.

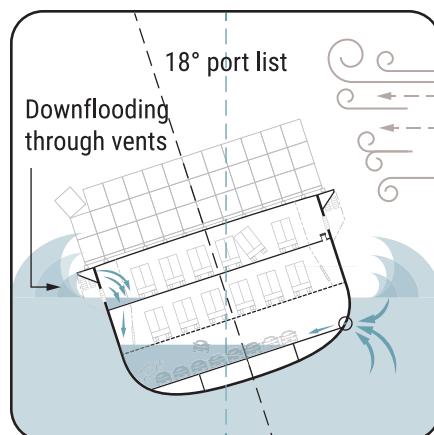
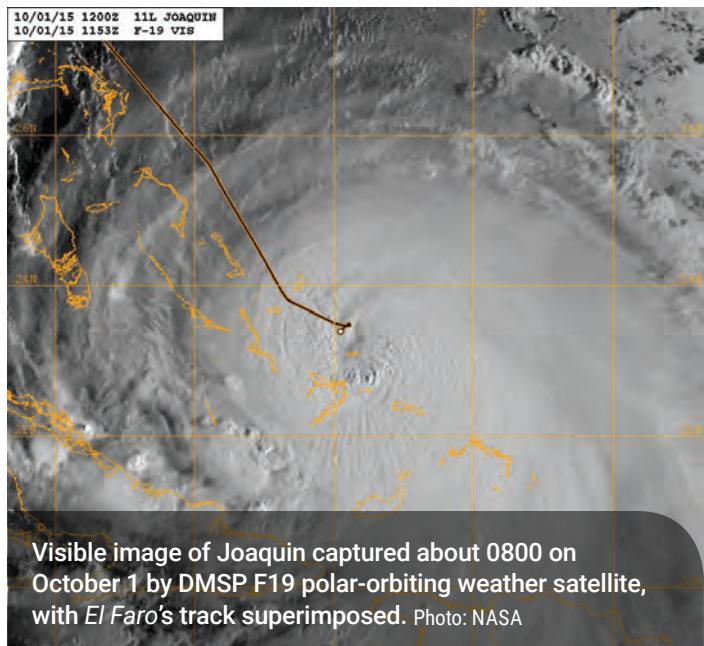
El Faro computer rendering in static surface water showing list to port of 18° with departure trim 5.8 feet by the stern due to flooding of hold 3 estimated at 20% and windheel.

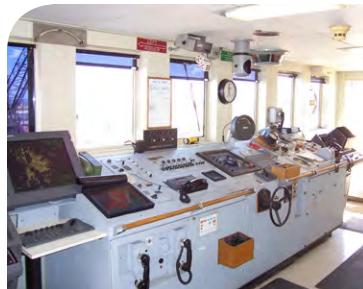
El Faro's bridge

Two members of the bridge team suggested or hinted that they disagreed with the captain's decisions, but the captain disregarded their concerns. For their part, the bridge crew deferred to the captain's authority and experience, rather than acting more assertively. Regardless, when the crew did voice concerns, the captain chose not to listen. The suggestions of not only one but two of his officers should have prompted him to at least return to the bridge and review the weather information.

Although bridge resource management (BRM) stresses assertiveness, traditional maritime culture emphasizes the captain's authority onboard and responsibility for the vessel. TOTE had not effectively implemented BRM, which involves modernizing centuries-old roles and including the bridge team in discussions pertaining to the safe navigation of the vessel.

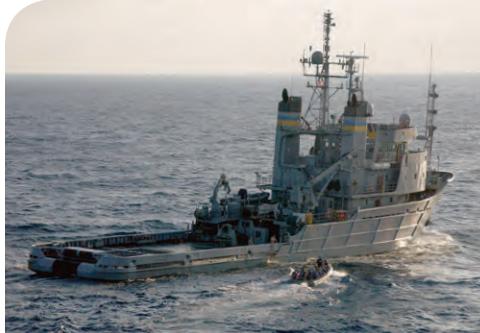
The ROV CURV-21 arrived at the site of the sinking, again hosted on board the Navy ship Apache. At 1950, CURV-21 successfully freed the VDR capsule from the partly buried mast and brought it to the surface.
