Airbag Performance in General Aviation Restraint Systems

Safety Study

NTSB/SS-11/01
PB2011-917001

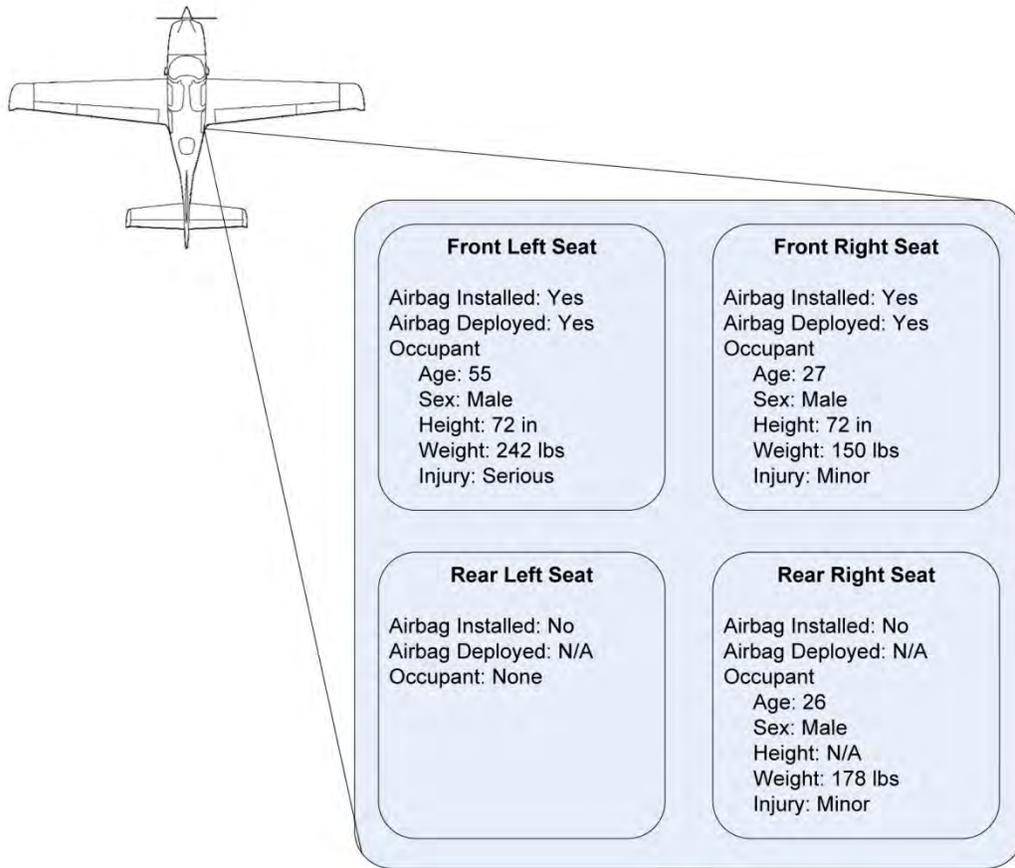
Figure 20. A seating chart from Cirrus SR22, N6568CD, which crashed in Boyceville, Wisconsin. (NTSB accident identification number is CHI06FA218.)

On August 5, 2006, at 1140 central daylight time, a Cirrus SR22, N658CD, received substantial damage on impact with terrain to the right of the approach end of runway 26 at Boyceville Municipal Airport in Boyceville, Wisconsin. The private pilot receiving instruction, seated in the left front seat, sustained serious injuries. The certified flight instructor (CFI), seated in the right front seat, and passenger, seated in the right rear seat, sustained minor injuries. Figure 20 shows a seating chart that summarizes occupant injury and demographic information.

The NTSB determined that the accident was caused by the pilot’s failure to maintain adequate airspeed and the certified flight instructor’s delayed remedial action and inadequate supervision of the flight training, which resulted in an inadvertent stall during a base to final turn to the landing runway. An additional cause was the pilot’s lack of total experience in the Cirrus SR22. A factor in the accident was the low altitude at which the stall occurred.

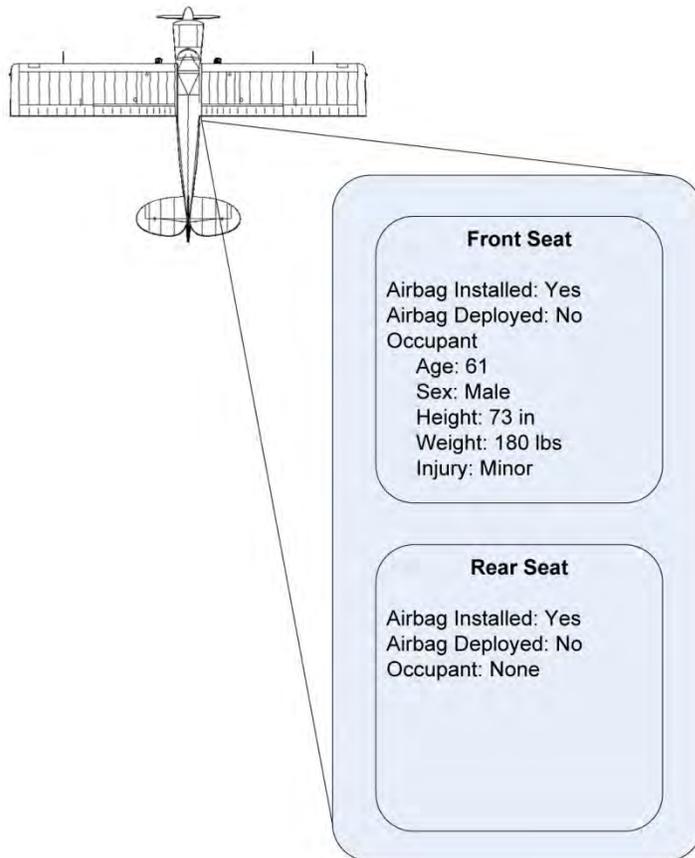
Figure 22. A seating chart from Aviat Husky A-1B, N94HY, which crashed in Owyhee, Oregon. (NTSB accident identification number is SEA06FA168.)

The airplane came to rest inverted on the dirt/sod runway. The pilot stated that the airplane's parking brake had been engaged prior to the water ski maneuver; however, he failed to release it after completing the maneuver and inadvertently landed with the brake set. After the crash, the pilot exited through the airplane door.

There was substantial damage to the airplane, shown in figure 23, including a bent propeller, dented spinner and engine cowling, damage to the leading edge of the left wing, bent right wing ribs, bent right wing strut, and deformation of the vertical stabilizer and rudder. The forward windscreen was broken, the forward left diagonal post (A-pillar) was compressed outward and downward about 3 inches, and the roof of the cockpit was deformed toward the cabin about 1 inch. There was a black smudge on the metal support tube that was located directly

above the occupant's head, and the tube was compressed upward about 1/16 inch. There was no damage to the instrument panel.

Both the forward and rear seats were intact and undamaged. The airplane had an airbag-equipped 5-point restraint system with lift latch buckles on each seat. The pilot was wearing his restraint system at the time of the crash. The restraint systems were undamaged, and neither the pilot's airbag nor the unoccupied rear seat airbag deployed during the accident sequence. Examination of both systems revealed that the inflator, the cable harness to the buckle switch, and the gas inflator hose were all connected. Two EMAs were present in this plane, one for the front seat and another for the rear seat. The EMAs, inflator assembly, squib connectors, and associated lines were intact, and no damage was noted.

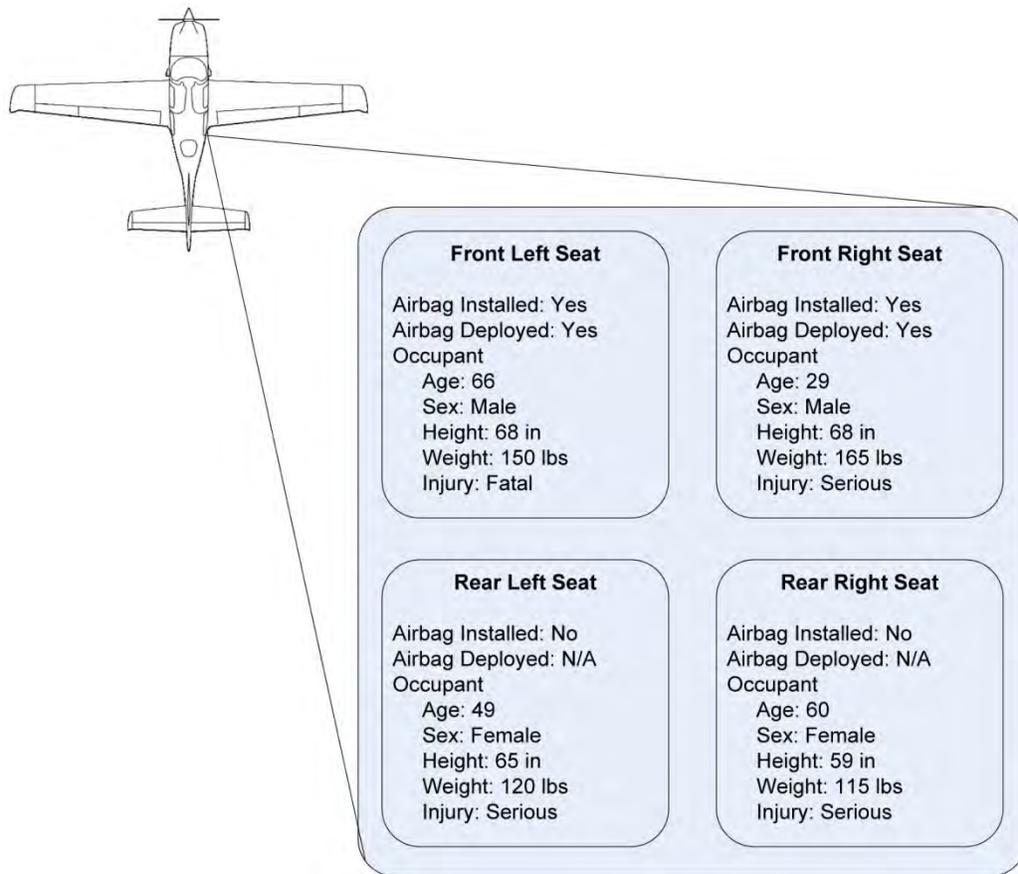
Figure 25. A seating chart from Cirrus SR22, N91MB, which crashed in Indianapolis, Indiana.

The NTSB determined that the accident was caused by the pilot's failure to maintain sufficient airspeed, which resulted in a stall and subsequent spin. Contributing to the accident were the pilot's inadequate preflight planning, the overloaded condition of the airplane, and the center of gravity aft of the center of gravity limit. Witnesses observed the airplane descending through the clouds with a partially deployed parachute. Data extracted from the PFD indicated that the airplane's airspeed decayed until the stall angle of attack of the wing was exceeded. The airplane was in a stalled condition for about 30 seconds and then entered a spin. About 4 seconds prior to impact, the PFD recorded a large decrease in longitudinal acceleration consistent with CAPS deployment. The altitude at that moment was about 1,340 feet mean sea level (msl) (528 feet above ground level). Based on the PFD data and the wreckage of both the airplane and the CAPS system, it was estimated that the airplane impacted the water with a 60-degree nose down attitude, the left wing down, and a vertical descent rate of about 56 mph (or 82 feet per second). Upon hitting the water, the fuselage likely continued downward and forward resulting in a cracking around the fuselage forward of the wing spar. The impact on the nose and the crushing of the fuselage toward the nose may have resulted in a reduction in the occupant space for both front seat occupants; this reduction likely occurred in the upper body region and on the left side.

The left front seat occupant, a 66-year-old male, was fatally injured. He was 5 feet 8 inches tall and weighed 150 pounds. He suffered severe head and chest trauma, and his cause of death was listed as multiple blunt force injuries. The head contact likely occurred on the left side instrument panel from intrusion into the occupant's space as a result of crushing of the front of the airplane. His chest injuries were also likely due to direct contact with the instrument panel resulting from intrusion into the occupant's space. The left front occupant also had lower spinal injuries that resulted from the vertical deceleration of the airplane. The spinal injuries may have been more severe because of the location of a traffic advisory system (TAS) transmitter receiver computer (TRC) box⁹⁴ installed below the seat, which may have reduced the total stroking distance⁹⁵ or deformation of the seating system. Such injuries would not require a large vertical deceleration if the occupant were bent forward, as would likely result from the nose-down position of the airplane.⁹⁶ In the case of this occupant, there is no evidence that the airbag mitigated injuries; however, airplane airbags are not currently designed to prevent injuries caused by severe intrusion or large vertical impacts.

The right front seat occupant, a 29-year-old male, was 5 feet 8 inches tall and weighed 165 pounds. He suffered serious injuries to his head, chest, and spine. It is likely that his head injuries resulted from direct contact between the right side of his head and the MFD unit in the instrument panel. The nature of his facial injury suggested that the occupant was likely turning his head to the left side at the time of impact. His lower spinal injuries resulted from the vertical deceleration of the airplane and may have been more severe because of the location of the air conditioning unit below the seat. Like the TAS TRC box under the left seat, the air conditioning unit may have reduced the total stroking distance or deformation of the seating system. The occupant also suffered a sternal fracture that likely resulted from direct contact between his chest and the GPS/radio control knobs or the throttle. As with the front left occupant, the airbag did not likely affect his injuries because there was airplane intrusion into the occupant space and direct contact of airplane structure to the head and chest. Airbags are not expected to mitigate injury caused by severe intrusion.

The left back seat occupant, a 49-year-old female, was 5 feet 5 inches tall and weighed 120 pounds. She suffered serious injuries including spinal injuries and sternal and rib fractures. Her spinal injuries resulted from the vertical deceleration of the airplane. Her sternal and rib fractures likely resulted from direct contact; however, the impact source was undetermined. Potential impact sources included the recessed armrest region on the left side wall or the seatbelt if it were in direct contact with the sternum.

The right back seat occupant, a 60-year-old female, was 4 feet 11 inches tall and weighed 115 pounds. She suffered serious injuries including spinal injuries, rib fractures, and burns. Similar to the other occupants, her spinal injuries resulted from the vertical deceleration of the airplane. The source of her rib fractures was again undetermined and may have resulted from seatbelt loading. The severity of her rib fractures was likely influenced by relative bone fragility associated with her small stature and age. The sources of the burns to her shoulder, back, and foot could not be determined.

In conclusion, the majority of occupant injuries were caused by the vertical deceleration of the airplane, and for the front seat occupants, intrusion of the instrument panel into the occupant space. The airbags, as they are currently designed, did not, and would not be expected to, mitigate these types of injuries. The front seat occupants' spinal injuries may have been more severe because of the substantial vertical deceleration, the occupants' positions, and the presence of a TAS TRC box under the left seat and an air conditioning unit under the right seat, which reduced the stroking distance of those seats. However, because the SR22 seats were able to meet the type certification basis specified in 14 CFR 25.562 without stroking, no additional testing had been required prior to their installation.

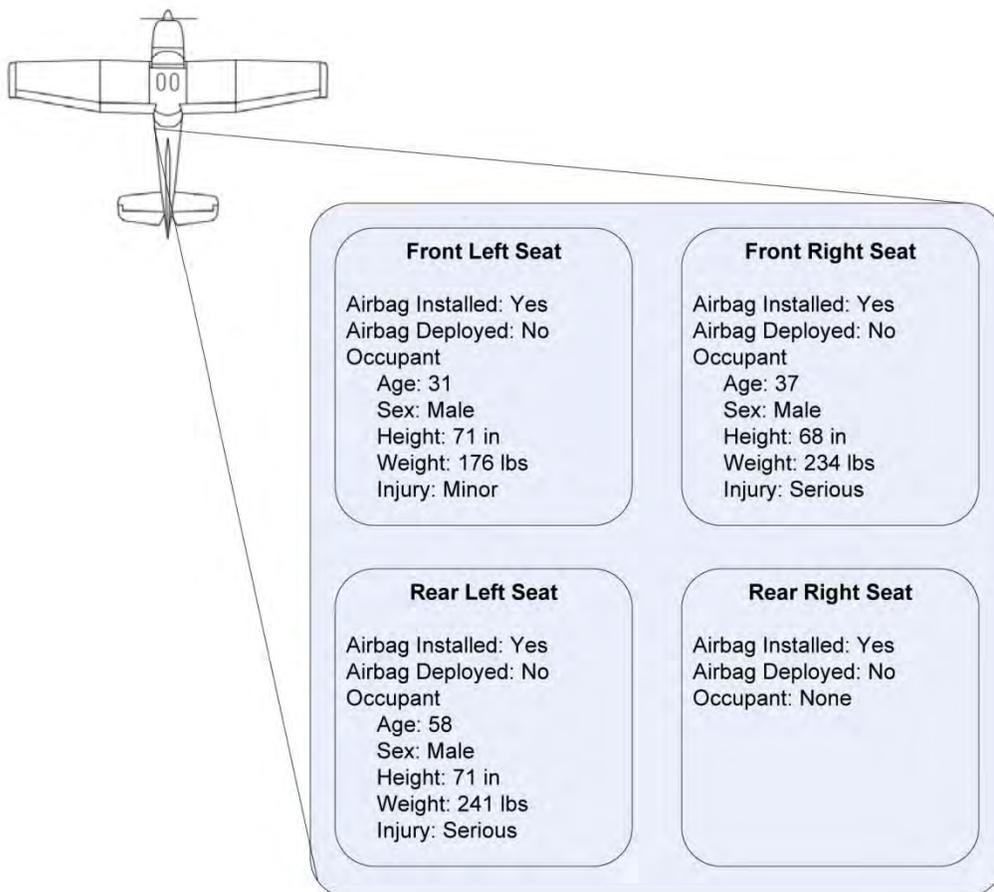
Figure 27. A seating chart from Cessna T182T, N14685, which crashed in Athens, Texas. (NTSB accident identification number is DFW07LA078.)

The NTSB determined that the accident was caused by a loss of engine power as a result of the failure of a mechanic to properly check the torque on the input and output fuel lines to the fuel transducer during the manufacturing process. A contributing factor was the lack of suitable terrain for the forced landing.

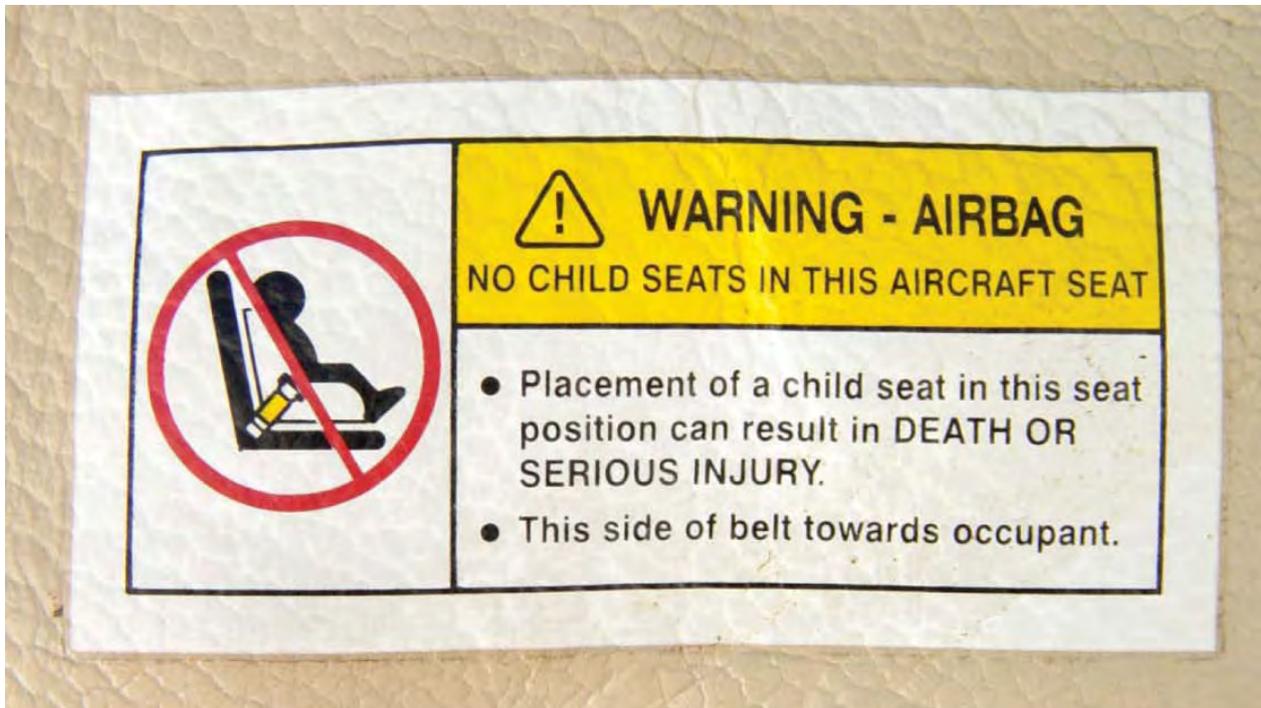
In response, AmSafe issued a supplement to the pilot's operating handbook for Cessna Skyhawk (172R, 172S), Skylane (182S, 182T, T182T), and Stationair (206H, T206H) models to include a reference to a warning label on the lap portion of the restraint.⁹⁸ On October 22, 2007, Cessna issued a service bulletin to owners of airbag-equipped Cessna aircraft to document the changes to the Pilot Operating Handbook.⁹⁹ The label, referenced in the above documents and shown in figure 30, is primarily designed to warn users that child safety seats should not be used in seats with airbag-equipped restraints because of the risks they pose to children in such seats. The label also contains a secondary bullet that informs users that the label side of the seatbelt should face the occupant.

Figure 30. A photograph of the label placed on the occupant-facing side of the lap belt portion of Cessna airbag-equipped restraints.

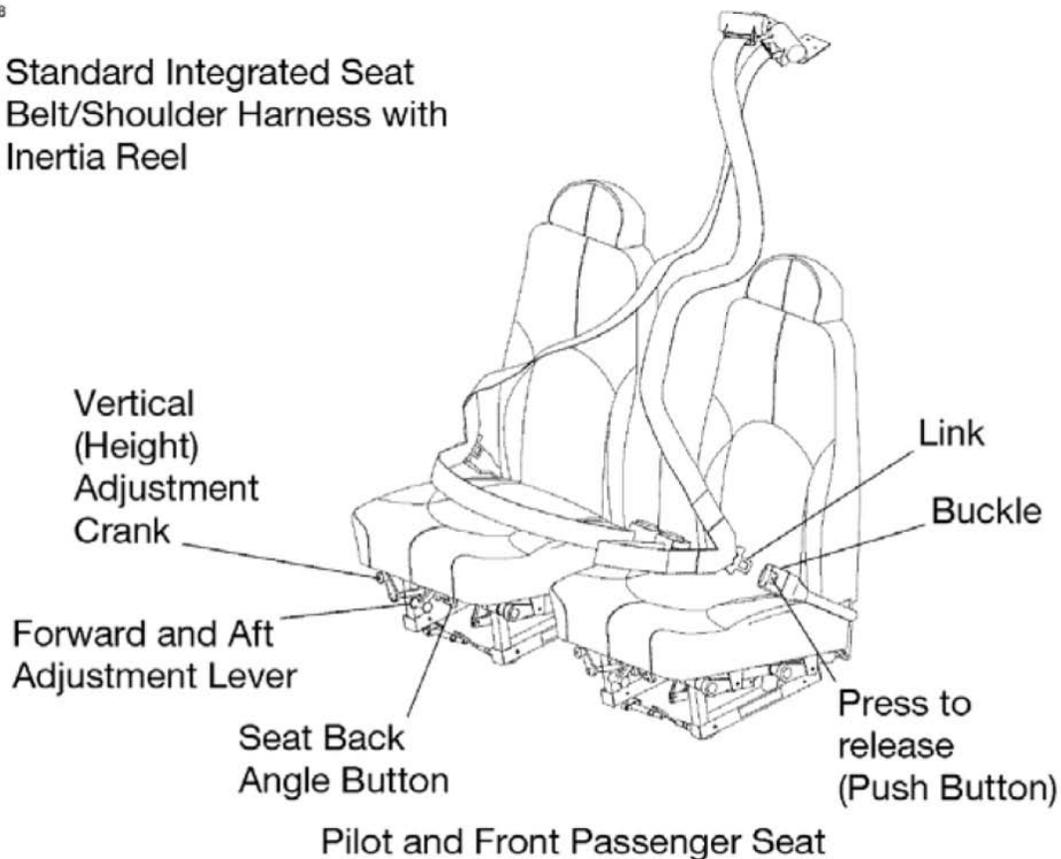
With respect to the possibility of crossing the restraints, Cessna has also noted that its pilot's operating handbook contains a picture of the seat and seatbelt installation showing which inertial reel goes with which front seatbelt. (See figure 31.) However, the NTSB is concerned that some airplane occupants may not fully review or understand this information, particularly passengers. Furthermore, the warning label on the lap portion of the 3-point restraint system is currently designed in a way that suggests its message is solely geared toward potential child safety seat users. Discussions with Cessna pilots have indicated that several occupants have unknowingly crossed the restraints, putting them at risk of not having the full benefit of the restraint or airbag in a crash.

Figure 31. A drawing showing the front seats and seatbelts/shoulder harnesses of the Cessna 172S.¹⁰⁰

The NTSB concludes that the 3-point restraint systems in certain Cessna airplanes can be crossed in such a way that the airbag and restraint systems are not used as designed and certified. Although the NTSB is not aware of any accidents in which occupants have crossed the restraints, the findings from this investigation suggest that crossing the restraints is not an unusual error and that doing so could result in a reduction of protection from the restraint system. Efforts thus far to address the problem, including labeling the seatbelt and adding text to the pilot's operating handbook, are unlikely to mitigate the problem of misuse, especially among passengers who are less familiar with aviation restraint systems. A more effective solution would be to redesign the restraint system to prevent occupants from using the incorrect restraint entirely (for example, by keying the buckle in such a way that only the correct restraint would fasten).

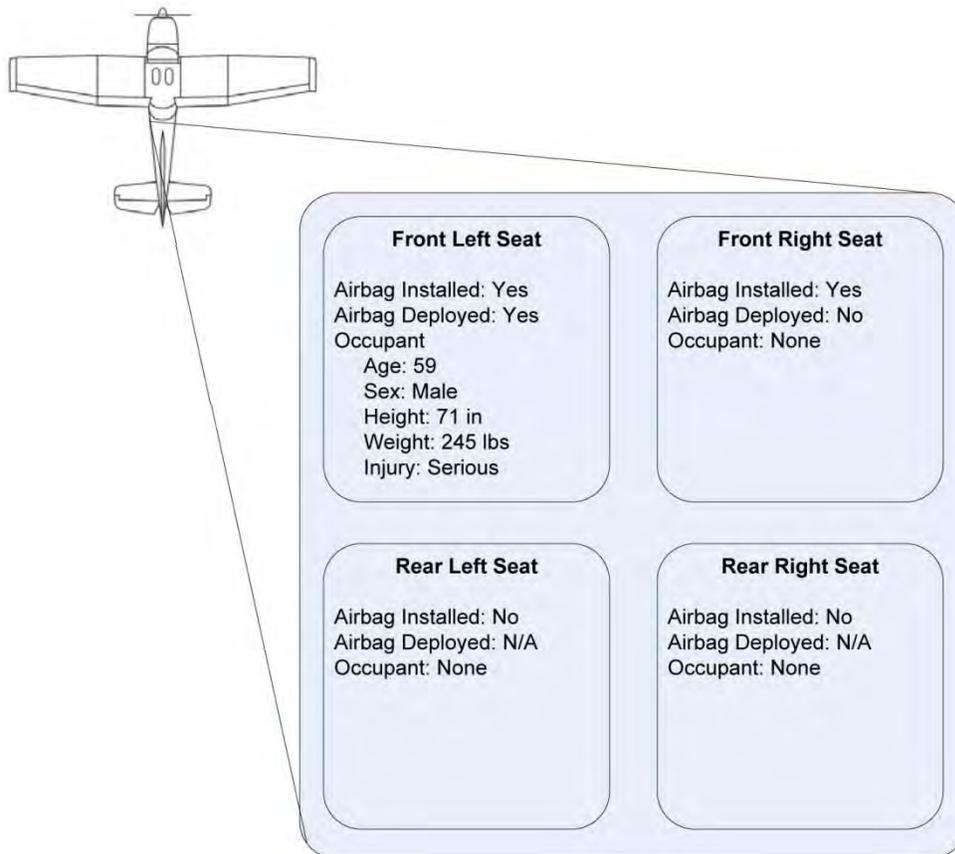
Figure 32. A seating chart from Cessna T172S, N2190W, which crashed in Fullerton, California. (NTSB accident identification number is LAX08FA301.)

The NTSB determined that the accident was caused by the pilot's failure to follow the takeoff checklist and verify the proper flap setting before takeoff. A security camera on the airport's tower with a frame rate of one frame per second captured several images of the accident airplane during its flight. The camera was positioned toward the airplane's impact location but did not capture the actual moment of impact because of the low sampling rate. An image approximately 1.5 seconds before impact showed a large roll angle to the right. The last image before impact shows the plane in an approximate 90-degree right bank. Based on the video

No noticeable deformation of the seat pan was found. In addition, there was no indication of vertical loading to the seat structure. There was, however, a slight displacement of the seat frame to the right.

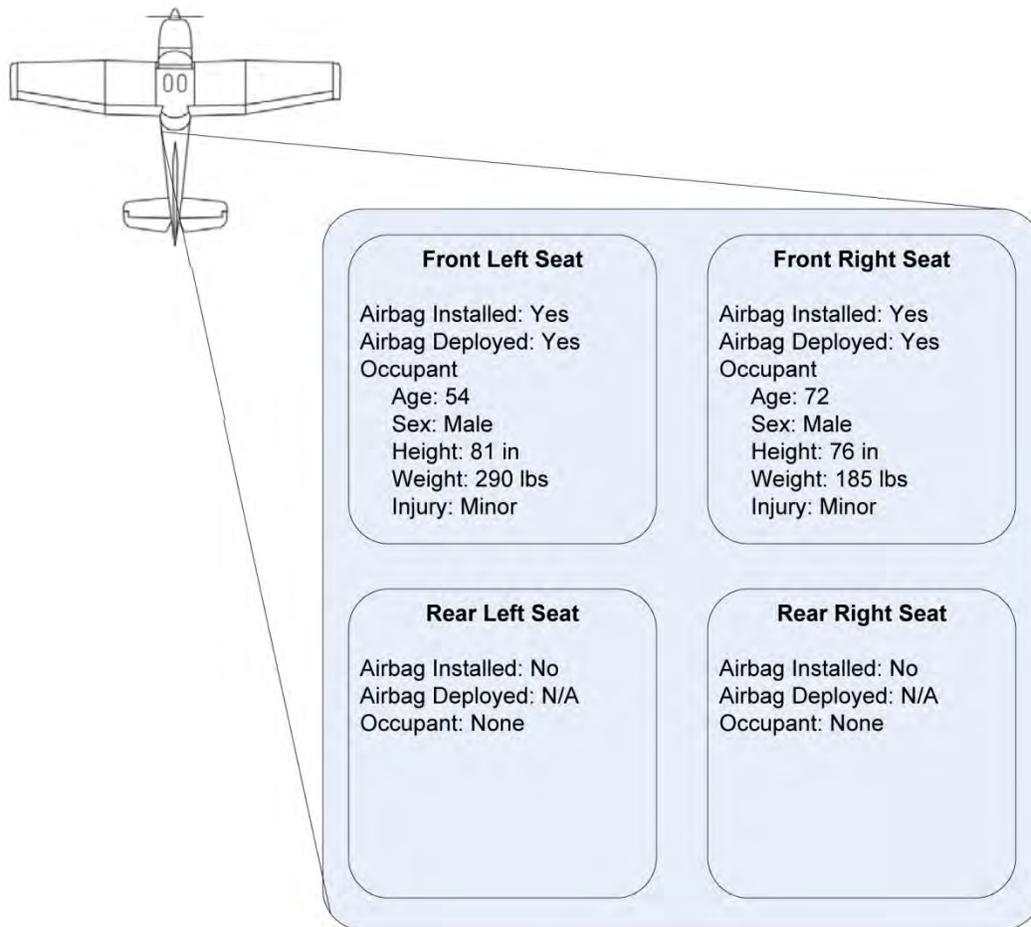
Figure 34. A seating chart from Cessna 172S, N2337F, which crashed in Groton, Connecticut. (NTSB accident identification number is ERA09LA064.)

The NTSB determined that the accident was caused by the student pilot's failure to maintain a proper descent profile to avoid trees during the night visual approach and the flight instructor's inadequate oversight. Interviews with the pilots and scene documentation revealed that the airplane impacted 30- to 40-foot tall trees about 1/4 mile from the runway during a practice landing. The trees were located in a hilly, heavily wooded area at an elevation of about 200 feet msl. Tree damage extended for about 100 feet and was generally aligned with the runway.

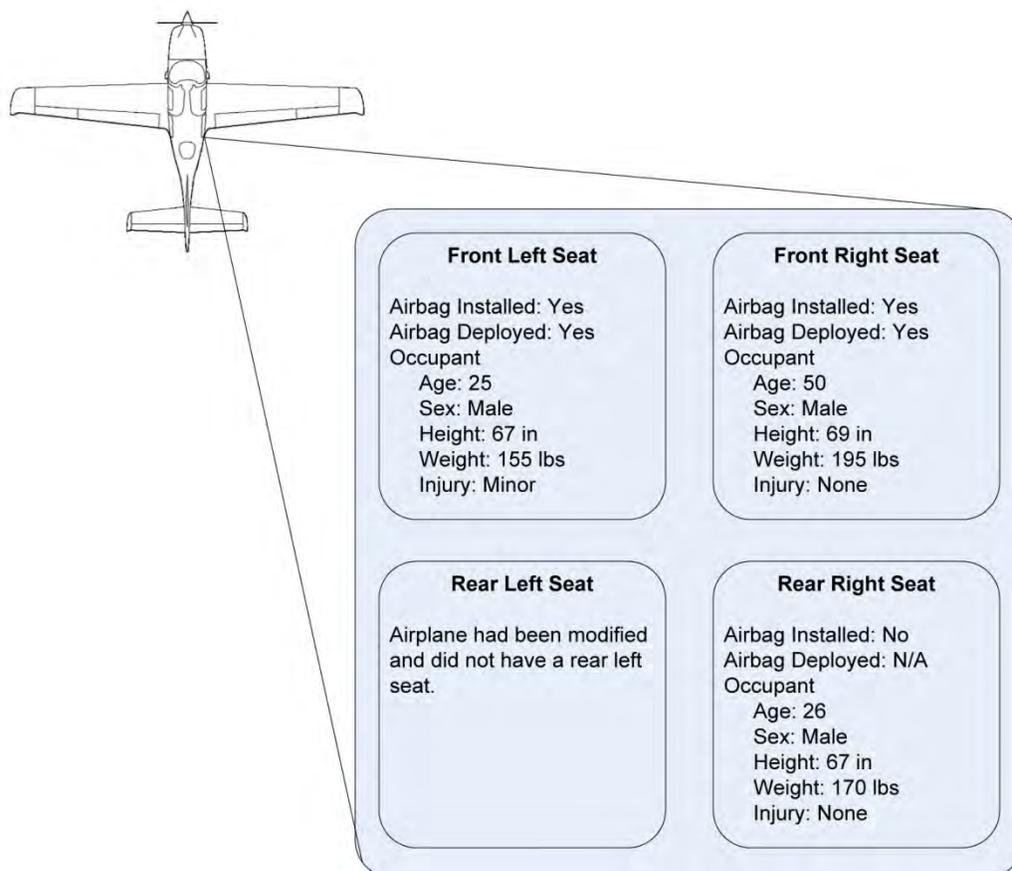
Figure 36. A seating chart from Cirrus SR20, N389CP, which crashed in Green Cove Springs, Florida. (NTSB accident identification number is ERA09LA062.)

The NTSB determined that the accident was caused by the fusing of an electrical cable from the No. 2 (standby) alternator with the throttle cable resulting in the flight crew's inability to move the throttle control. Contributing to the accident was the failure of maintenance

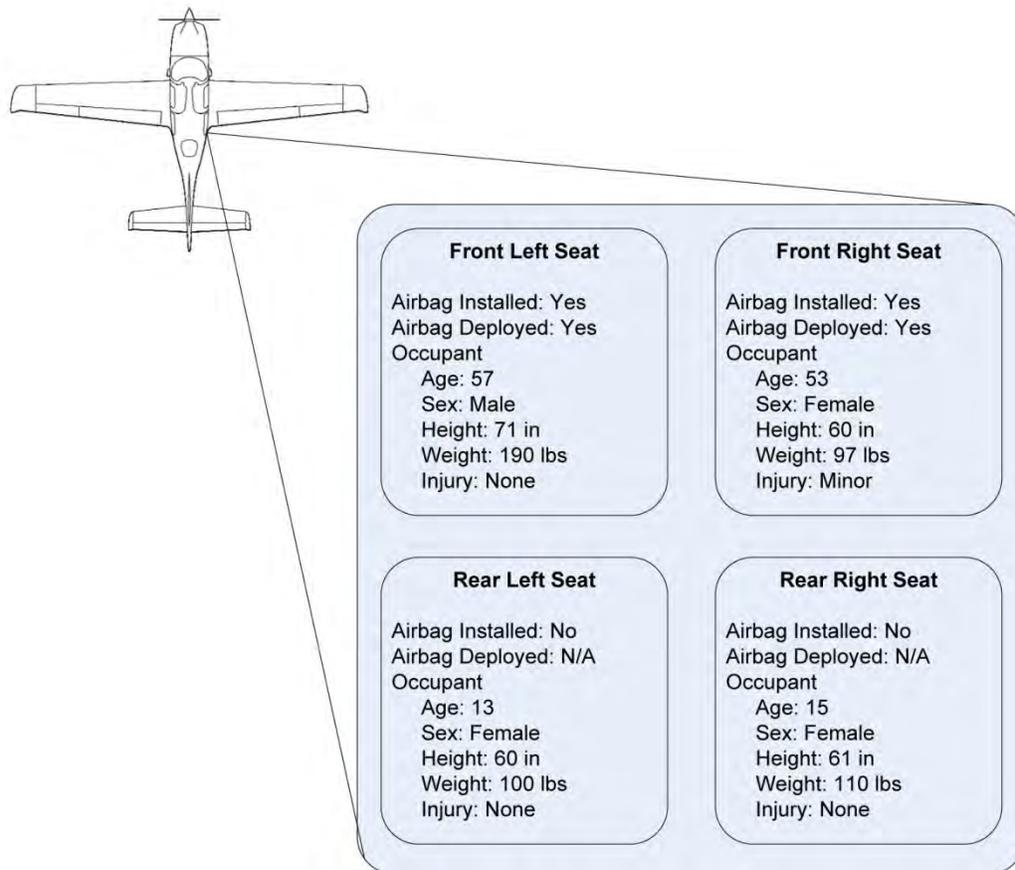
Figure 38. A seating chart from Cirrus SR22, N486CD, which crashed in Steamboat Springs, Colorado. (NTSB accident identification number is CEN09LA165.)

The NTSB determined that the accident was caused by the pilot's failure to apply brakes in a timely manner while landing on a snow-packed, ice-covered runway and his delay in executing a go-around. The pilot reported that during the landing roll, the airplane hit a patch of ice and began turning sideways. As a result, the pilot decided to initiate a go-around. According to airport staff, as the airplane lifted off, the landing gear struck a 19-inch snow berm 49 feet past the end of the runway, and the airplane nosed over. (See figure 39.) The pilot used the egress hammer to break a hole in the right front window. The four occupants then released their seatbelts and exited through the window.

The extended position of the lap portion of the seatbelt webbing for the two occupants in the rear seats and the account from the occupant in the front right seat indicated that the 4-point restraint systems were likely worn incorrectly. When unbuckled and not in use, the 4-point restraint systems on the Cirrus SR22 appear as shown in figure 40. The buckle portion rests at the midpoint of the seatback because when they are unfastened, the inertial reel retracts and takes up the slack in the shoulder harness portion of the restraint.

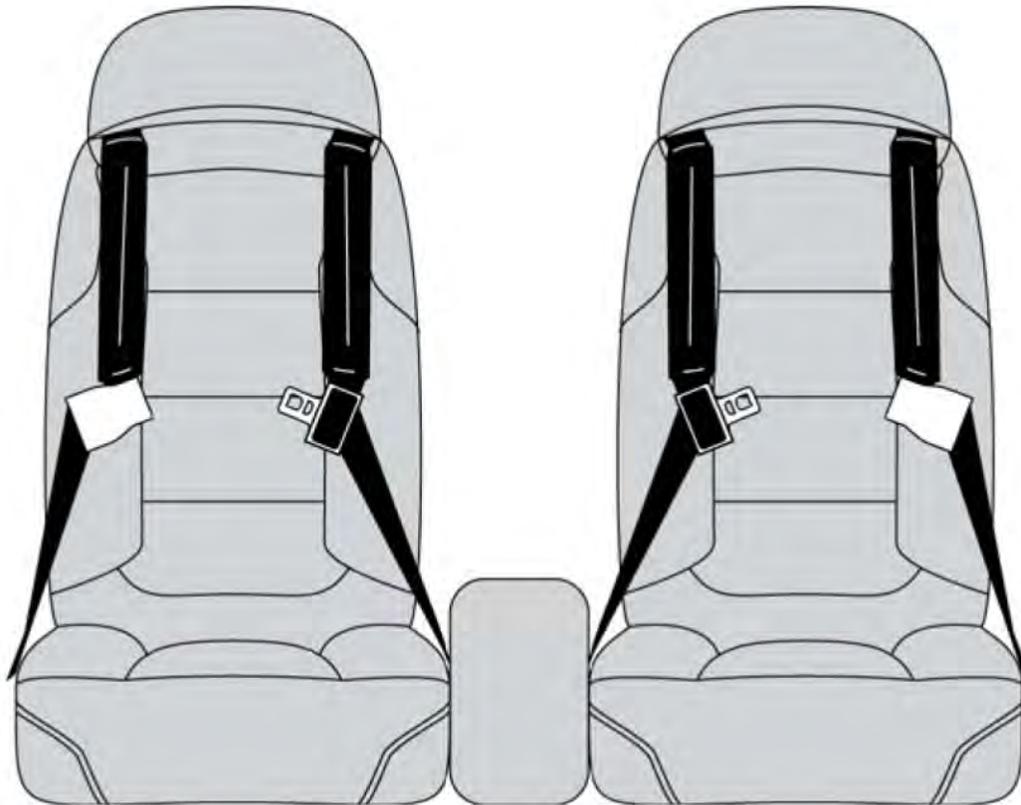
Figure 40. A drawing showing a pair of unbuckled Cirrus SR22 4-point restraint systems.

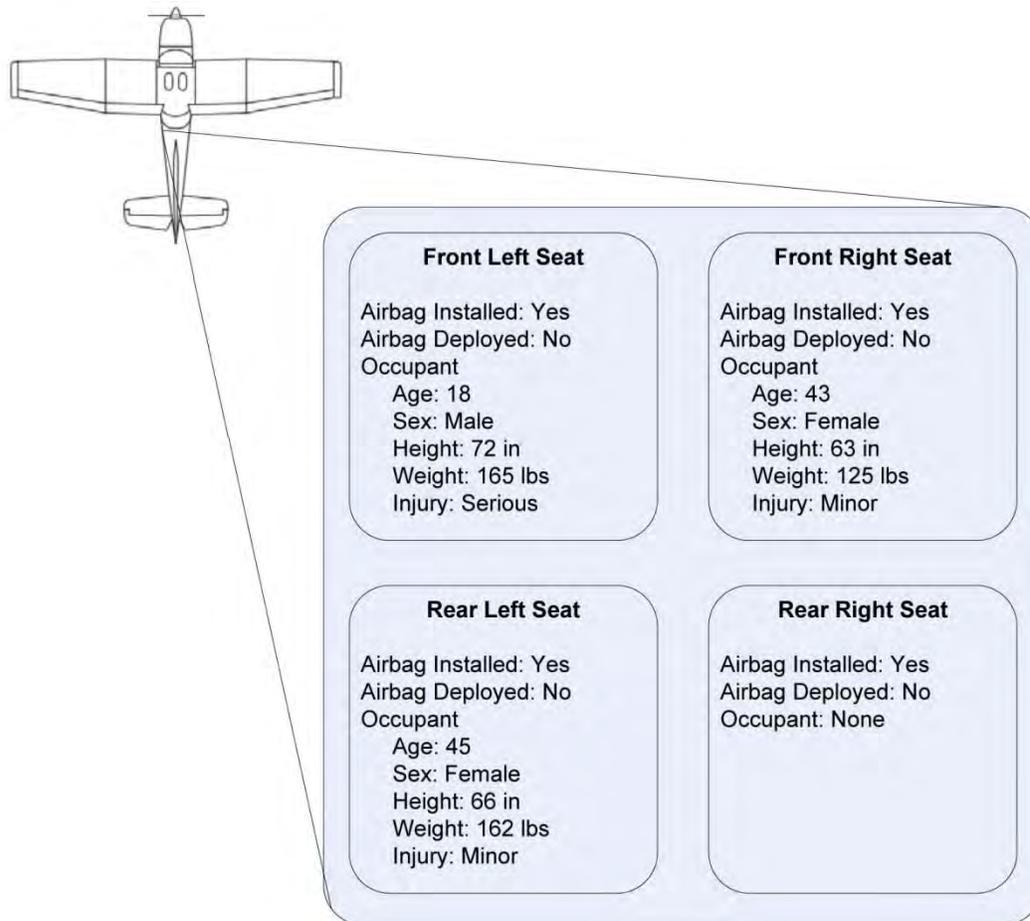
Figure 41. A seating chart from Cessna 182T, N1491D, which crashed in Stigler, Oklahoma. (NTSB accident identification number is CEN09LA247.)

The NTSB determined that the accident was caused by a loss of directional control during takeoff. Contributing to the accident was the pilot's decision to take off with 40 degrees of flaps and with a tailwind. The accident occurred during a soft field takeoff from a 2,000-foot downhill private grass runway. With winds gusting from the southeast, the private pilot elected to depart to the north. During the takeoff sequence, the airplane likely became airborne at about 40 knots (46.1 mph) because of the incorrect flap setting. At this airspeed, there was likely insufficient rudder authority to counteract the winds, and the airplane was pushed to the left.

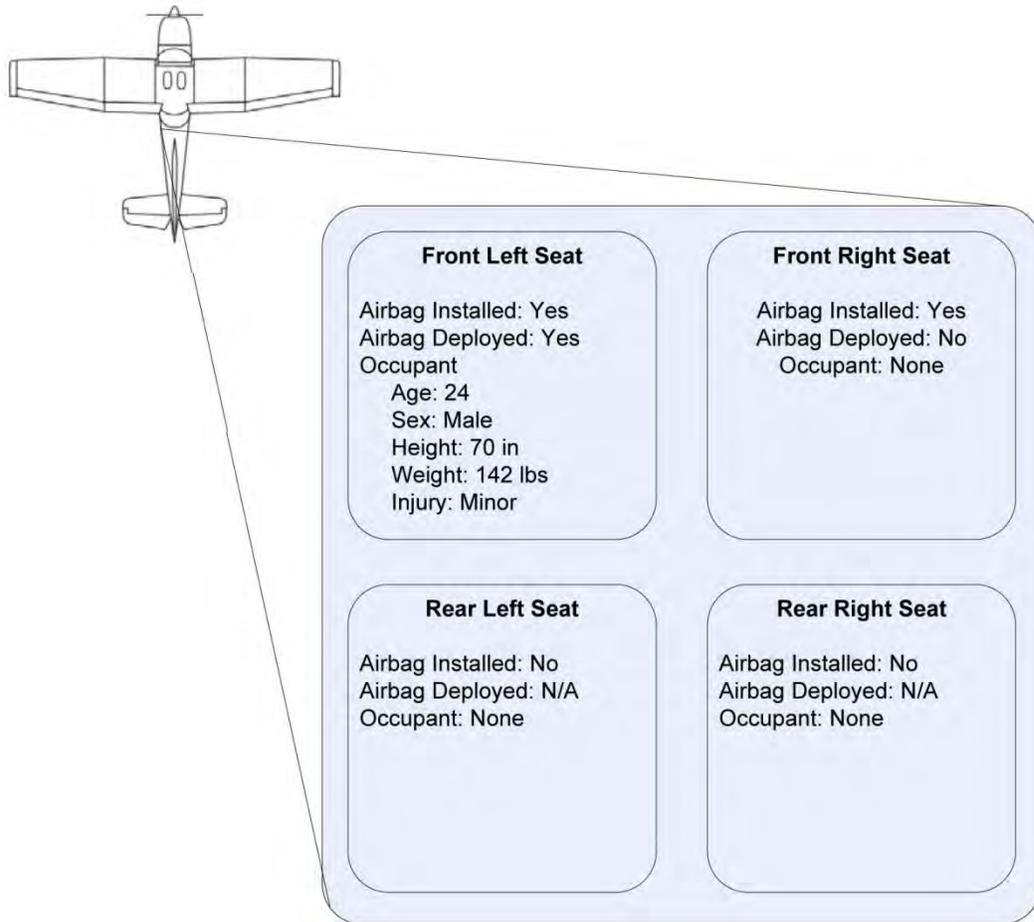
Figure 44. A seating chart from Cessna 172S, N2446F, which crashed in Boyd, Texas. (NTSB accident identification number is CEN09LA442.)

According to an FAA inspector, the airplane, shown in figure 45, came to rest in an upright position in a pasture after hitting a cattle fence, becoming airborne again, hitting a tree, and then hitting a man-made embankment of a stock water pond. The pilot stated that, after the airplane came to a stop, he remained seated on the forward left seat and was able to open his door to exit the airplane.
