Collision with Terrain During Takeoff
of Parachute Jump Flight
Beech King Air 65-A90, N256TA
Mokuleia, Hawaii
June 21, 2019

Accident Report

NTSB/AAR-21/02
PB2021-100909

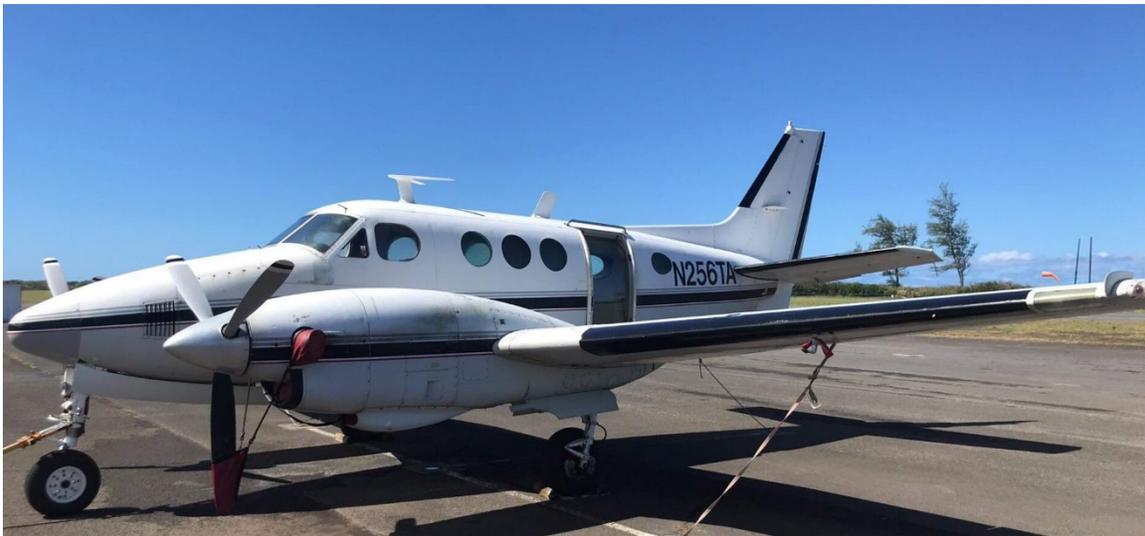
Figure 1. Accident airplane

Beechcraft Aircraft Corporation manufactured the accident airplane with the serial number LJ-256, and the FAA issued a standard airworthiness certificate for the airplane on March 2, 1967.²¹ The airplane had been owned by N80896 LLC, Granite Bay, California, since 2011 and was leased to OPC for 2 years starting May 15, 2017.²² Figure 1 shows the accident airplane at HDH.

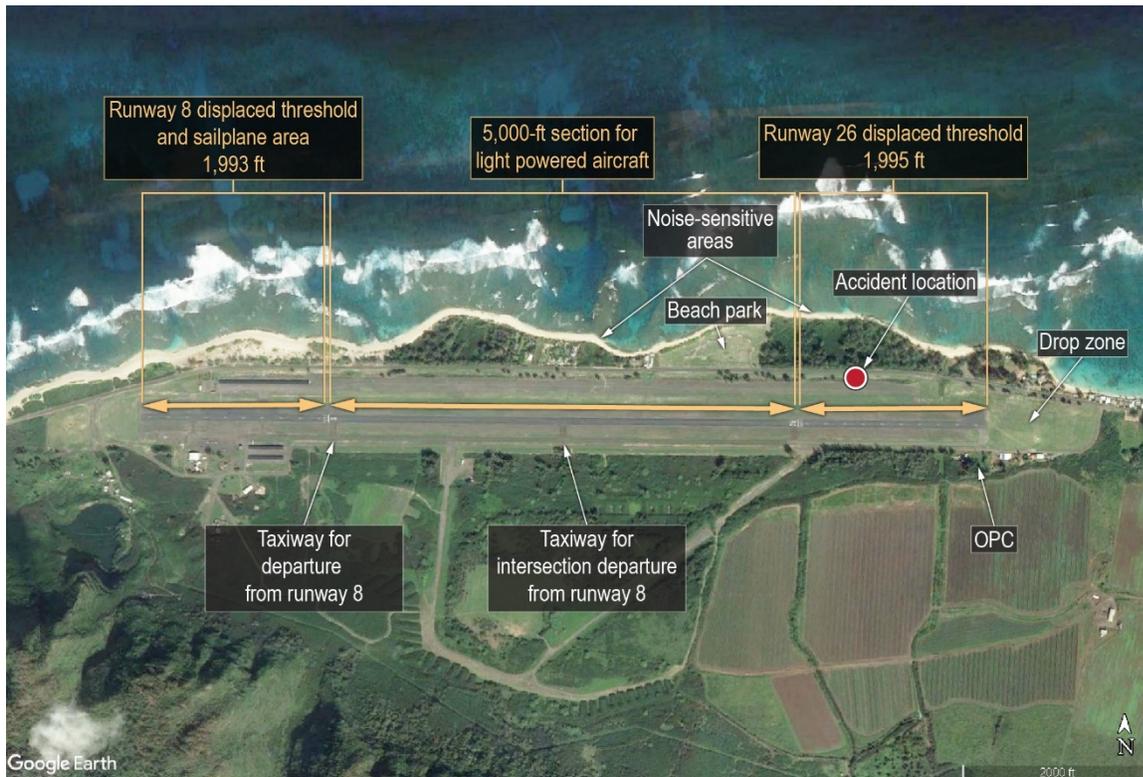
Figure 5. Airport environment

active parachute drop zone was located at the east end of the airport beyond the runway 26 displaced threshold. Figure 5 provides an overview of the airport.

According to the OPC owner and a former OPC pilot, for departures from runway 8, the airplane would turn left at midfield and fly over the adjacent beach park to avoid noise-sensitive areas along the beach and the drop zone at the east end of the airport. The accident airplane owner stated that he had observed takeoffs from runway 8 and did not see any operators (including OPC) perform intersection departures (that is, departures from any runway intersection other than the one at the runway designator). An intersection departure from the 5,000-ft section of runway 8 for light powered aircraft would leave about 2,500 ft of runway remaining. The 1,995-ft length of the runway 26 displaced threshold would also be available for departure.

According to a former OPC pilot, the standard departure from runway 8 necessitated a turn to the left at midfield to fly over the adjacent beach park to avoid the noise-sensitive areas along the beach and the drop zone at the east end of the runway (see figure 5). Airplane performance data were consistent with the former OPC pilot's statement and showed that, for a runway 8 departure using the 7,000 ft of runway available, the airplane had ample distance to rotate, climb, and turn toward the beach park (the established turning point) to avoid the noise-sensitive areas and the drop zone.⁶⁶ However, a departure from runway 8 using the intersecting taxiway at midfield would leave 4,500 ft of available runway for takeoff, resulting in rotation farther down the runway (adjacent to the beach park) and a turn soon thereafter to avoid the noise-sensitive areas and the drop zone.

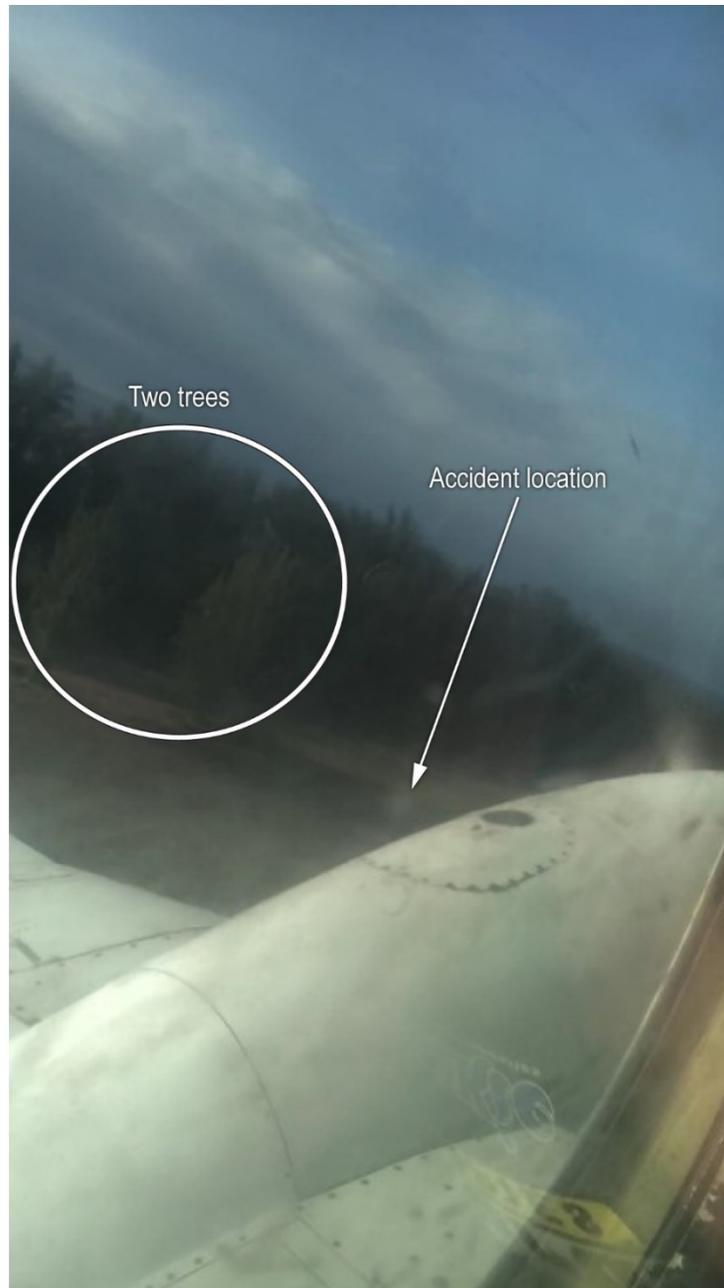
The NTSB received a video from a personal electronic device that was recorded by a passenger on the flight preceding the accident flight. The passenger video showed mostly the interior of the airplane; ground references—the ocean and two trees—were visible through a window for 3.5 seconds. The trees were visible for 2.1 seconds; during that timeframe, the airplane appeared to be in a nose-up attitude (having already departed from runway 8) and was transitioning to a left turn toward the ocean. Figure 6 is a still image from the video in which the two trees can be seen through one of the airplane windows; the location of the accident site is also noted.

The passenger video also recorded sound. The spectrum analysis of the sound signal indicated that both of the airplane's engines were operating at the same constant speed during the previous flight.

Figure 6. Video image from the flight preceding the accident flight showing the two trees in relation to the accident location
