National Transportation Safety Board

Marine Accident Brief

Collision and Subsequent Sinking of Towing Vessel *Specialist*

Accident no.	DCA16FM033
Vessel name	<i>Specialist</i>
Accident type	Collision; sinking
Location	Hudson River at Tappan Zee Bridge, pier 31, Tarrytown, New York
Date	March 12, 2016
Time	0500 eastern standard time (coordinated universal time – 5 hours)
Injuries	3 fatalities
Property damage	Constructive total loss of vessel
Environmental damage	Oil sheen observed
Weather	Clear, 5-knot winds from the west, air temperature 34°F
Waterway information	Hudson River, Tarrytown, New York. At the time of the accident, the current was ebbing from the north at about 1.2 knots, and the water temperature was 39°F.

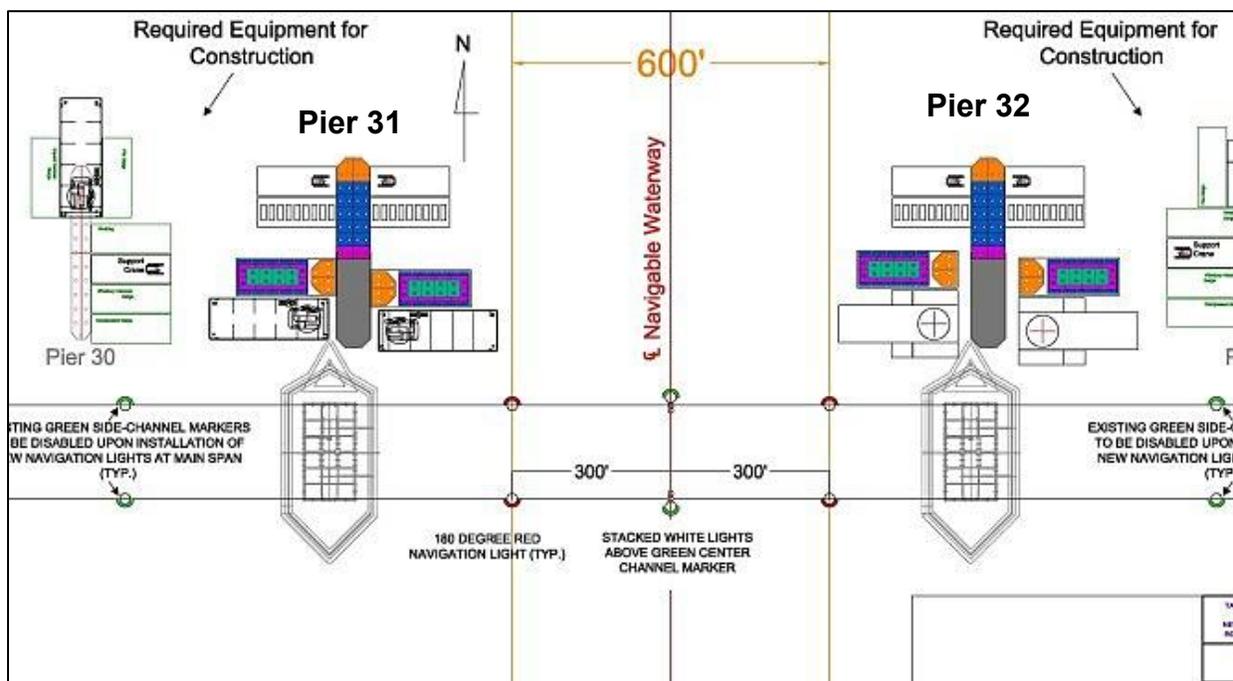
Temporary navigational lights . . . relocated as per the diagram below at the existing Tappan Zee Bridge across the Hudson River at mile 27.0. The new temporary navigational lighting plan includes marking the 600-foot wide main channel by affixing four-180° steady, red navigation lights to the underside of the main span, 2 each on the upstream and downstream sides of the structure, 300 feet either side of the centerline of the bridge. Each green center of channel light will have 3 white lights stacked vertically above it. The center 600-feet of the Main Navigation Channel will be free for the passage of marine traffic and clear of all obstructions at all times.

The night of the accident, the US Coast Guard inspected the navigation lights at the construction site and found them to be working properly.

Navigation lighting diagram included in Coast Guard Local Notice to Mariners.

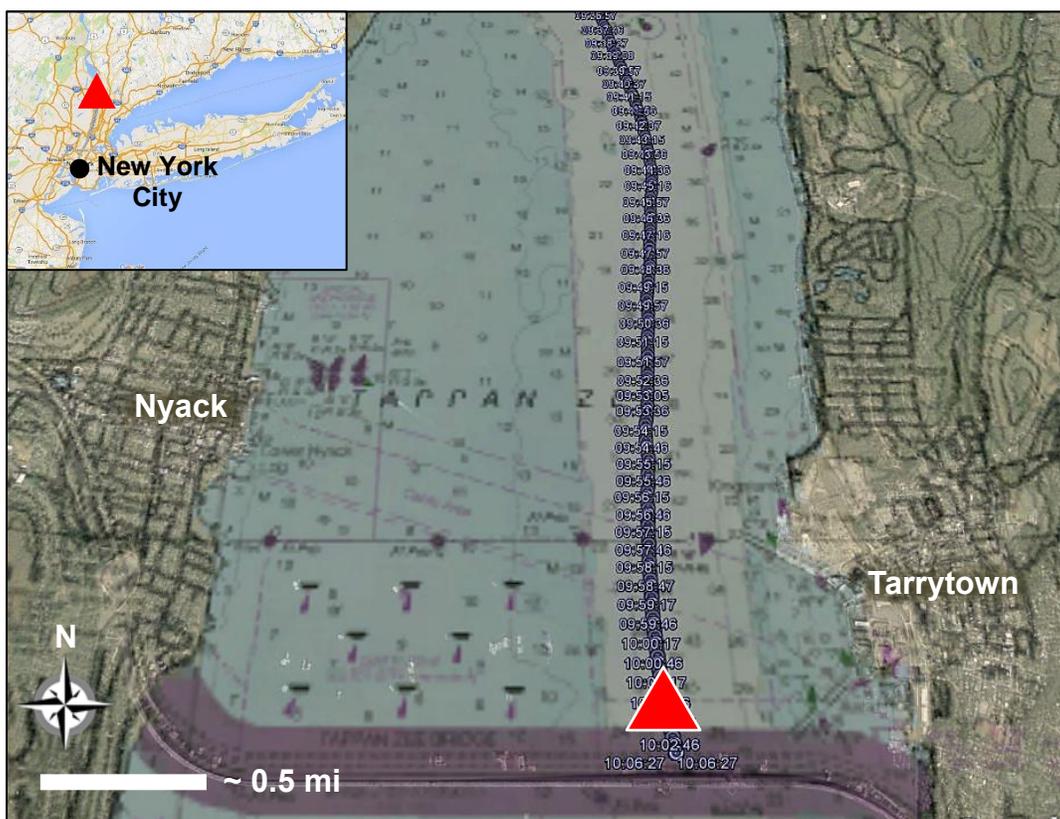
AIS data of the *Specialist's* track with an overlaid red triangle marking the approximate site of the accident. (Data from the Coast Guard Navigation Center) Insert shows a larger view of the area, with the accident site marked by a red triangle. (Google Maps)

Before the flotilla could maneuver away from the spudded barge, the starboard side of the *Specialist* struck the forward starboard corner of *N181* at about 7.8 knots, causing significant damage to the *Specialist* above the waterline. The mate, who had been at the helm, jumped off the *Specialist* and onto the construction barge after the collision. The ebbing current pushed the *Specialist* into the raked bow of the construction barge and began pushing the tugboat under water. According to statements from the workers on *N181*, the mate returned to the tugboat to attempt to help a deckhand who was trapped inside and calling for help. The *Specialist* took on water through open doors and rapidly sank with the mate and two deckhands aboard. After the vessel sank, several workers from the construction barge saw the mate in the water, being swept away by the current. They threw life rings toward him but he was unresponsive. A nearby rescue boat recovered the mate about 100 yards from the accident site moments later and rushed him to shore; attempts to revive him were unsuccessful.
