National Transportation Safety Board

Aircraft Accident Investigative Update

On November 4, 2025, about 1714 eastern standard time (EST), United Parcel Service (UPS) flight 2976, a Boeing (McDonnell-Douglas) MD-11F airplane, N259UP, was destroyed after it impacted buildings and the ground shortly after takeoff from runway 17R at Louisville Muhammad Ali International Airport (SDF), Louisville, Kentucky. The 3 crewmembers aboard the airplane and 11 people on the ground were fatally injured, 2 people on the ground were seriously injured, and 21 people on the ground sustained minor injuries.¹ Flight 2976 was a domestic cargo flight operating under the provisions of Title 14 *Code of Federal Regulations (CFR)* Part 121 from SDF to Daniel K. Inouye International Airport (HNL), Honolulu, Hawaii.

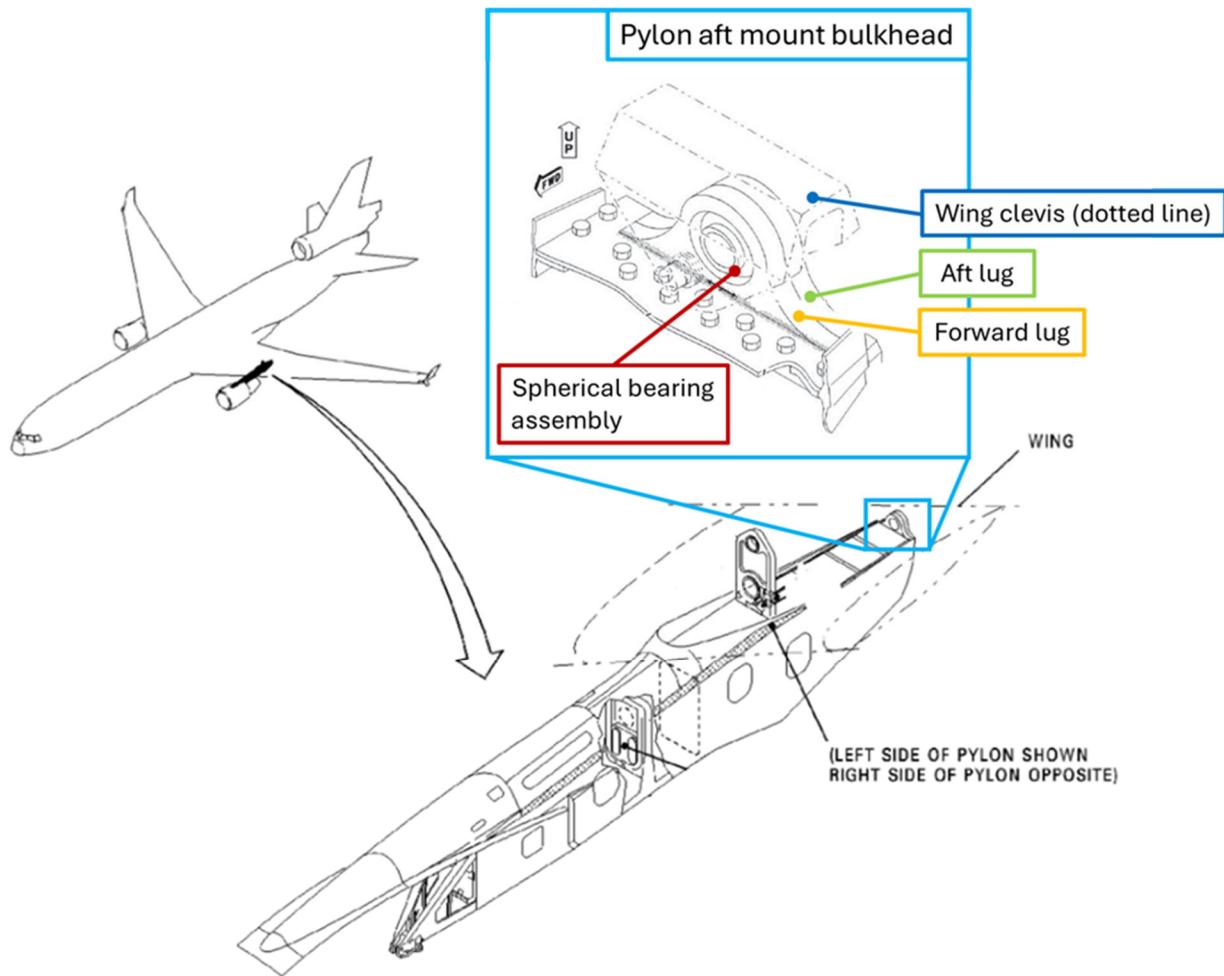
As indicated in the preliminary report for this investigation, airport surveillance videos that captured part of the airplane's takeoff roll showed that the left (No. 1) engine and pylon separated from the wing shortly after airplane rotation, and a fire ignited on the left engine and near the area of the left pylon wing attachment. The pylon aft mount bulkhead is an assembly composed of two independent fittings, bolted together, with lugs (forward lug and aft lug) that house a single spherical bearing assembly (see figure 1). The lugs from the left pylon aft mount bulkhead were found fractured, and the associated spherical bearing assembly for this location, consisting of a ball element and bearing race, was found still installed on the left wing clevis at the accident site and was exposed to the postcrash fire. The spherical bearing race, which is normally one piece and housed within the lugs of the aft mount bulkhead, was found fractured into forward and aft portions.

Figure 1. The pylon-to-wing mount diagram, with the inset image showing details of the pylon aft mount bulkhead connection to the wing clevis. The hardware that attaches the wing clevis and the lugs are not shown in this diagram. (Source: Adapted from a Boeing diagram)
