# Aviation Investigation Preliminary Report

<b>Location:</b>	Louisville, KY	<b>Accident Number:</b>	DCA26MA024
<b>Date &amp; Time:</b>	November 4, 2025, 17:14 Local	<b>Registration:</b>	N259UP
<b>Aircraft:</b>	McDonnell Douglas MD-11F	<b>Injuries:</b>	14 Fatal, 2 Serious, 21 Minor
<b>Flight Conducted Under:</b>	Part 121: Air carrier - Non-scheduled

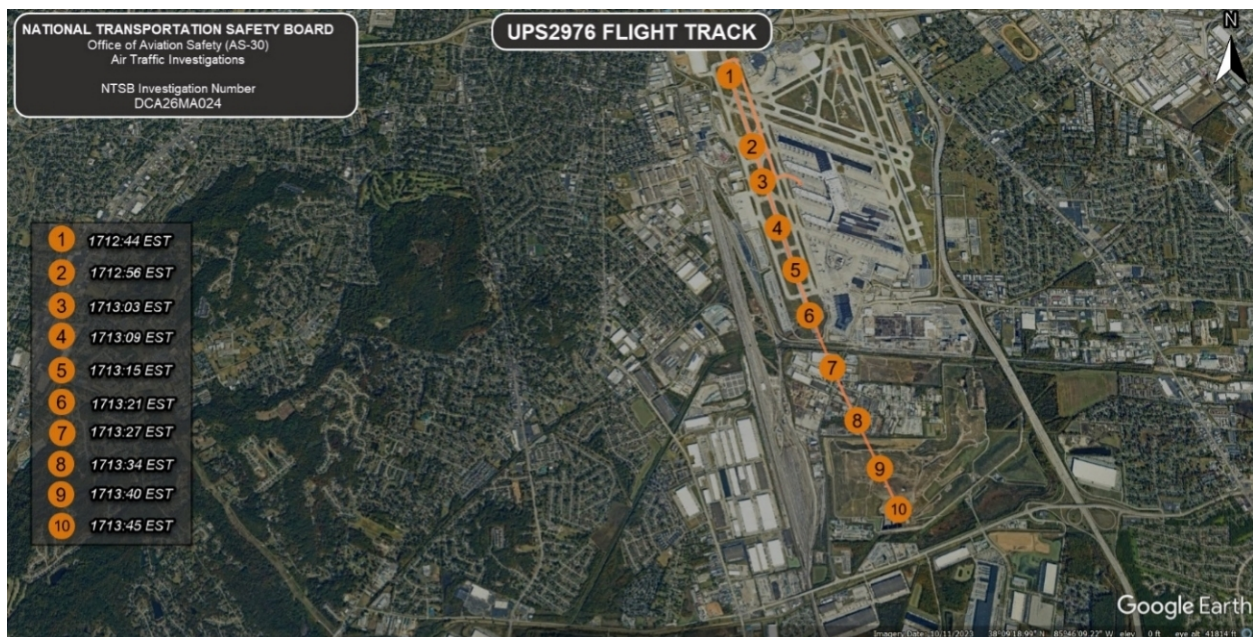
**Figure 3.** Graphic depicting the flight track of UPS flight 2976 based on ADS-B data.

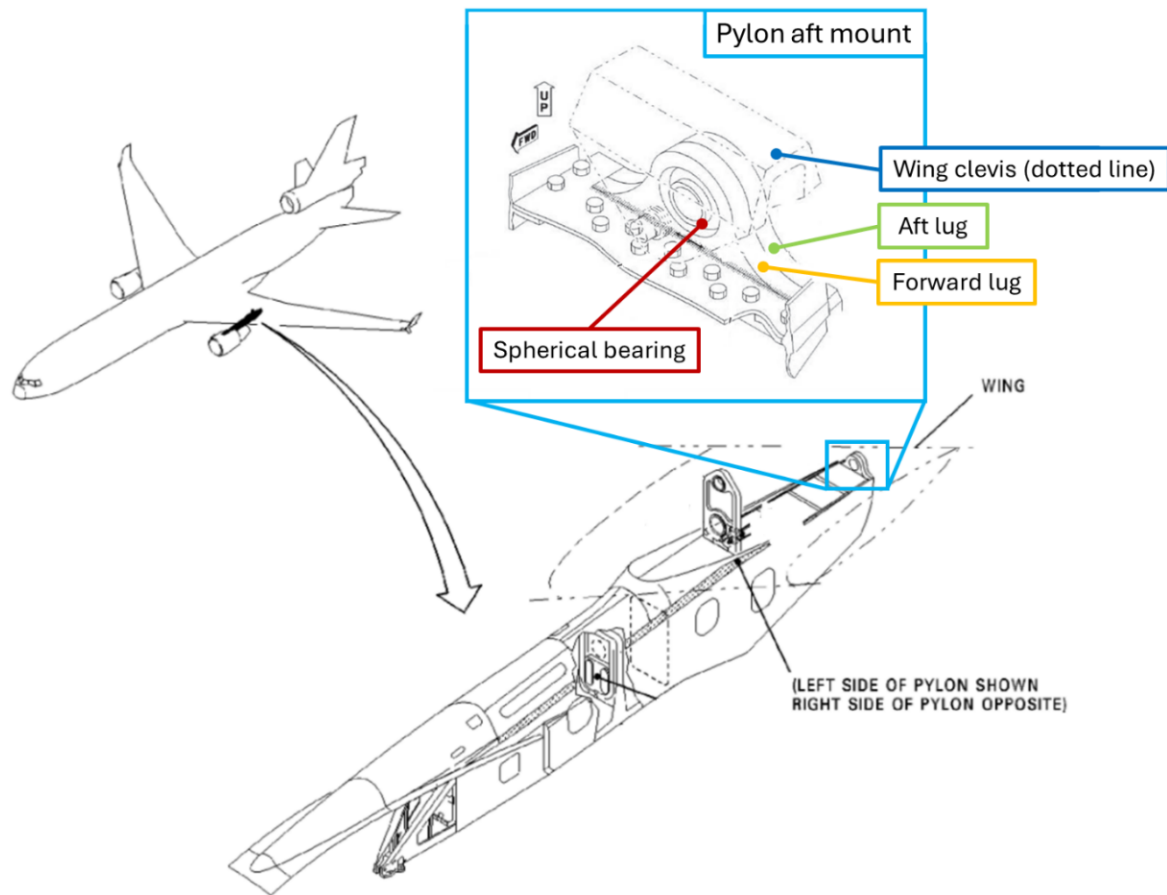
The thrust link assembly, located immediately behind the forward mount’s lower spherical bearing, primarily transmits thrust loads. The pylon aft mount is an assembly composed of two independent fittings bolted together, with lugs (forward lug and aft lug) that house a single spherical bearing (see figures 5 and 6). For this report, references to the pylon aft mount spherical bearing includes both the bearing’s ball element (sphere) and its outer race. A clevis

on the underside of each wing ("wing clevis") connects to the pylon aft mount via attachment hardware.

**Figure 5.** The pylon-to-wing mount diagram, with the inset image showing details of the pylon aft mount connection to the wing clevis. (Source: Boeing, edited by NTSB)

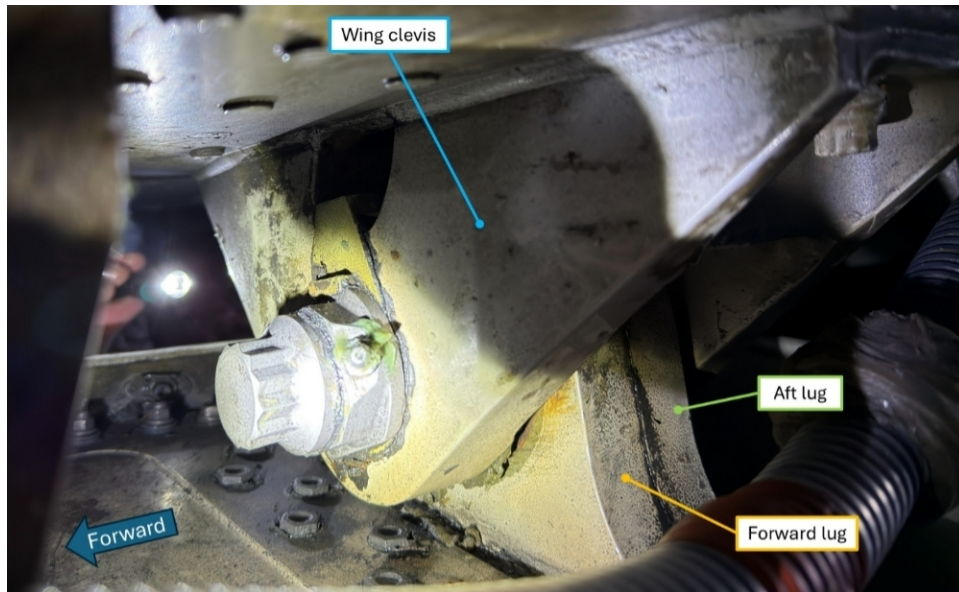
**Figure 6.** An exemplar installation of the pylon aft mount to the wing clevis. The aft mount spherical bearing is obscured by the wing clevis.
