PB90-910406
NTSB/AAR-90/06

AIRCRAFT ACCIDENT REPORT

**UNITED AIRLINES FLIGHT 232
McDONNELL DOUGLAS DC-10-10
SIOUX GATEWAY AIRPORT
SIOUX CITY, IOWA
JULY 19, 1989**

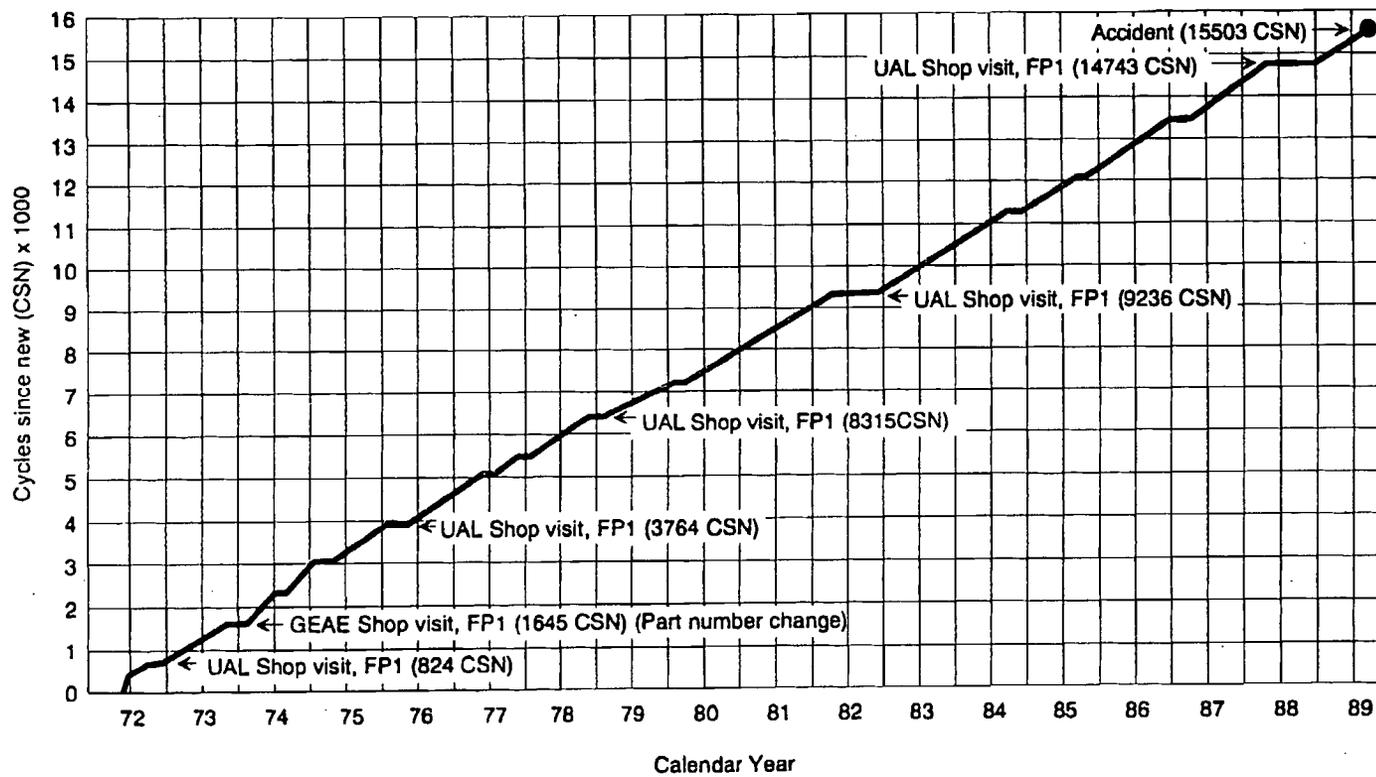
Figure 9.--Inspection history of accident fan disk.
(Data source GEAE)

During the next 17 years, the engines in which this stage 1 fan disk were installed were routinely overhauled and the fan module was disassembled. The disk was removed on the following dates for inspection: September 1972, November 1973, January 1976, June 1978, February 1982 and February 1988. This disk was accepted after each of six fluorescent penetrant inspections (FPI).² (See figure 9). Five of the six inspections were performed at the UAL CF6 Overhaul Shop in San Francisco, California. One of them was performed at the GEAE Airline Service Department in Ontario, California, in 1973. At the time of the accident, the stage 1 fan disk had accumulated 41,009 hours and 15,503 cycles since new. The last shop visit in February 1988, was 760 flight cycles before the accident, and FPI was performed at that time. The engine had been removed because of corrosion in the high pressure turbine (HPT) stage 1 nozzle guide vanes. At that time, the stage 1 fan disk had accumulated 38,839 hours and 14,743 cycles since new. Following this inspection, the disk was installed in engine S/N 451-243, the No. 2 engine on the accident airplane.

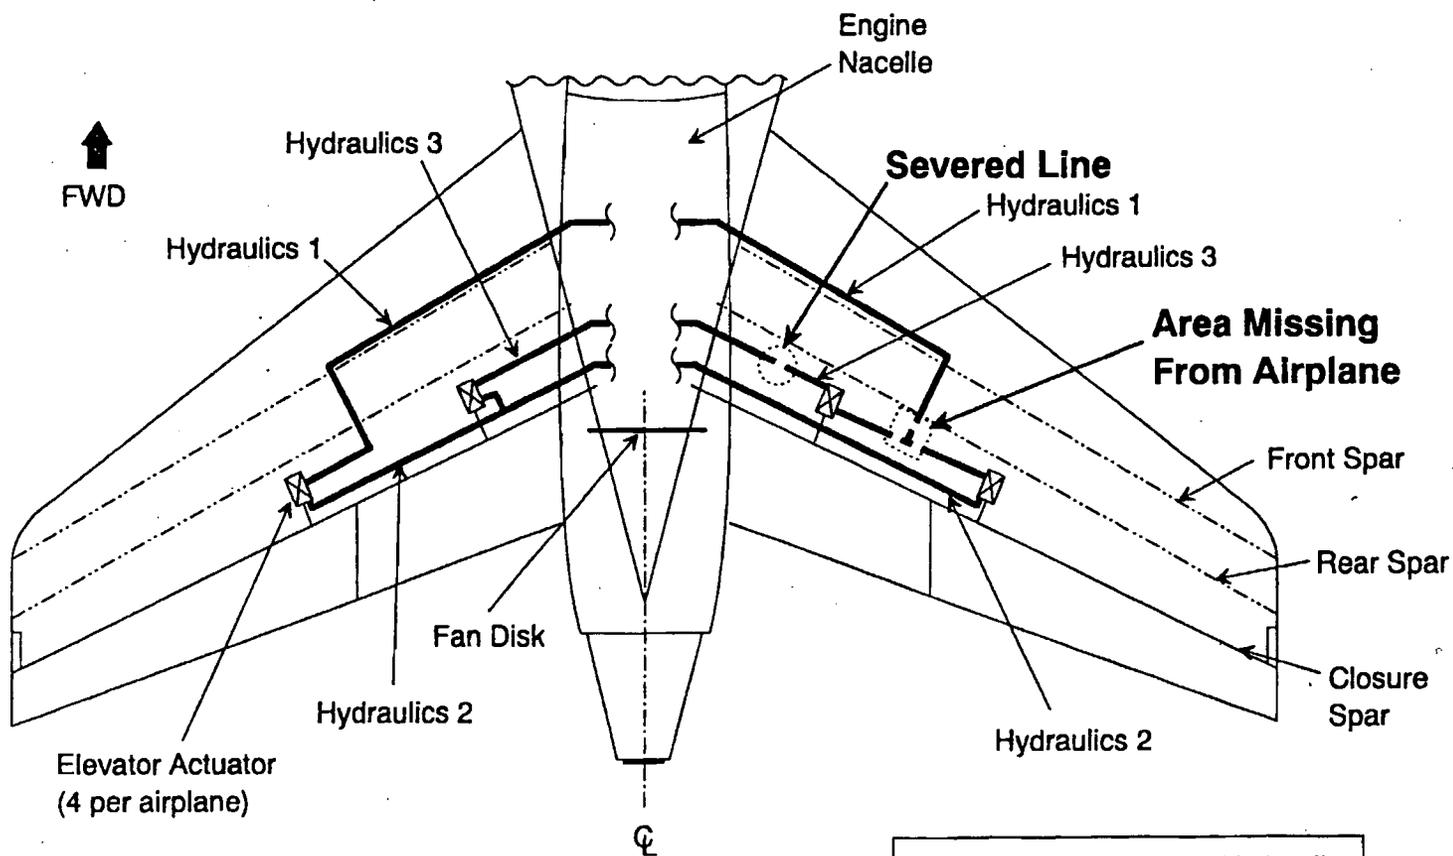
During reconstruction of the empennage, it was noted that a portion of the right horizontal stabilizer was not recovered at the Sioux City Airport. A photograph taken from the ground prior to impact shows that this section was missing before impact. The missing area contained the No. 1 hydraulic system tubing that supplies hydraulic fluid to the right inboard and outboard elevator actuators. (See figure 13 and 14).
