# NATIONAL TRANSPORTATION SAFETY BOARD

## AIRCRAFT ACCIDENT REPORT

IN-FLIGHT LOSS OF PROPELLER BLADE  
FORCED LANDING, AND COLLISION WITH TERRAIN  
ATLANTIC SOUTHEAST AIRLINES, INC., FLIGHT 529  
EMBRAER EMB-120RT, N256AS  
CARROLLTON, GEORGIA  
AUGUST 21, 1995

**Adopted: November 26, 1996  
Notation 6609B**

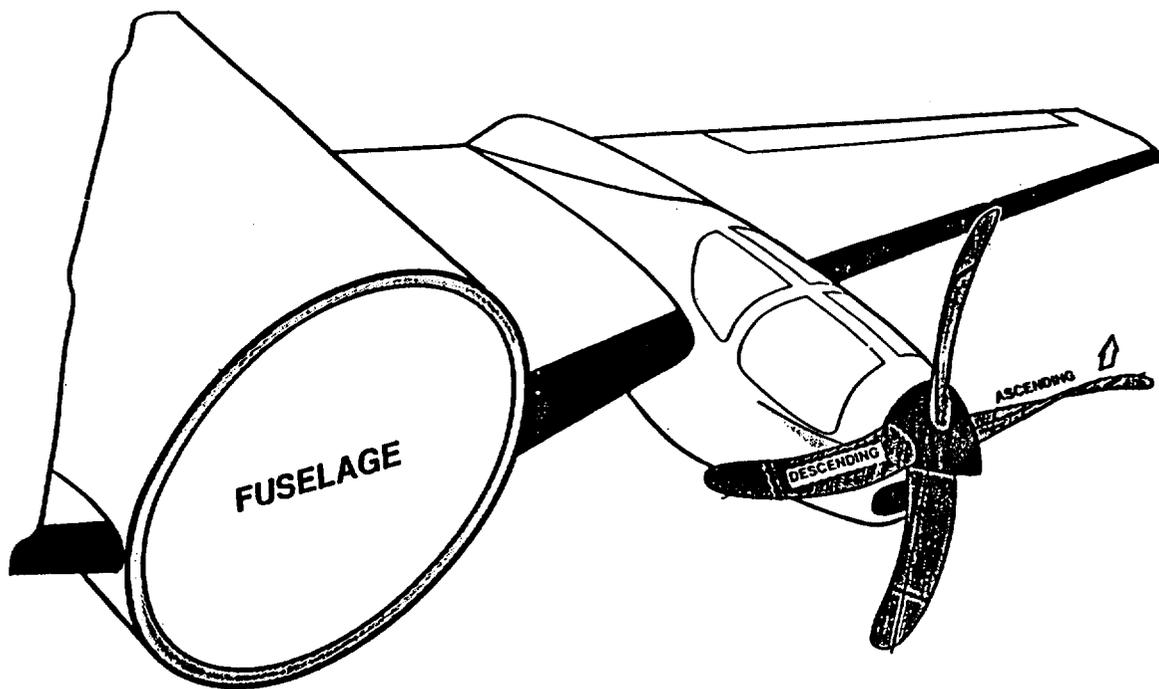
Figure 1.--Propeller installation - left wing.

wing. The flight attendant said that she looked out the left side of the aircraft and observed, “a mangled piece of machinery where the propeller and the front part of the cowling was.” Other passengers observed the propeller displaced outboard from its original position on the engine (see Figure 1). The flight attendant stated that after the first officer notified her of the flight’s emergency return to ATL (at 1245:46), she prepared the cabin for an emergency landing and evacuation. She stated that she had no further dialogue with the flightcrew.
