PB90-916301  
NTSB/RAR-90/01

## **RAILROAD ACCIDENT REPORT**

**REAR-END COLLISION OF TWO  
NEW YORK CITY TRANSIT AUTHORITY TRAINS  
103RD STREET STATION  
NEW YORK, NEW YORK  
MARCH 10, 1989**

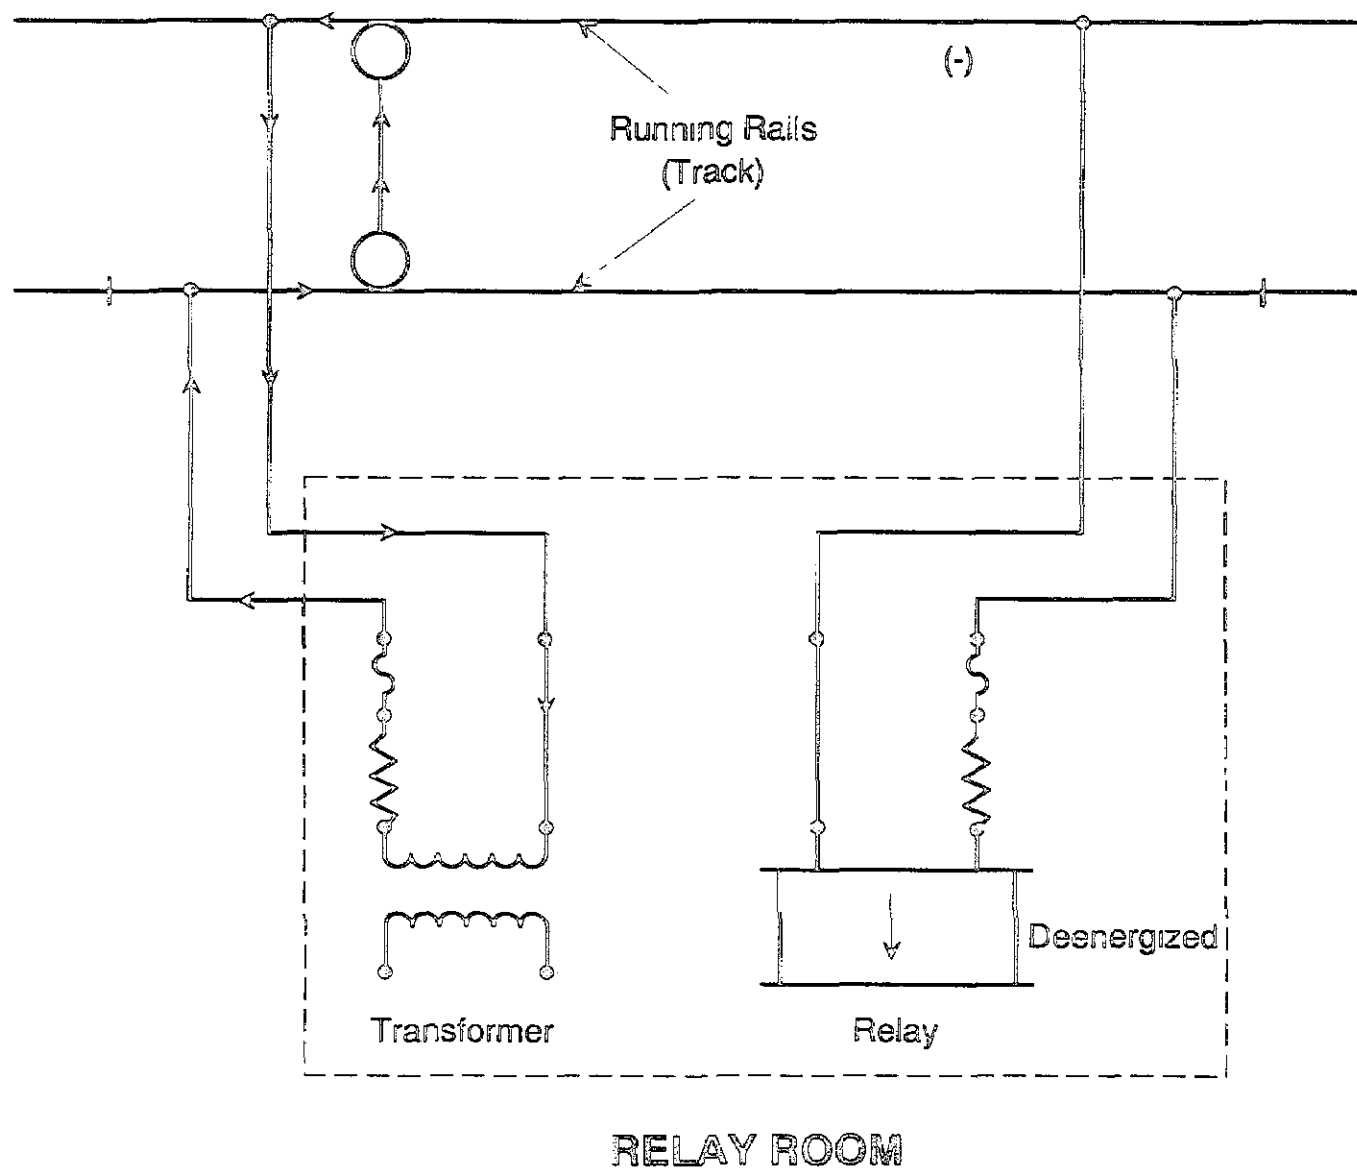
Figure 6.-- Track Circuit Shunting.

The track circuits are designed so that when a track circuit is unoccupied, current flows from the transformer through a resistor, a fuse and electrical wire to the positive (signal) rail, then through electrical wire, a fuse, a resistor, and a relay to the negative (propulsion) rail, and then again through electrical wire to the transformer; much of electrical wire is routed through the concrete inverts which support the tracks. When the relay is energized the signal system will display a clear indication (see figure 5). When a set of wheels are on the rail, the track circuit is shunted. Thus, current will not flow to energize the relay and the signal system will display a stop indication (see figure 6).
