Fishing Vessel Safety Digest 2010

MARINE ACCIDENT INVESTIGATION BRANCH

This *Safety Digest* draws the attention of the marine community to some of the lessons arising from investigations into recent accidents.

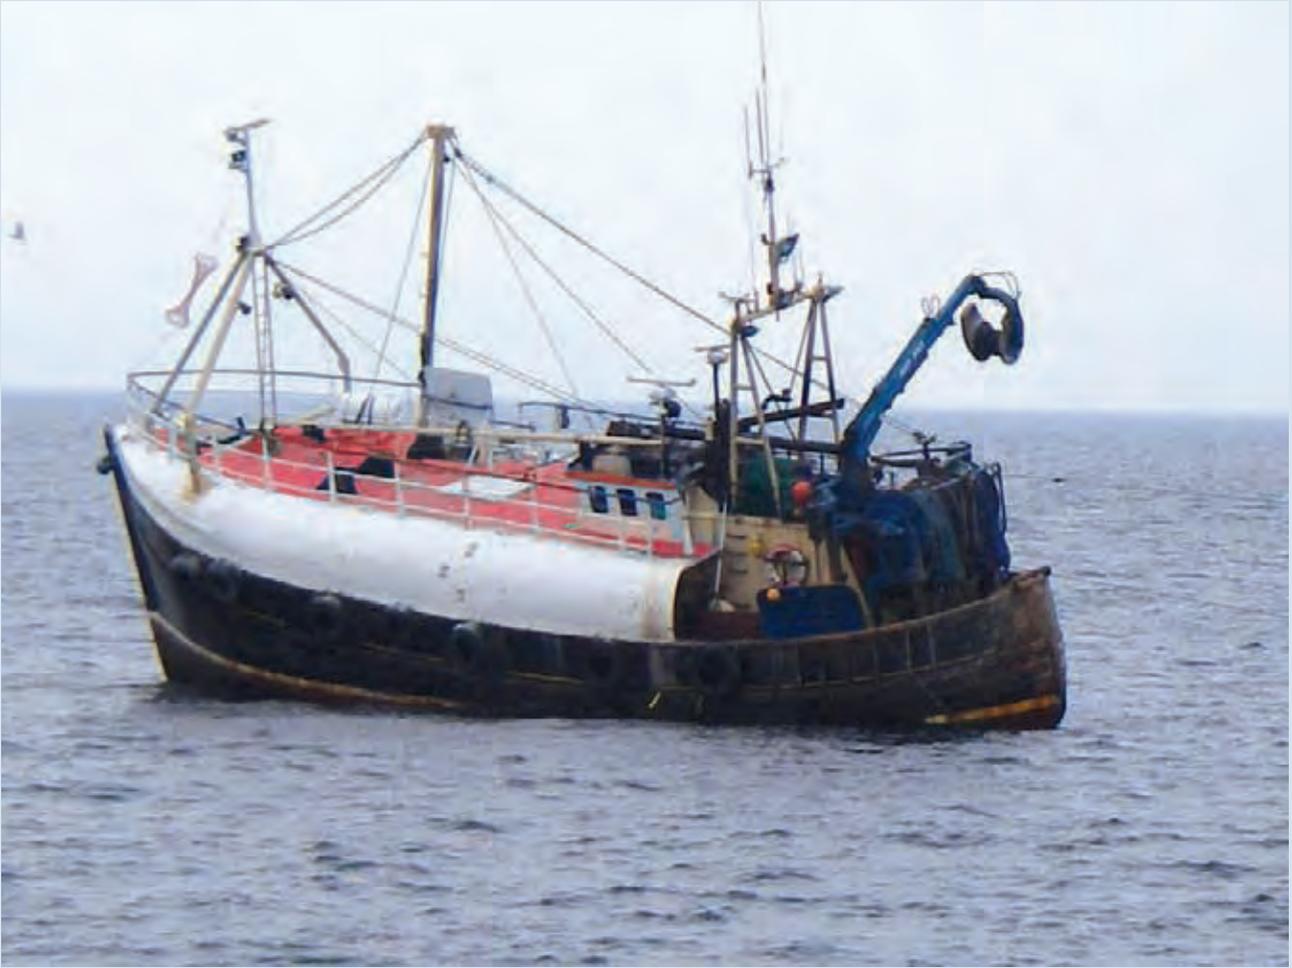
The skipper was able to obtain the assistance of two passing fishing vessels to tow his vessel off the shoal at the next high water. The trawler then returned to harbour, where it was found that damage was limited to the forefoot and the steel keel band.

1 It is essential that watchkeepers maintain a proper navigational watch at all times and do not undertake any other duties that would interfere with the safe navigation of the vessel. Further advice on best navigational practice can be found in the MCA's MGN 313 (F).

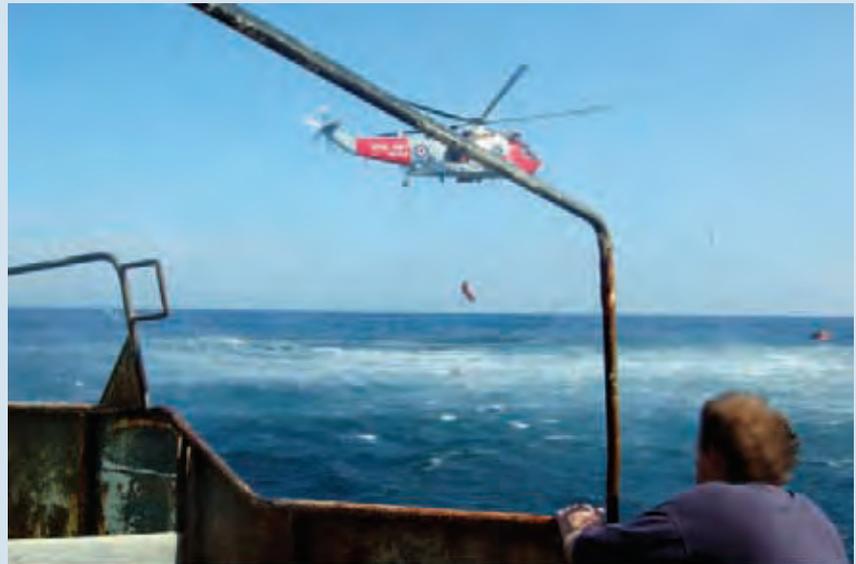
Figure 2

The skipper checked the accommodation area and found that the cabin deck was just under water. Sensibly, he did not enter the compartment because at about the same time the vessel made a sudden lurch and began to roll to starboard.

Without the vessel being available to inspect, the cause of the flooding is a matter of speculation. However, the rate of flooding calculations suggested that a 60mm diameter hole or comparable split would have caused the conditions which led to the foundering. The skipper was unable to see the source of water ingress, which suggested that it was under the engine room floor plates, below the water level. It is noteworthy that the main engine sea water cooling system used 60mm diameter pipes.

- 1 Investigate bilge level alarms on every occasion. It is all too easy to become complacent and switch on the bilge pump without identifying the cause of the alarm.
- 2 Use suitable components when penetrating watertight bulkheads so as to maintain, so far as is practicable, the watertight integrity.
- 3 Consider fitting extended spindles to sea valves that are not already required by regulation to be fitted, and regularly check the condition of related pipework.
- 4 Ensure that all bilge pumps, including hand-operated emergency pumps, are maintained ready for immediate use.
- 5 Conduct regular emergency drills.
- 6 Consult MGN 165 (F) – Fishing Vessels: The Risk of Flooding. This publication, which is available on the MCA’s website, provides comprehensive advice on flooding prevention measures, and makes essential reading.

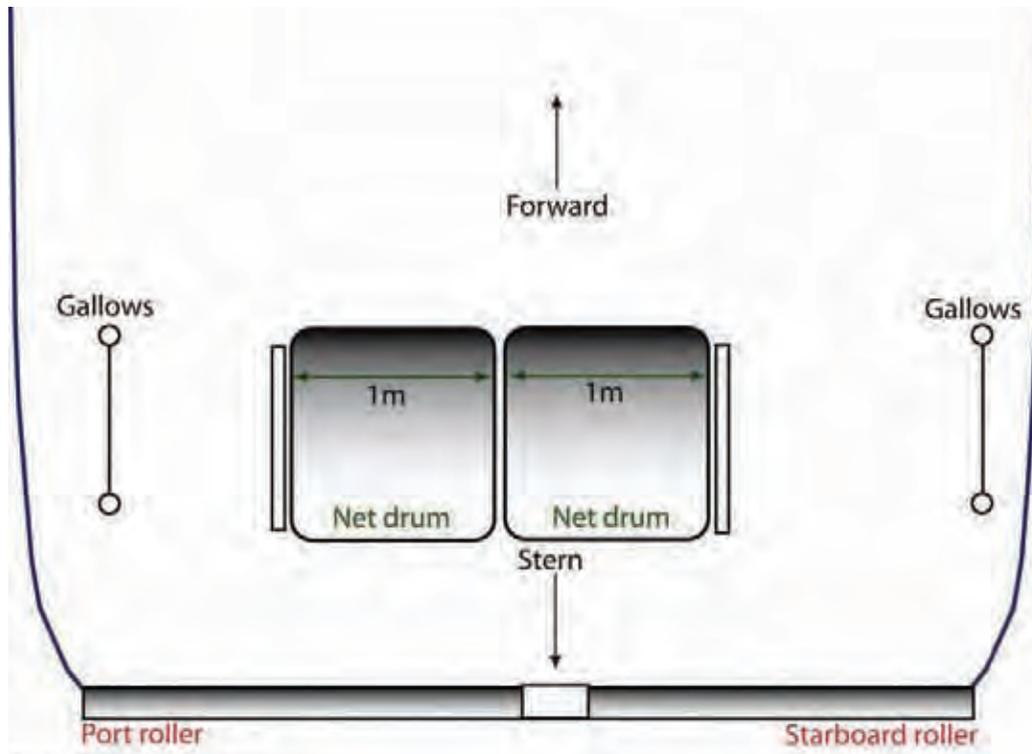
Figure 2: Plan of the stern

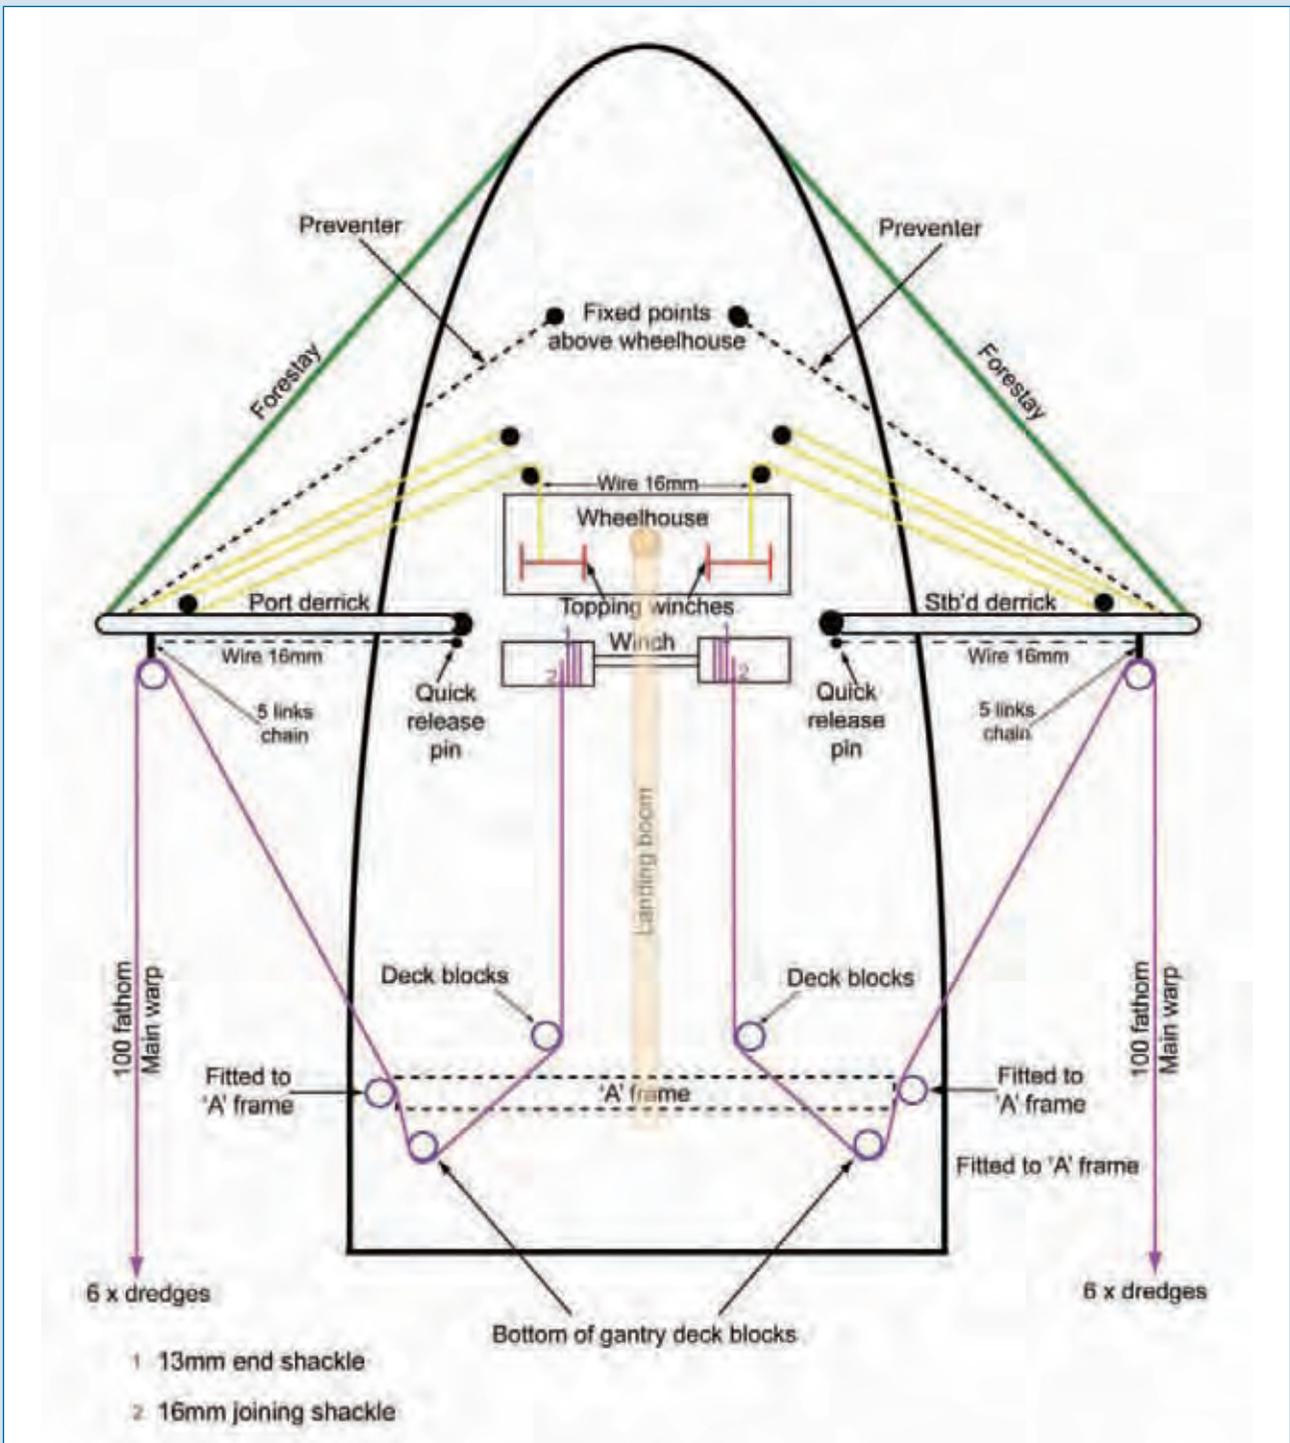
variously used as a stern trawler and scallop dredger. During the last rig change to the dredger configuration, two of the main warp blocks were changed to smaller throated blocks. A schematic of the rig configuration is at Figure 2.

Figure 2: Beam trawler arrangement

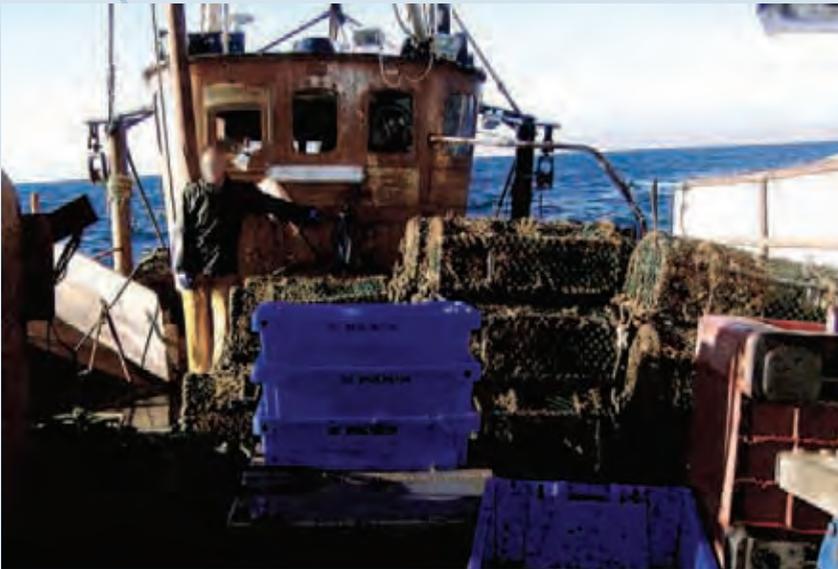
The second crewman was able to free his colleague's foot from the bight as the skipper manoeuvred the boat to keep the weight off the pot rope. The man's foot was very badly bruised as a result of the accident, and he had to be airlifted off the boat to receive medical attention.

Figure 1: Position of casualty at time of accident

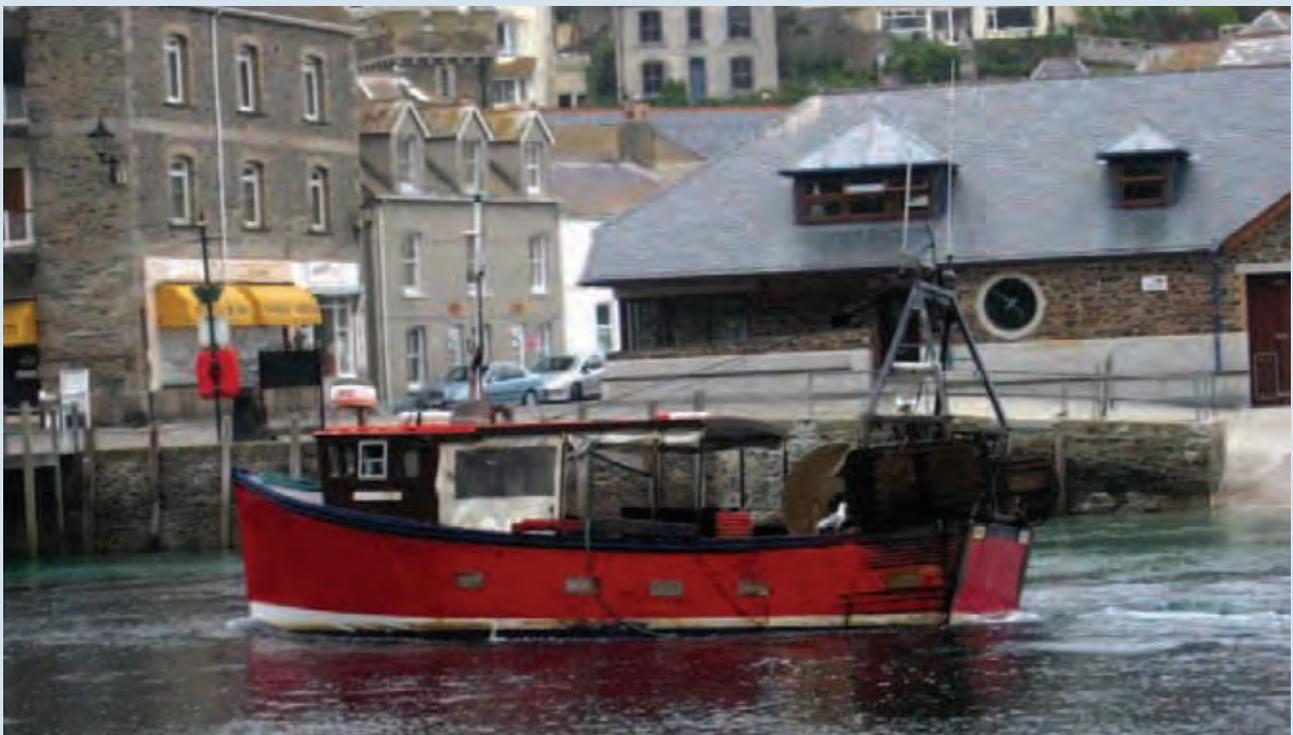
Figure 1

The liferaft, still in its canister, floated to the surface close to the skipper. It had not inflated automatically because the painter had not been attached to the weak link of the hydrostatic release unit (HRU). With some difficulty, the skipper managed to pull the painter

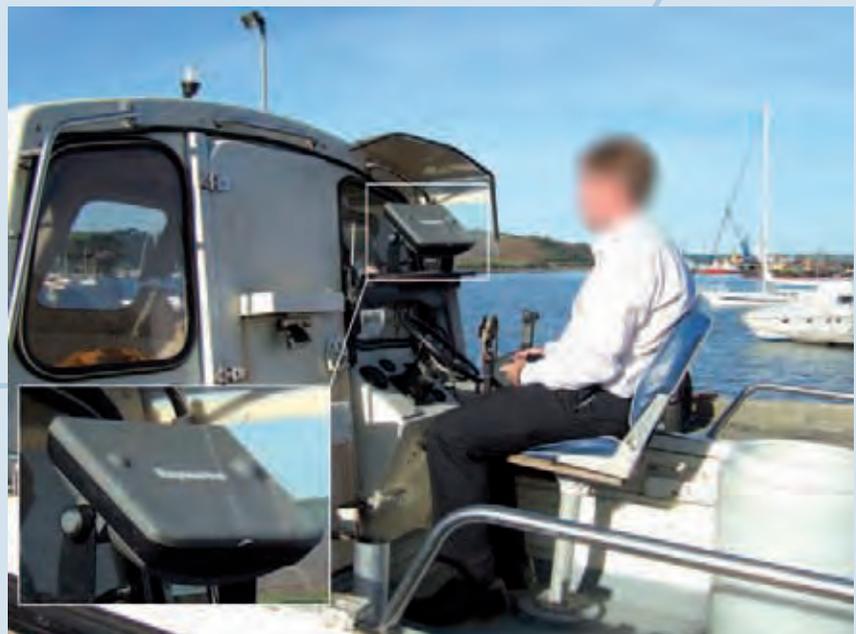
a chart plotter (Figure 1) and fell to the deck. He then possibly lost consciousness for a short period as the boat's engine continued to run. The skipper managed to drive the dory back to port, and from there was taken to hospital for treatment.

Figure 1: View from the seated position on the dory

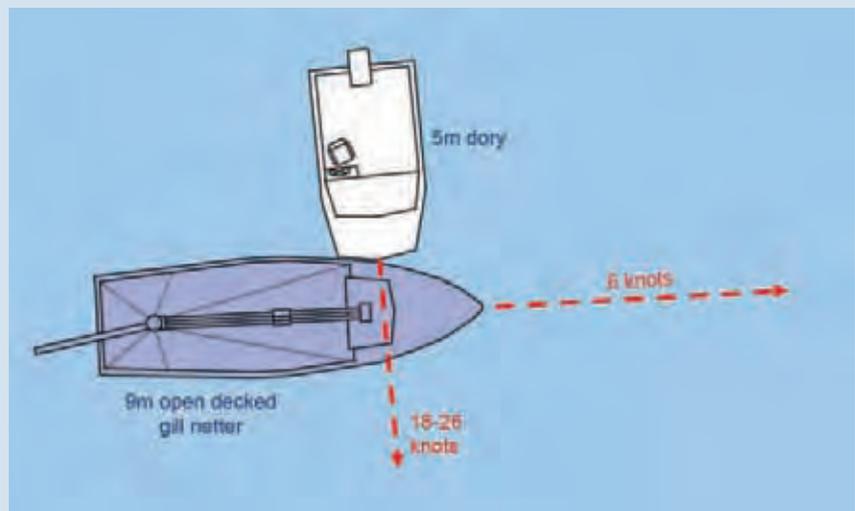
Figure 2: Relative positions on impact

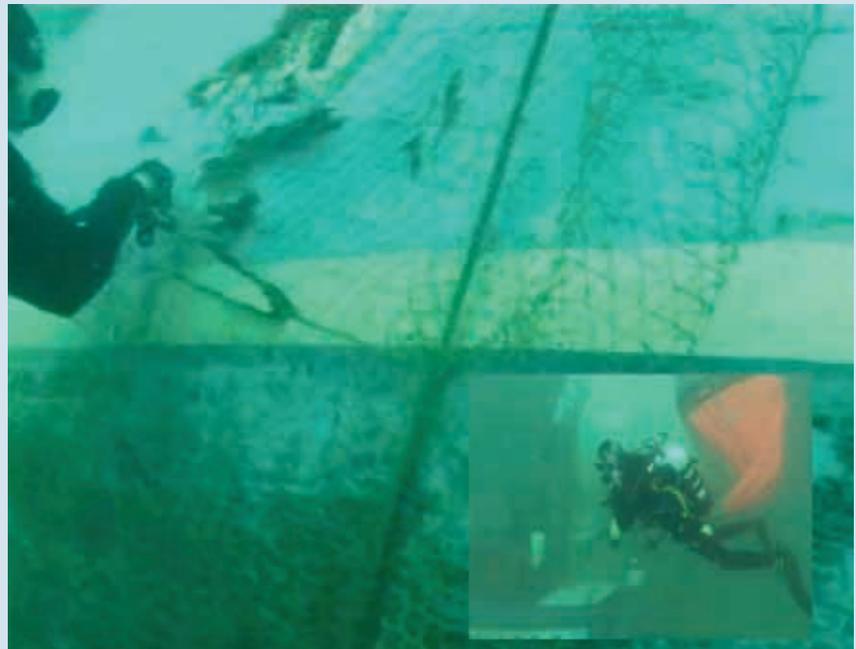
The gill netter's skipper, who was on watch in the wheelhouse, and two deckhands, who were sleeping, were all thrown to the deck. The vessel was holed above and below the waterline and her wheelhouse was displaced to starboard (Figure 3). With the vessel taking on water, the skipper used a mobile phone to inform the coastguard while the deckhands launched a liferaft over the stern. However, the liferaft did not fully inflate due to there being insufficient gas in its cylinder; it had not been serviced in accordance with its manufacturer's instructions. Fortunately, a local pilot boat quickly arrived on the scene and recovered the skipper and his crew. Although the damaged fishing vessel was taken in tow, she sank at 0646.

Figure 4: Gill netter diving survey

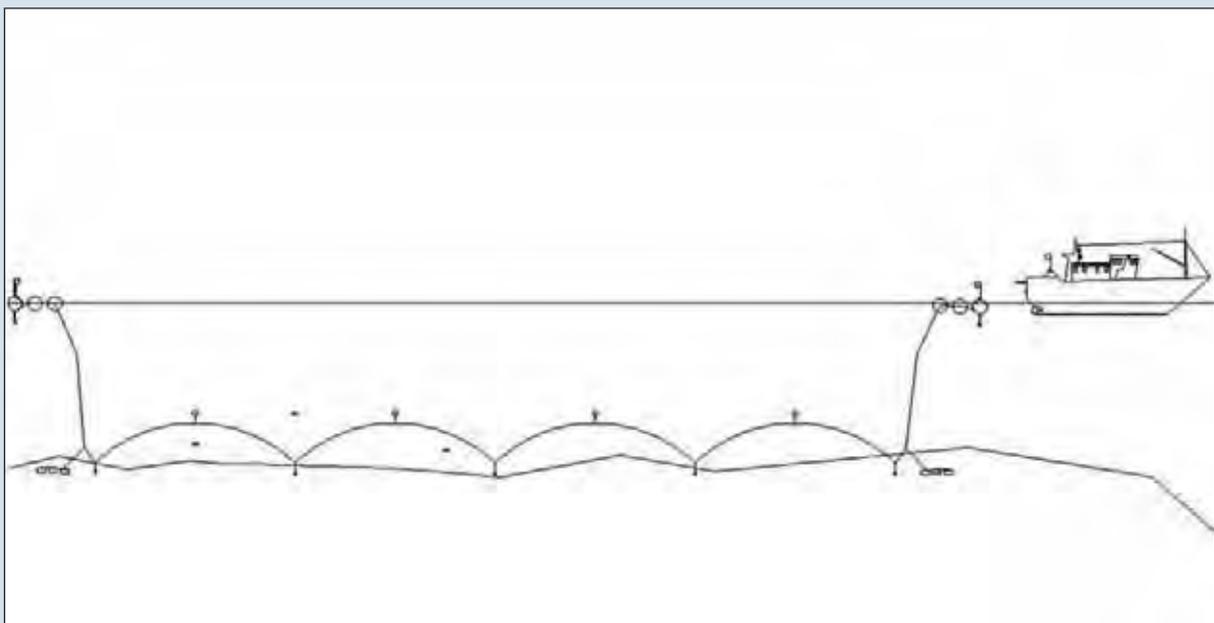
It is likely that the deckhand had stood in a bight of the connecting rope and was thrown overboard when weight came onto the rope between the dhan buoys and the marker buoy.

Figure 1: Diagram showing the long-line on the seabed

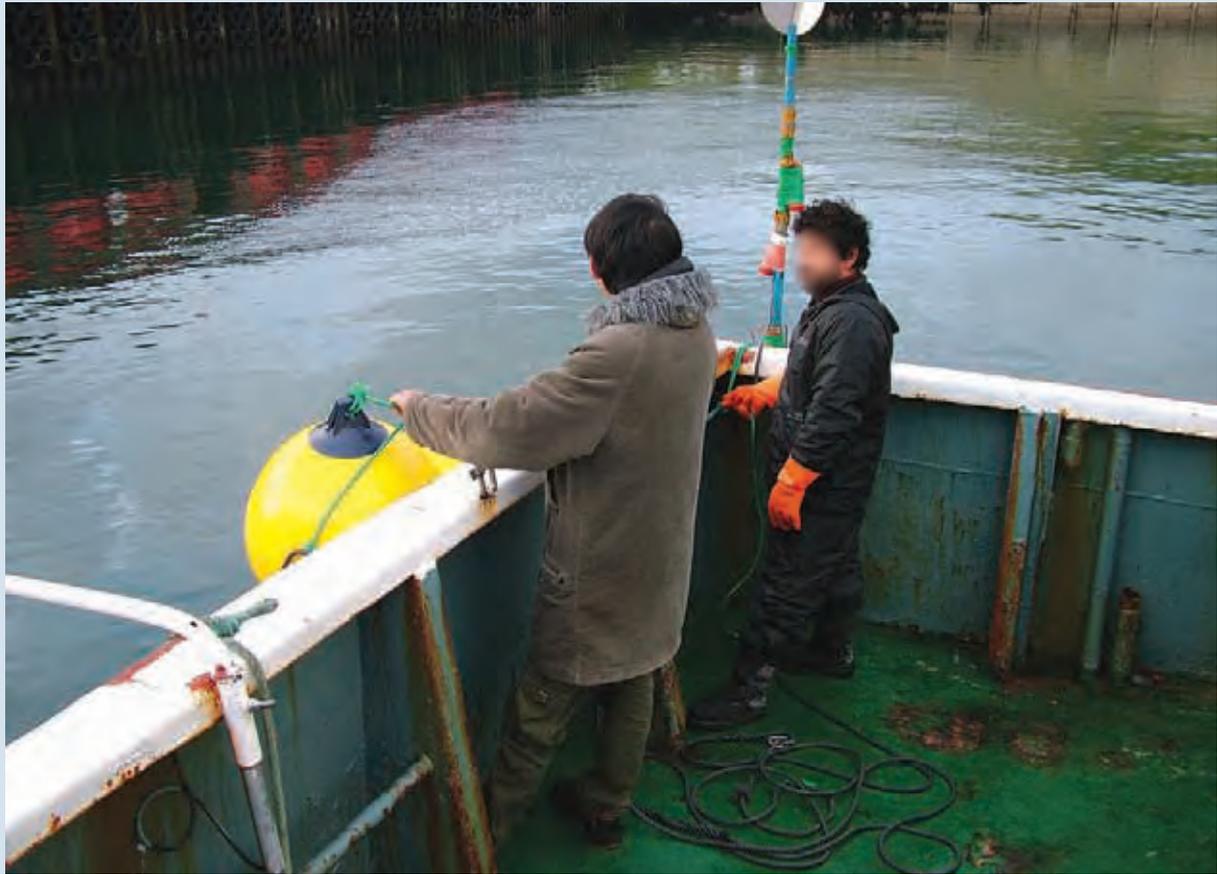
Figure 2: Two fishermen showing the point of letting go of the dhan buoy

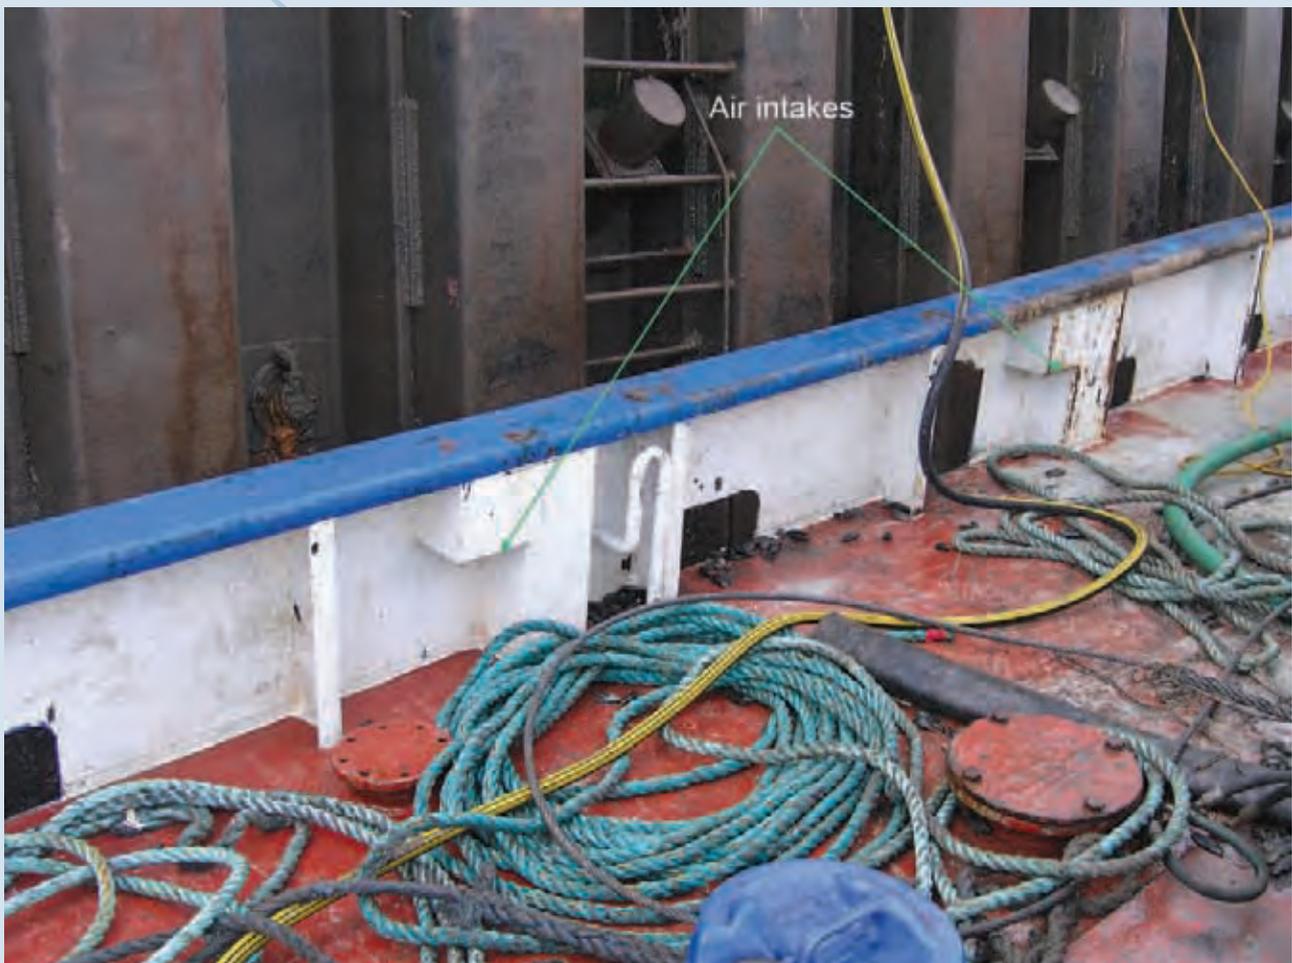
Figure 1: Deck, showing engine room air intakes
