MAIB TRILOGY REPORT

Korenbloem

Osprey III

Optik

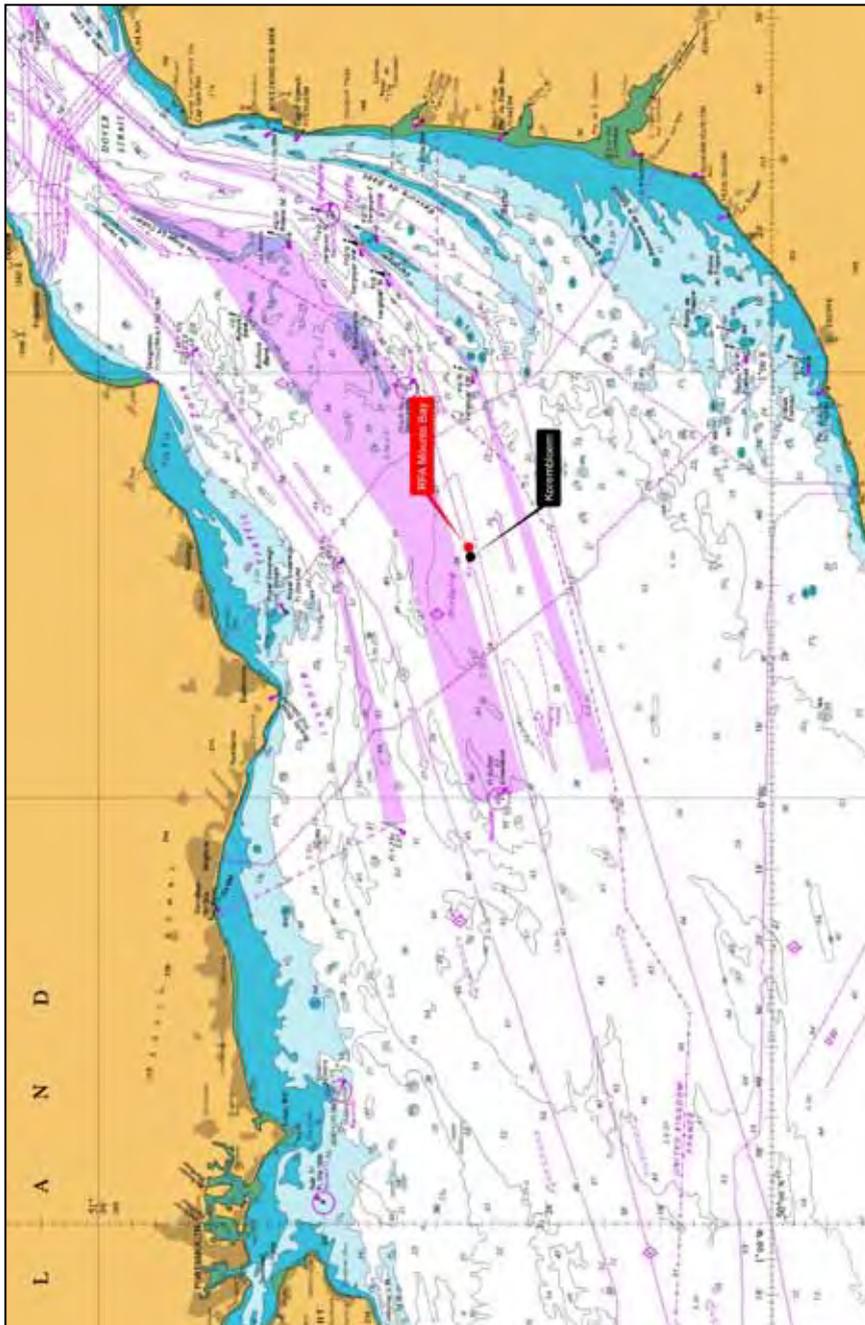
Figure 2

Location of the vessels just before airlifting the casualty

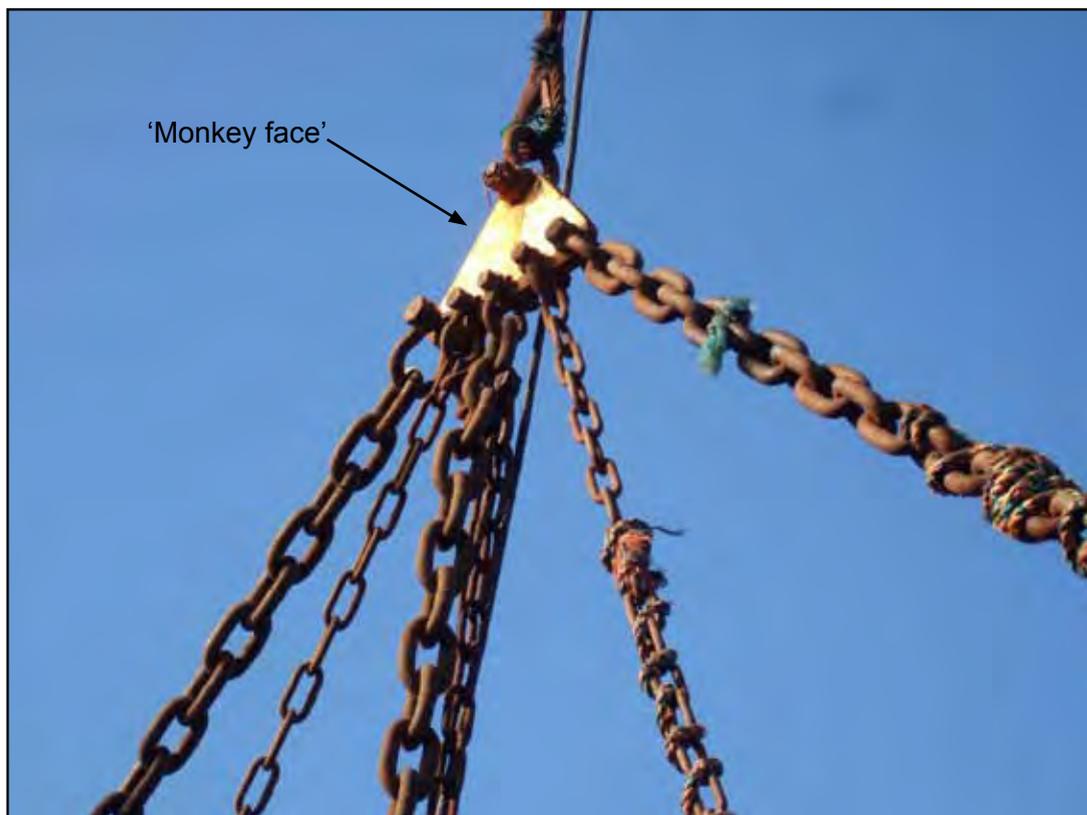
Figure 3

Korenbloem had a 30cm diameter hollow steel towing beam on both port and starboard sides, each equipped with 12 dredge bags. The towing beams were suspended from 'monkey face' plates (**Figure 3**), and were fitted with solid rubber wheels on both ends. The bottom ends of the dredge bags were connected via chains to tipping bars, which also were suspended from the 'monkey face' plates. The tipping bars could be lifted independently of the towing beams by using G-clips to attach the gilson wires (**Figure 4**). The tipping bars were of a lighter construction than the towing beams, and were suspended at the same level as the towing beams when out of the water (**Figure 5**).

'Monkey face'

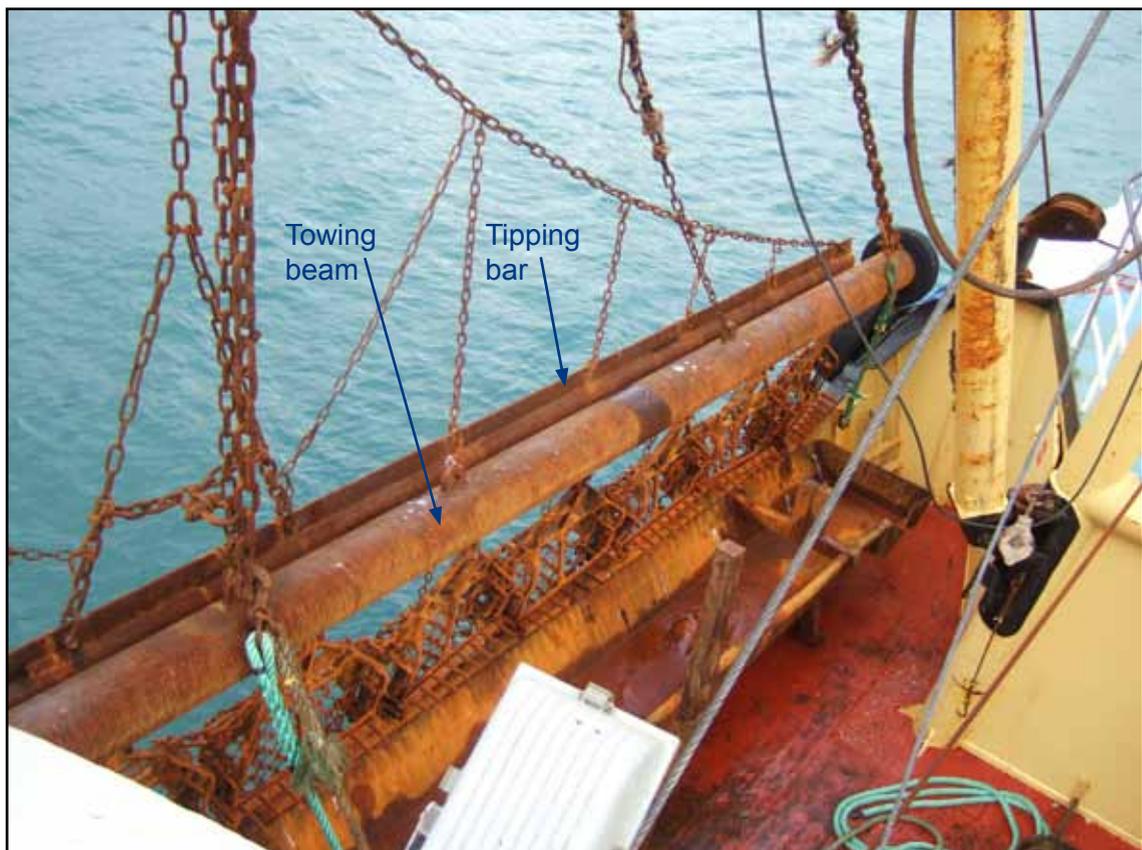
Towing beam and tipping bar with bridle chains

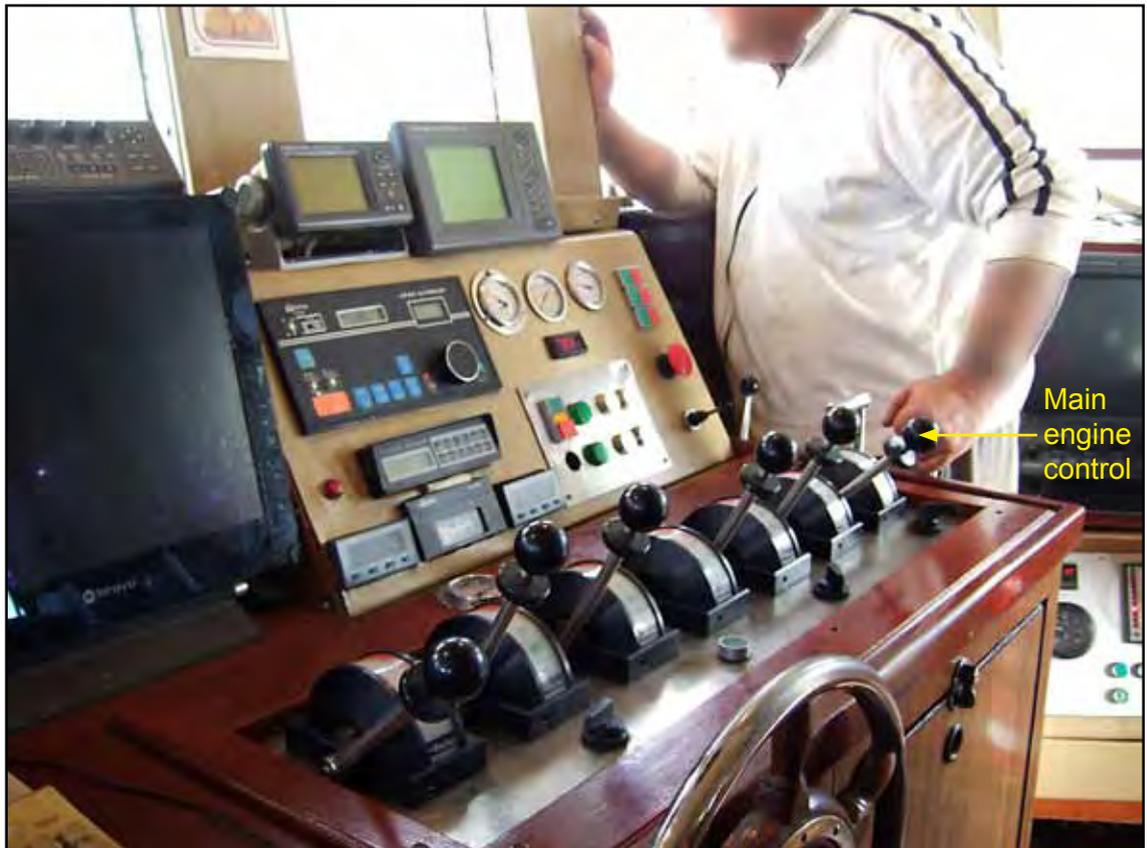
Figure 6

Each of the six winches could be individually clutched in or out; but they were operated simultaneously using a single lever located next to the main engine speed control lever (**Figure 6**).

Winch controls for operating fishing gear

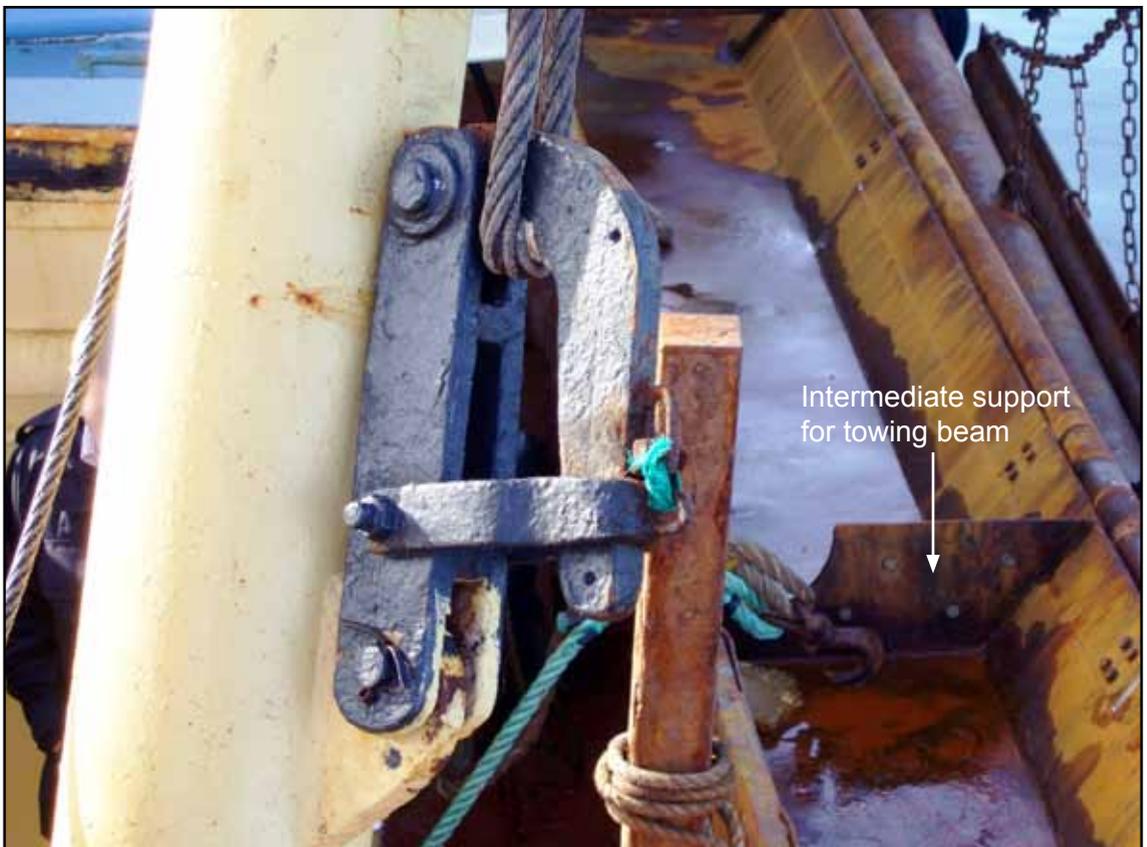
Figure 7

Catches of scallops were emptied into large bins on each side of the main deck. The bins had hydraulically operated rams under them which allowed them to be tipped for emptying any waste material overboard. When not in use, the fishing gear, including the tipping bars and towing beams, were stowed in cradles positioned directly over their respective bins. Intermediate supports for the towing beams were built into the cradle (**Figure 7**).

Intermediate supports for towing beam cradle arrangement

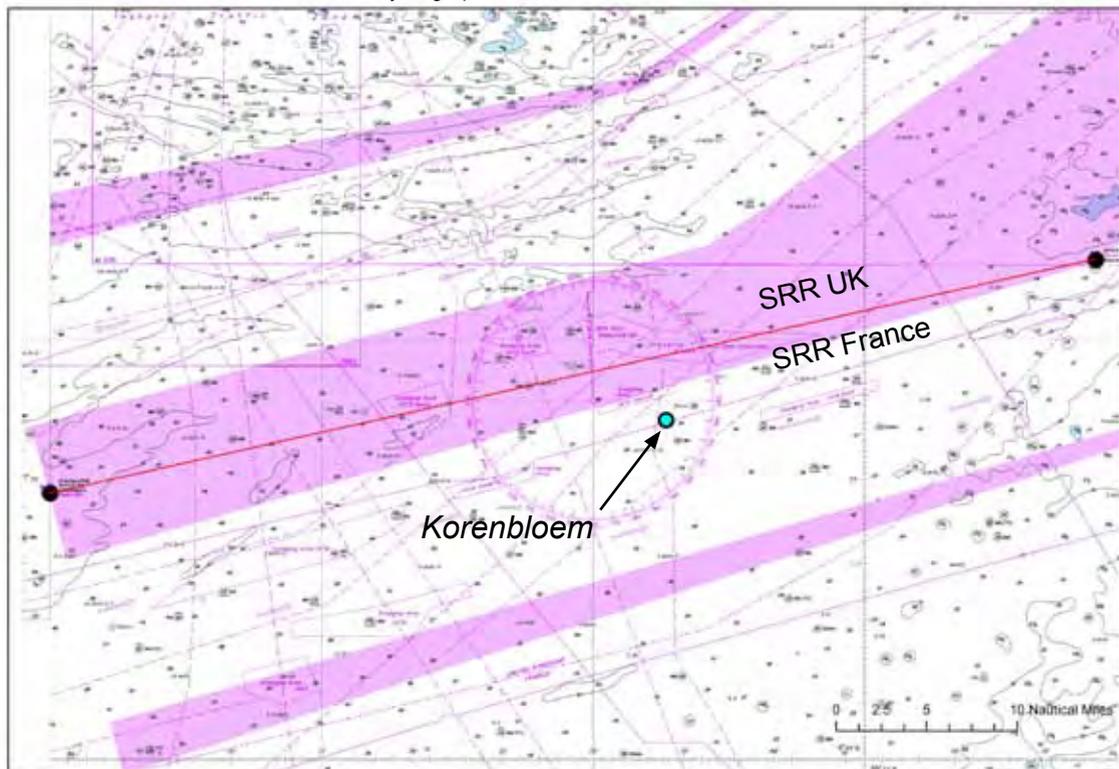
Figure 11

The regional subdivisions and the international boundaries of the UK SRR are indicated in **Figure 10**. When an incident takes place in the UK SRR, the Aeronautical Rescue Co-ordination Centre (ARCC) at the Royal Air Force (RAF) base at Kinloss, Scotland, assigns the nearest available search and rescue (SAR) helicopter to the incident. On this occasion, the accident occurred approximately 2nm into the French SRR (**Figure 11**), and thus the responsibility for the helicopter evacuation fell to the French coastguard at Cap Gris Nez.

Boundary of UK and French Search and Rescue Regions

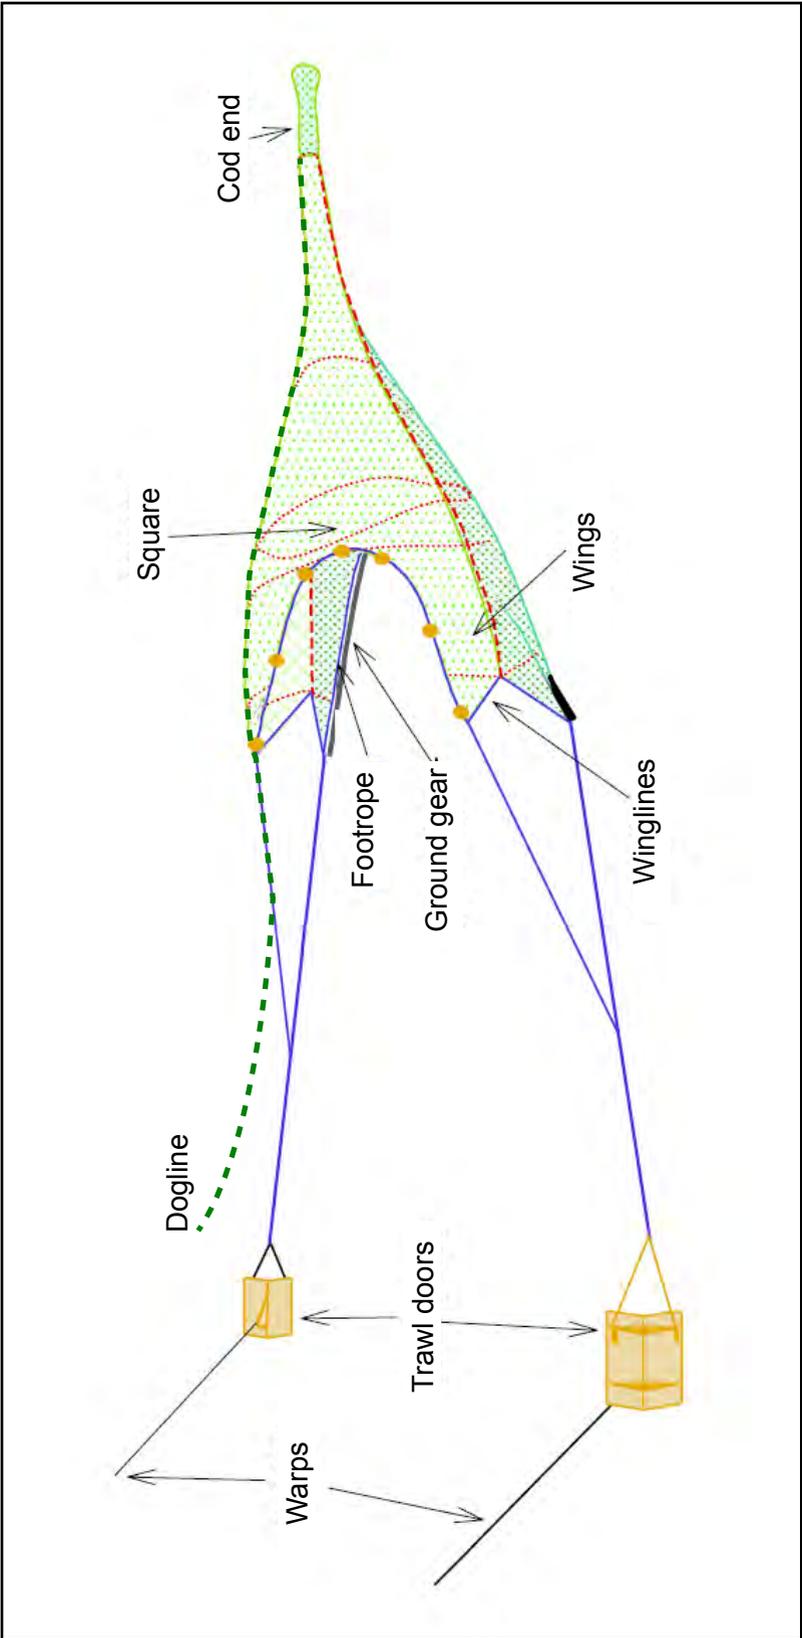
Figure 5

The vessel was designed by Macduff Ship Design Ltd and built by Macduff Shipyards Ltd. She was driven by a Caterpillar 3406-TA engine, which also powered the vessel's hydraulic system. Two bottom trawl nets were stowed on net drums sited near the stern. The starboard net, which was used on 11 November, was designed for rocky seabeds. Its ground gear consisted of a series of discs with rubber spacers attached to its footrope. In addition to the ground gear, the footrope of the net had a flip up line attached to it to prevent large boulders from being swept into the net and causing damage (**Figure 17**). The port net was designed for use with sandy seabeds.

Bottom trawl net

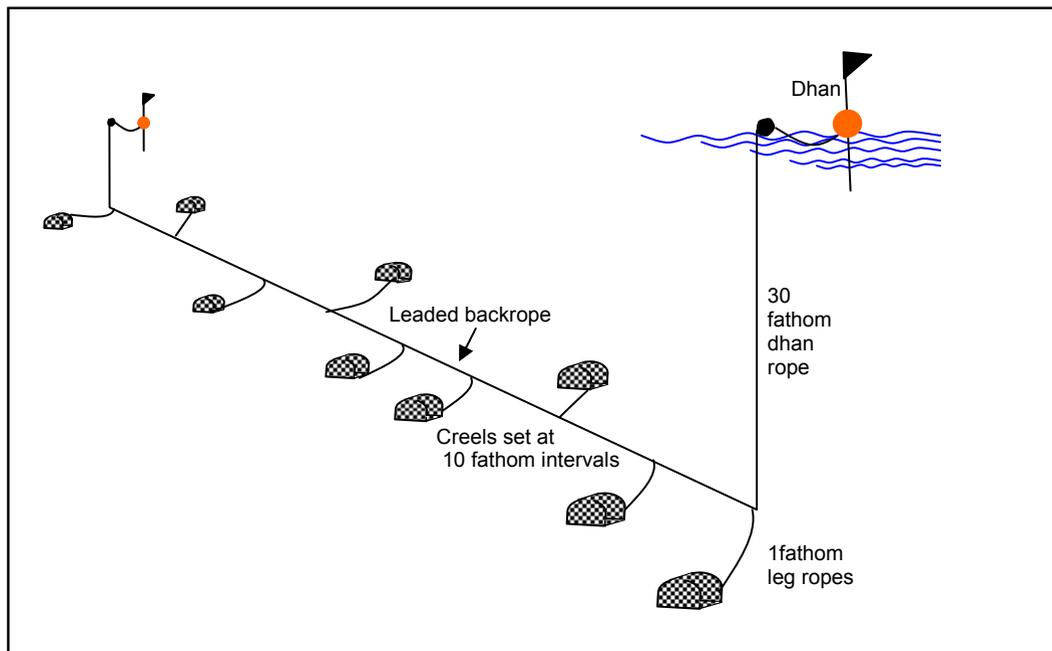
Each fleet consisted of 20 creels of typical dimensions 66cm x 48cm, which fitted comfortably onto *Optik's* shooting table. The creels were set at 10 fathom (18.3m) intervals on the seabed, attached to a 10mm diameter leaded back rope (main line) by 1 fathom (1.83m) long leg ropes. At the end of each fleet was a 30 fathom (54.9m) dhan rope leading to the surface, attached to a dhan and marker buoy to facilitate retrieval from the sea (**Figure 23**).

Diagram of a typical creel fleet

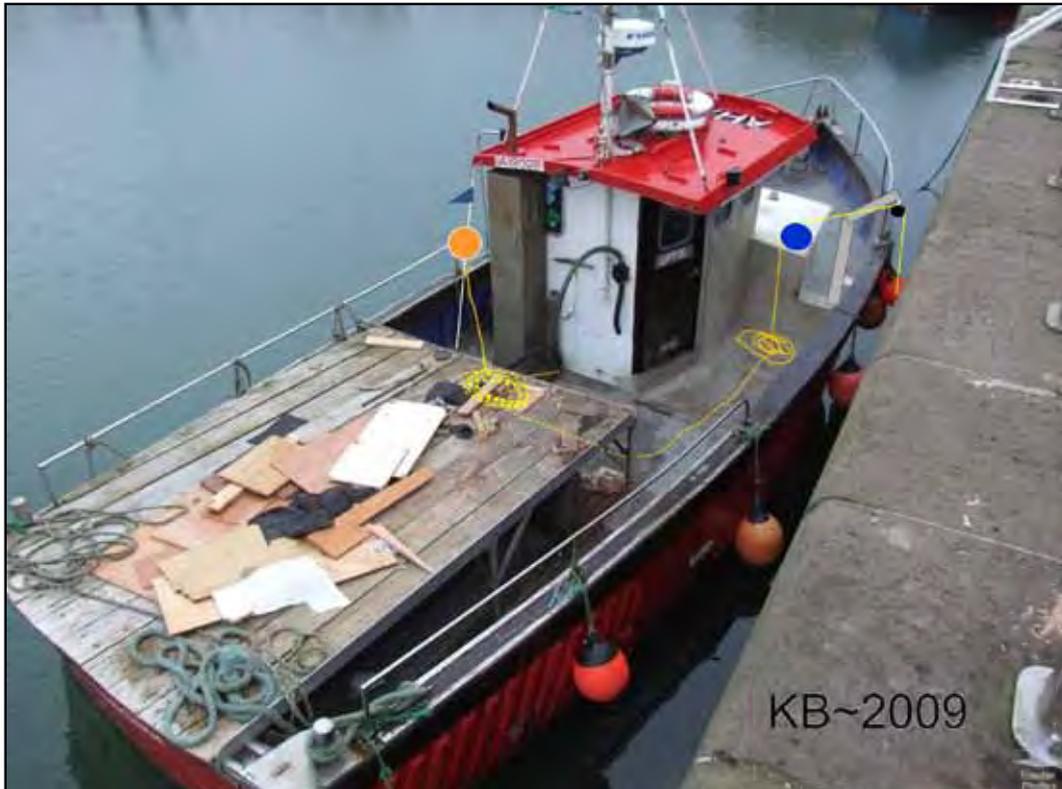
Representation of dhan buoy in recovered position with section of rope obscured between shooting table and wheelhouse

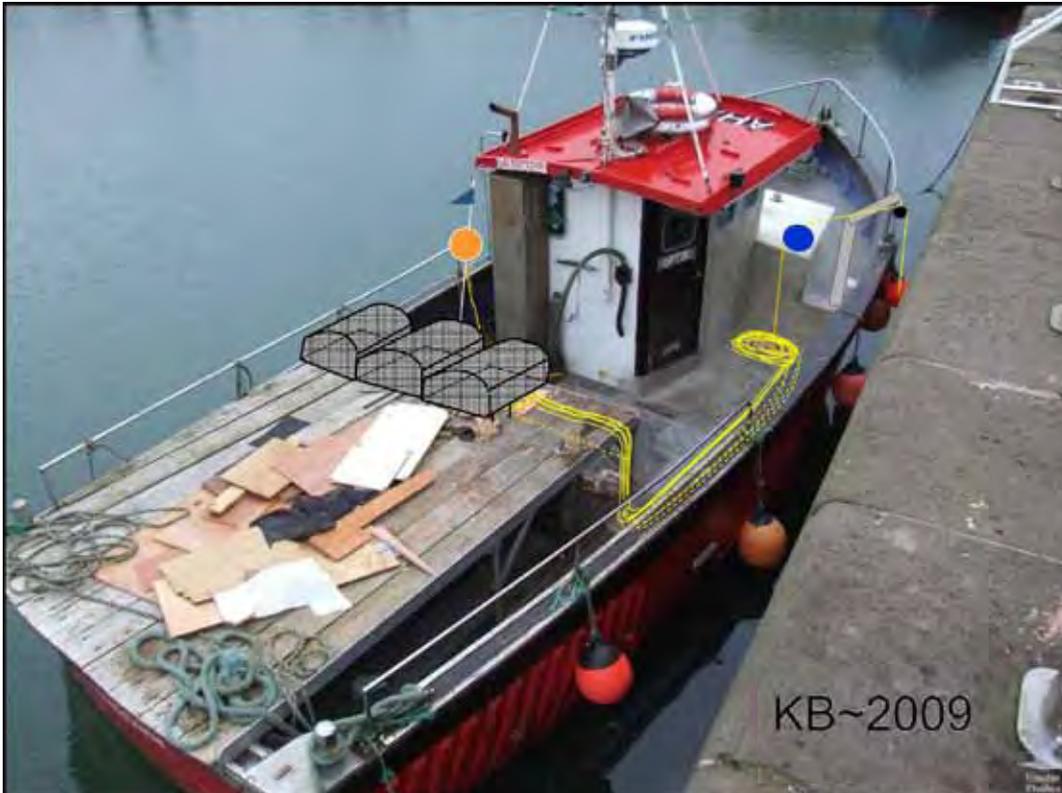
Representation of back rope coiled under the hauler and initial sequence of creels stowed on the shooting table

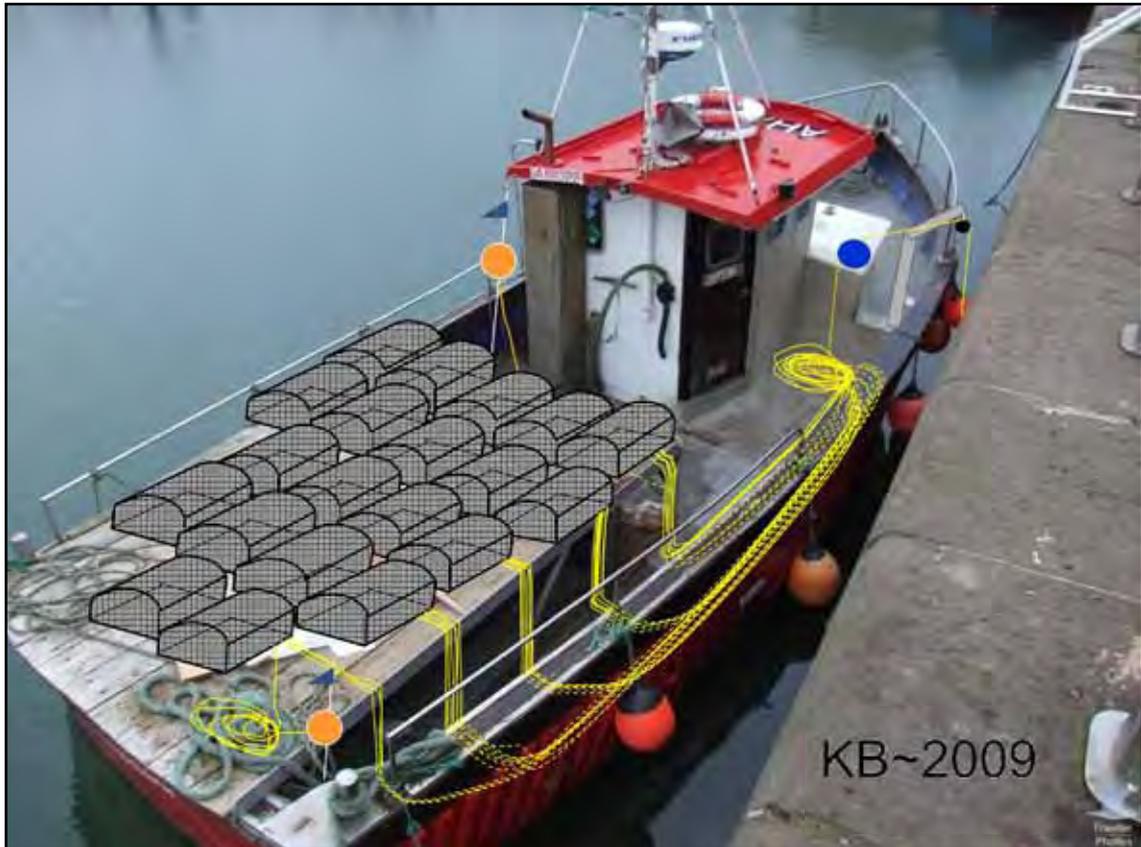
Representation of fleet of recovered creels stowed on the shooting table in preparation for shooting

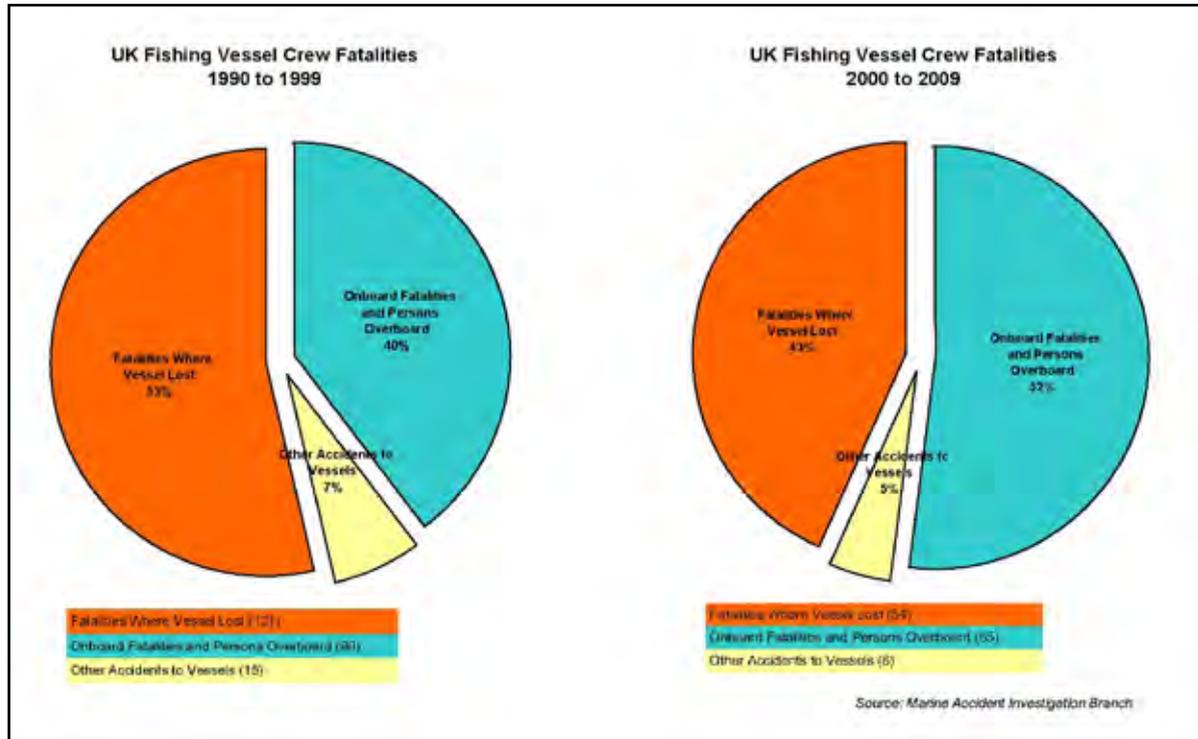
Figure 25

Between 1990 and 1999, the majority of fishing crew fatalities occurred when a vessel was lost. Since 2000 the majority of fatalities have been due to occupational accidents which have occurred on board the vessel, or as a consequence of fishermen falling or being dragged overboard as demonstrated by the three tragic cases detailed in this report (**Figure 25**). This shift should be recognised and the focus of safety authorities should be adapted accordingly.

UK Fishing Vessel Crew Fatalities 1990 - 1999 and 2000 - 2009

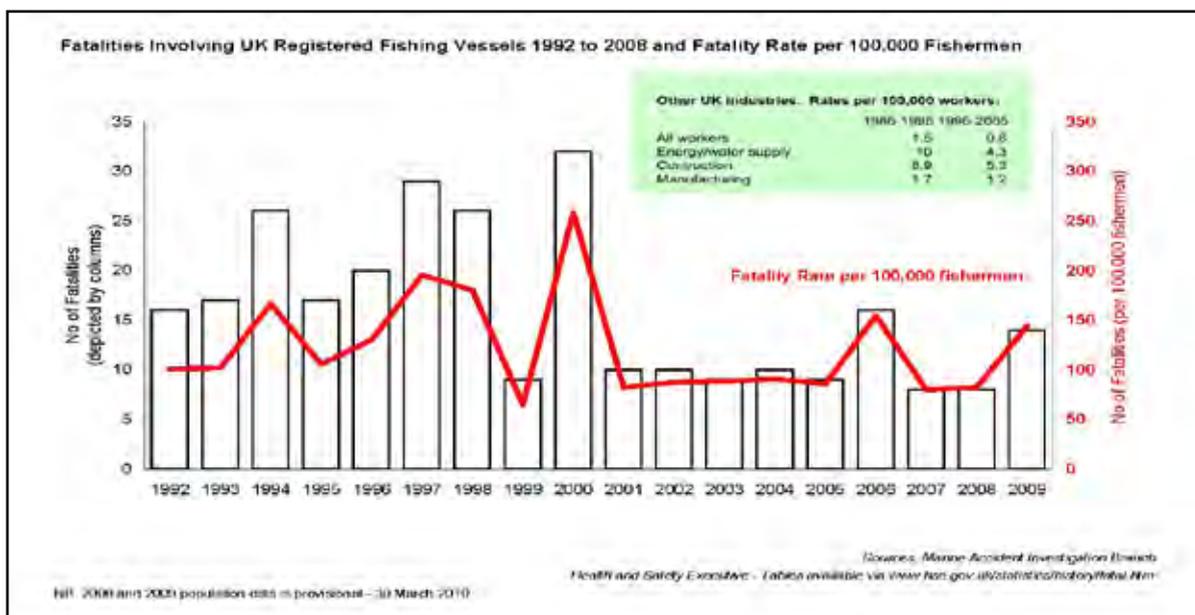
Figure 26

Sadly, the above comment still has resonance in 2010. Between 1992 and 2009, the ratio of deaths occurring in the fishing industry has been many orders of magnitude greater than the level of comparable industries ashore (**Figure 26**). Some industry observers argue that such comparisons have limited value because of the relatively small numbers of fishermen under scrutiny. However, an indisputable and telling statistic is that, throughout this period, the ratio of fishermen who have died has remained broadly constant, while other comparable industries ashore have all shown significant reductions in their fatality rates.

Chart of Fatalities Involving UK Registered Fishing Vessels 1992 - 2009 and Fatality Rate per 100,000 Fishermen
