National
Transportation
Safety Board

Enbridge Hazardous Liquid
Pipeline Rupture and Release
Marshall, Michigan
July 25, 2010

Fracture Mechanism of the Pipeline Rupture

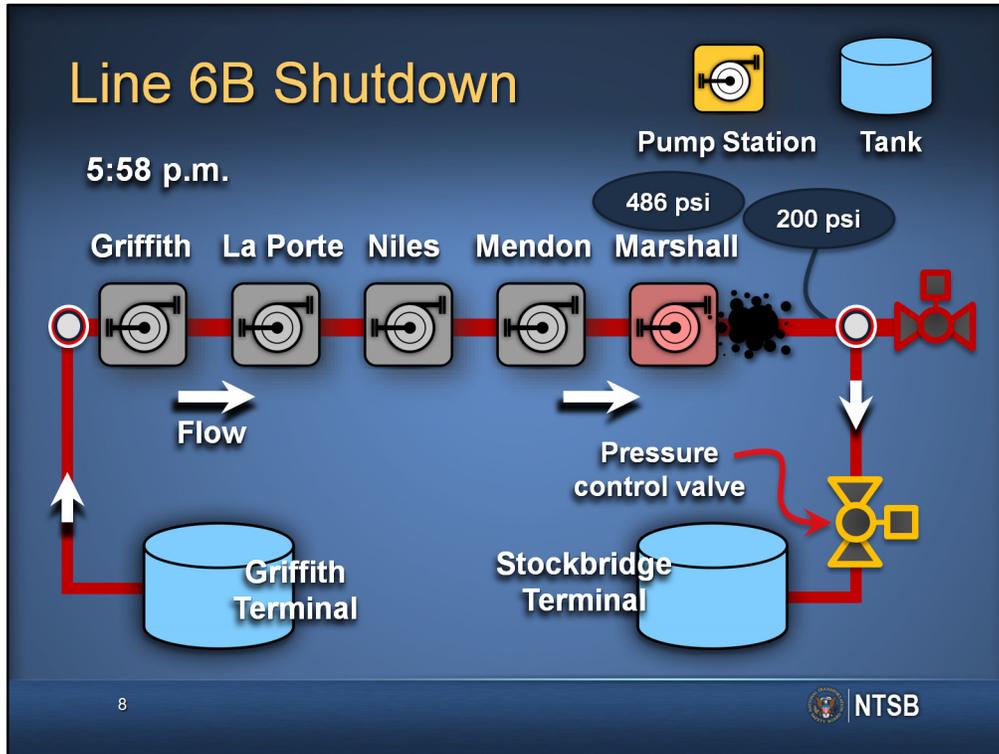
About one minute after the change in pressure at the control valve, a pipeline segment, downstream of the Marshall pump station, ruptured, and the pump automatically shut down due to low pressure. The highest recorded pressure, at the time of failure, was 486 psi. The stated maximum operating pressure of the ruptured segment was 624 psi. [\[Click\]](#)

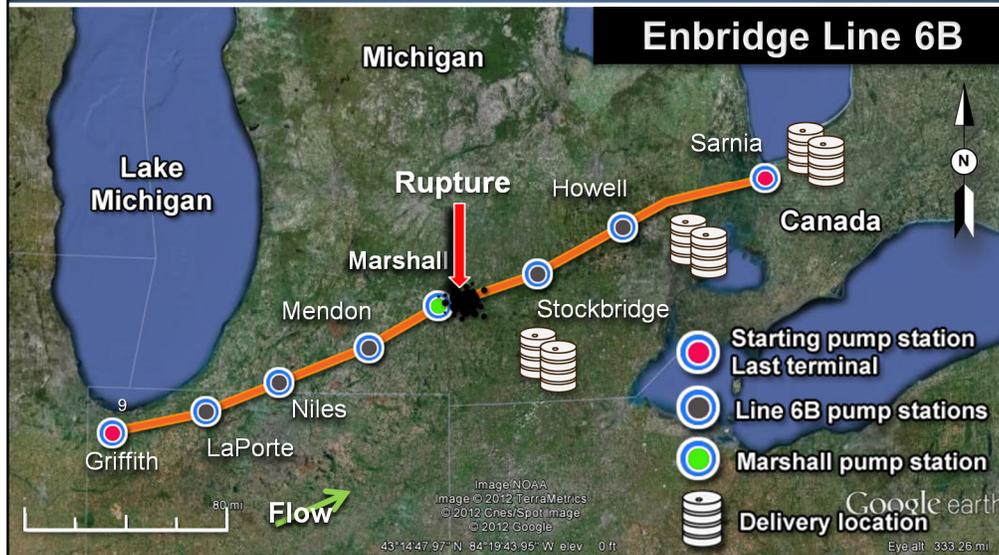
Line 6B Ruptured Segment

- Located in wetland about 1/2 mile from Marshall Pump Station
- Hydrostatically tested 1969 - wrapped with polyethylene tape

The ruptured pipeline segment was located in a mostly rural wetland region just over a half mile downstream from the Marshall pump station and designated as a high consequence area by Enbridge. The segment was constructed from double submerged arc welded carbon steel pipe, fabricated and shipped from Italy. The segment was hydrostatically pressure tested at the time of construction and wrapped with a polyethylene tape coating. [\[Click\]](#)

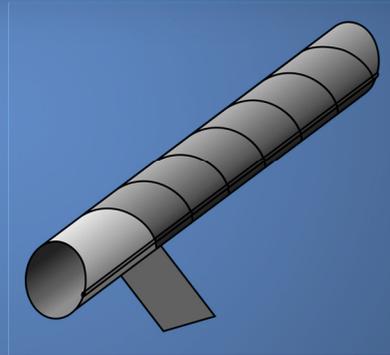
Pipe Construction

- Steel pipe coated with adhesive plastic tape wrap
- Tape wrap coating is an element of the corrosion protection system

The ruptured pipe segment was made of steel with a one quarter inch nominal wall thickness and a double submerged arc welded longitudinal seam. The pipe was coated with an adhesive plastic tape applied in a spiral wrap as shown in this slide. The coating was an element of the outer surface corrosion protection system for the steel pipe. [\[CLICK\]](#)

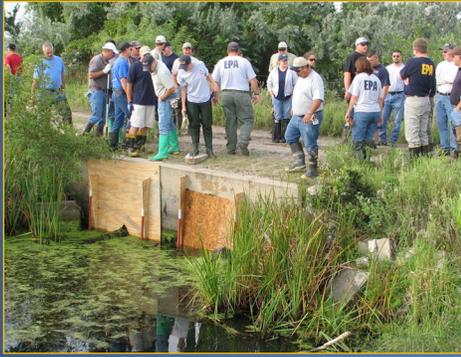
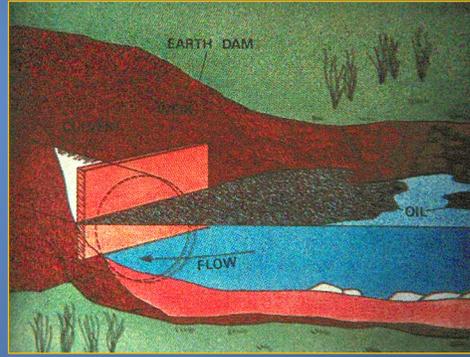
Oil Containment Techniques

The Coast Guard Research and Development Center published the diagram displayed on the right side of the screen in its field guide for oil spill response in fast moving currents to depict how a wooden underflow dam would function to contain oil at a culvert. Seven such culvert pipes where this technique could have been used were located on Talmadge Creek between the source area and the Kalamazoo River. [\[CLICK\]](#)
