**NTSB** *TRAINING CENTER*

## **Practical Exercise**

**Cessna 210N  
In-Flight Fire**

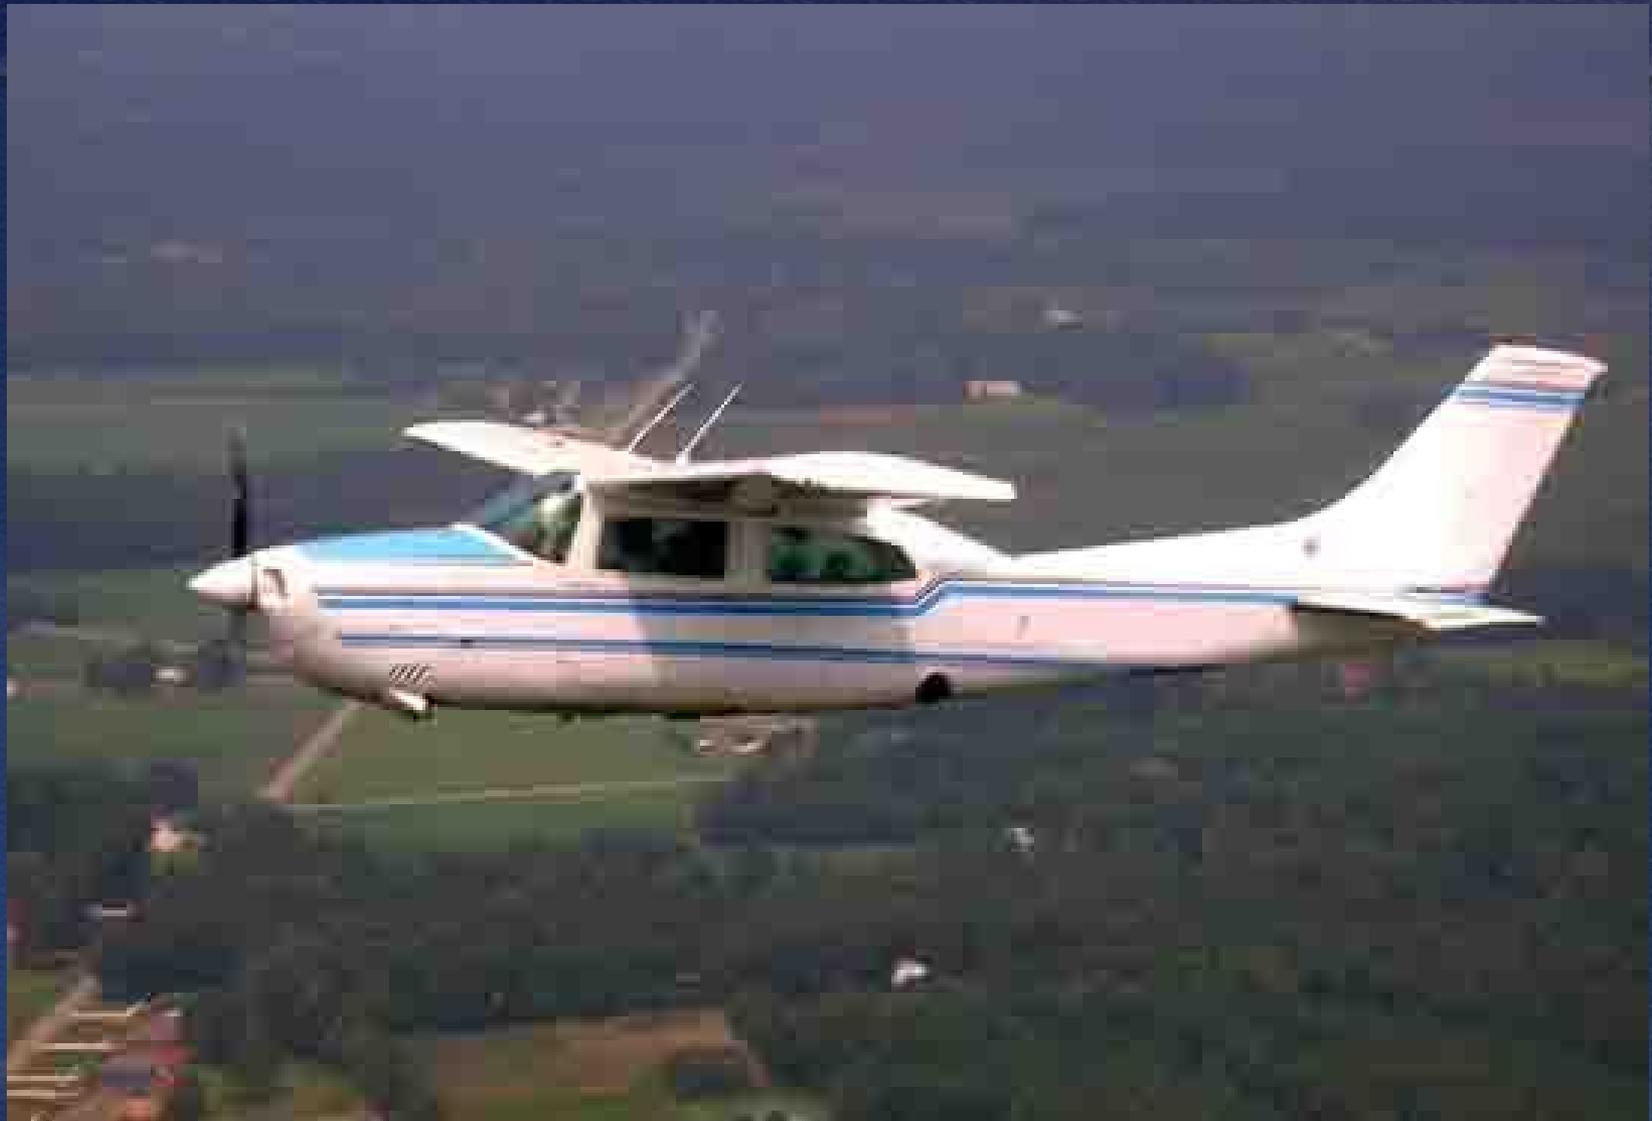
- 5 minutes after t/o from PDK, requested return
- 1 minute later, specified “smoke in the cockpit” and “gear won’t go down”
- ATC gave straight-in approach to 20L

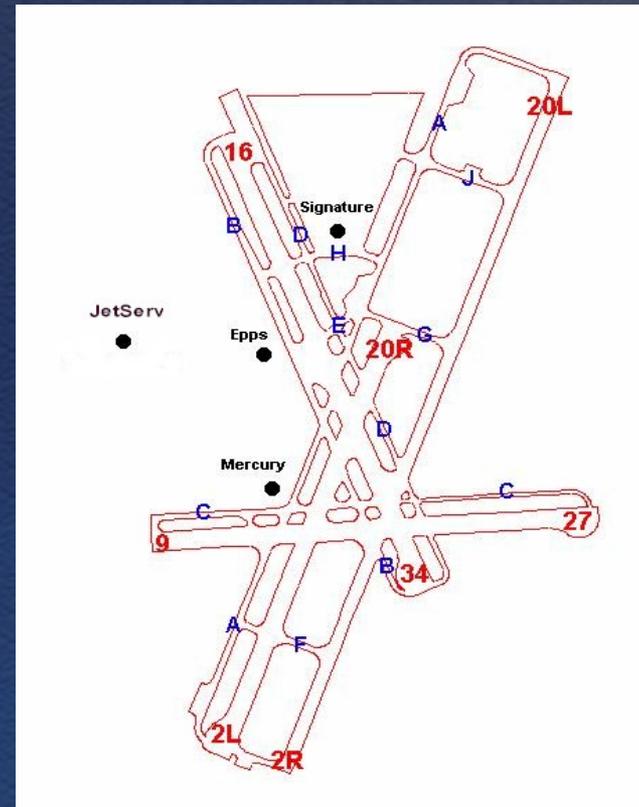
- 4 miles out: ATC asked if pilot wanted left base for 20L or runway 27
- Pilot: right base for runway 2R

- Reported gear not down
- “Say request...”

- Pilot conducted fly-by

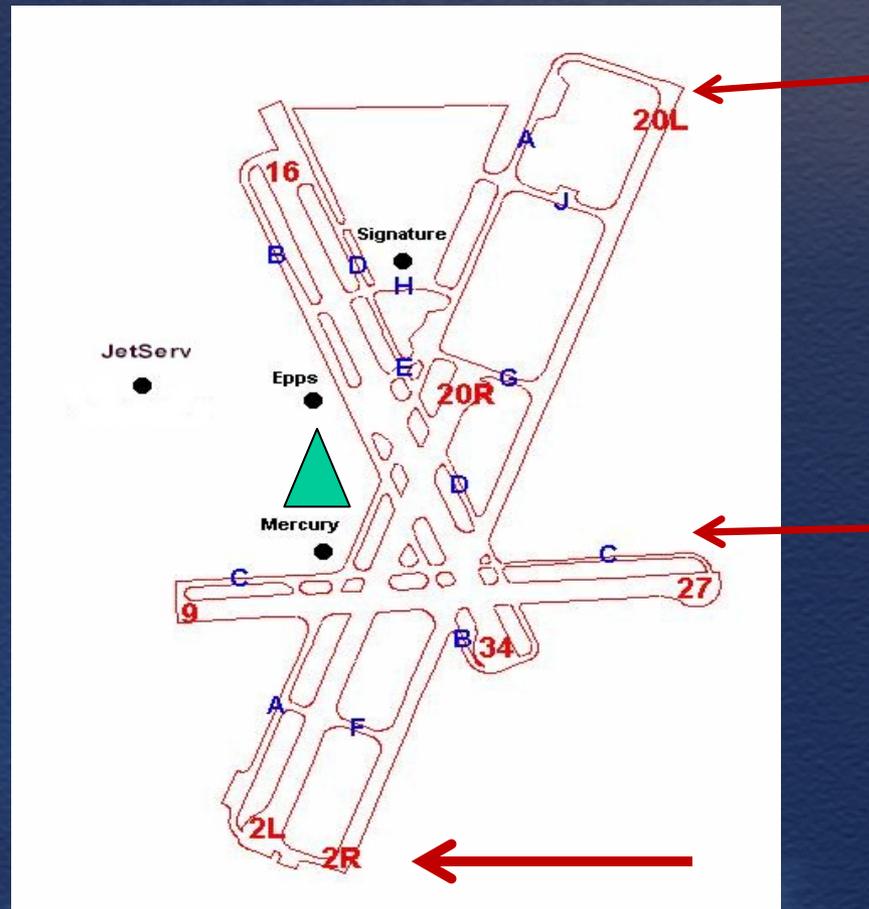
- ATC: cleared to land 2R; wind: 320 at 3 kts
- 26 seconds later, ATC reported gear not down... “Go around.”
- 20 seconds later, ATC reports smoke from cockpit.. “Say request”
- Airplane made right 270 degree turn; to runway 27

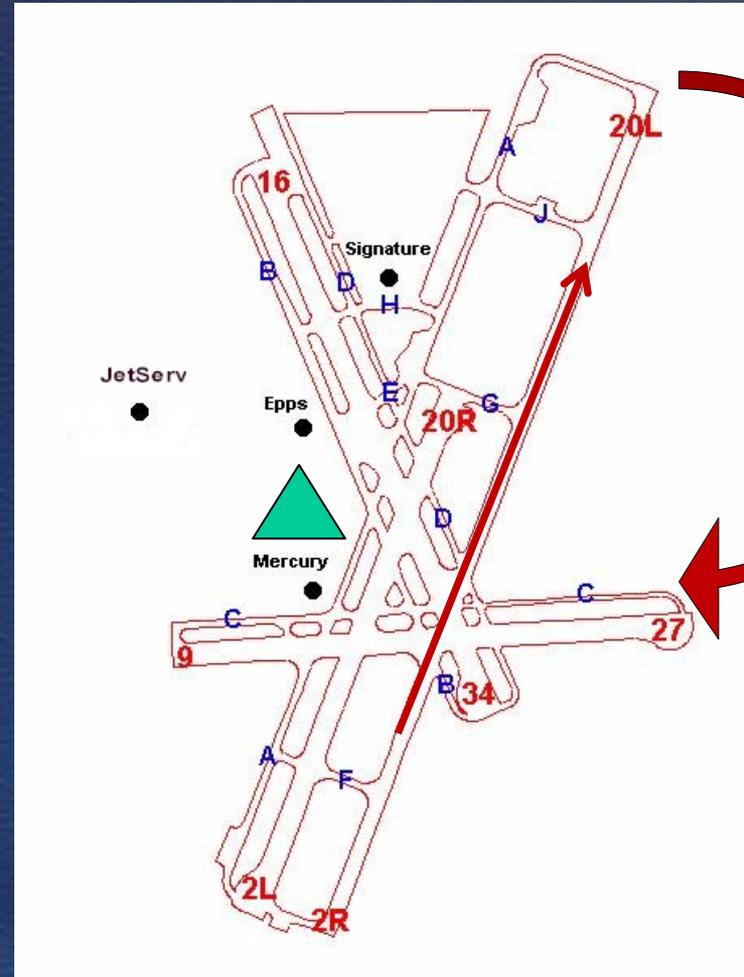
- ATC states vehicles on runway; asks if he can go-around
- Repeated transmission
- Asked for turn to 2L or any runway

- Witness observed left turn to ground impact

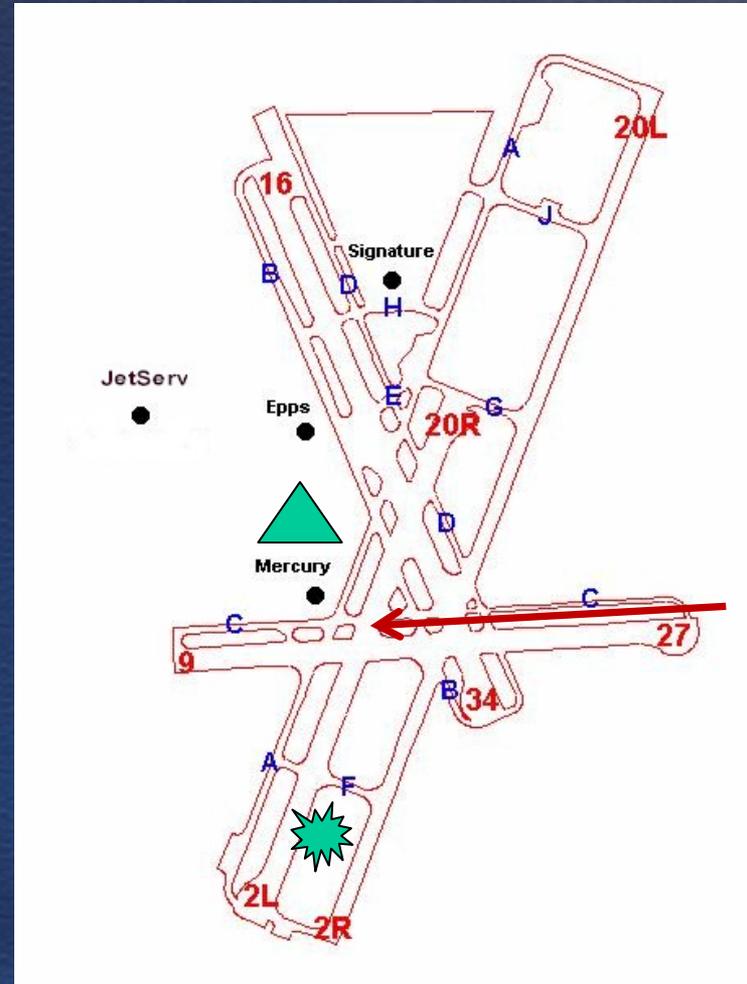
- Aircraft collided with the ground and burst into flames between runways 2L and 2R
- Emergency response was immediate but unsuccessful
