National Transportation Safety Board

Sinking of Cargo Vessel *El Faro*Atlantic Ocean, Northeast of Acklins and Crooked Island, Bahamas
October 1, 2015

Engineering Factors

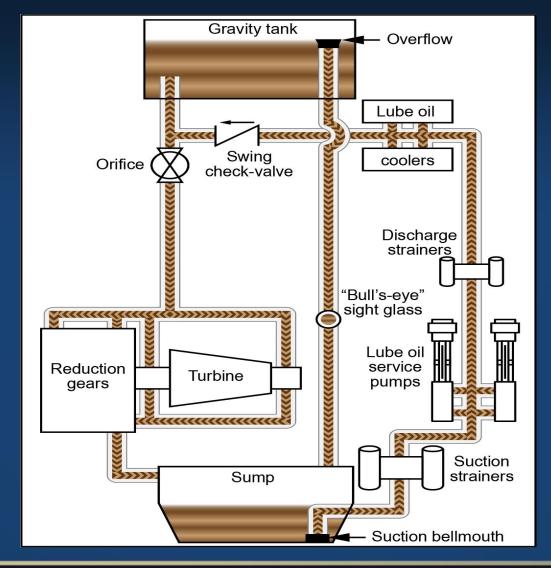
Lube Oil System

0440/0513 – Chief Engineer reported oil levels affected by list

After 0600 – Vessel began losing speed

0616 – Bridge notified of loss of propulsion
