# National Transportation Safety Board

## Flooding of Cargo Holds

Eric Stolzenberg

Naval Architecture Group Chairman

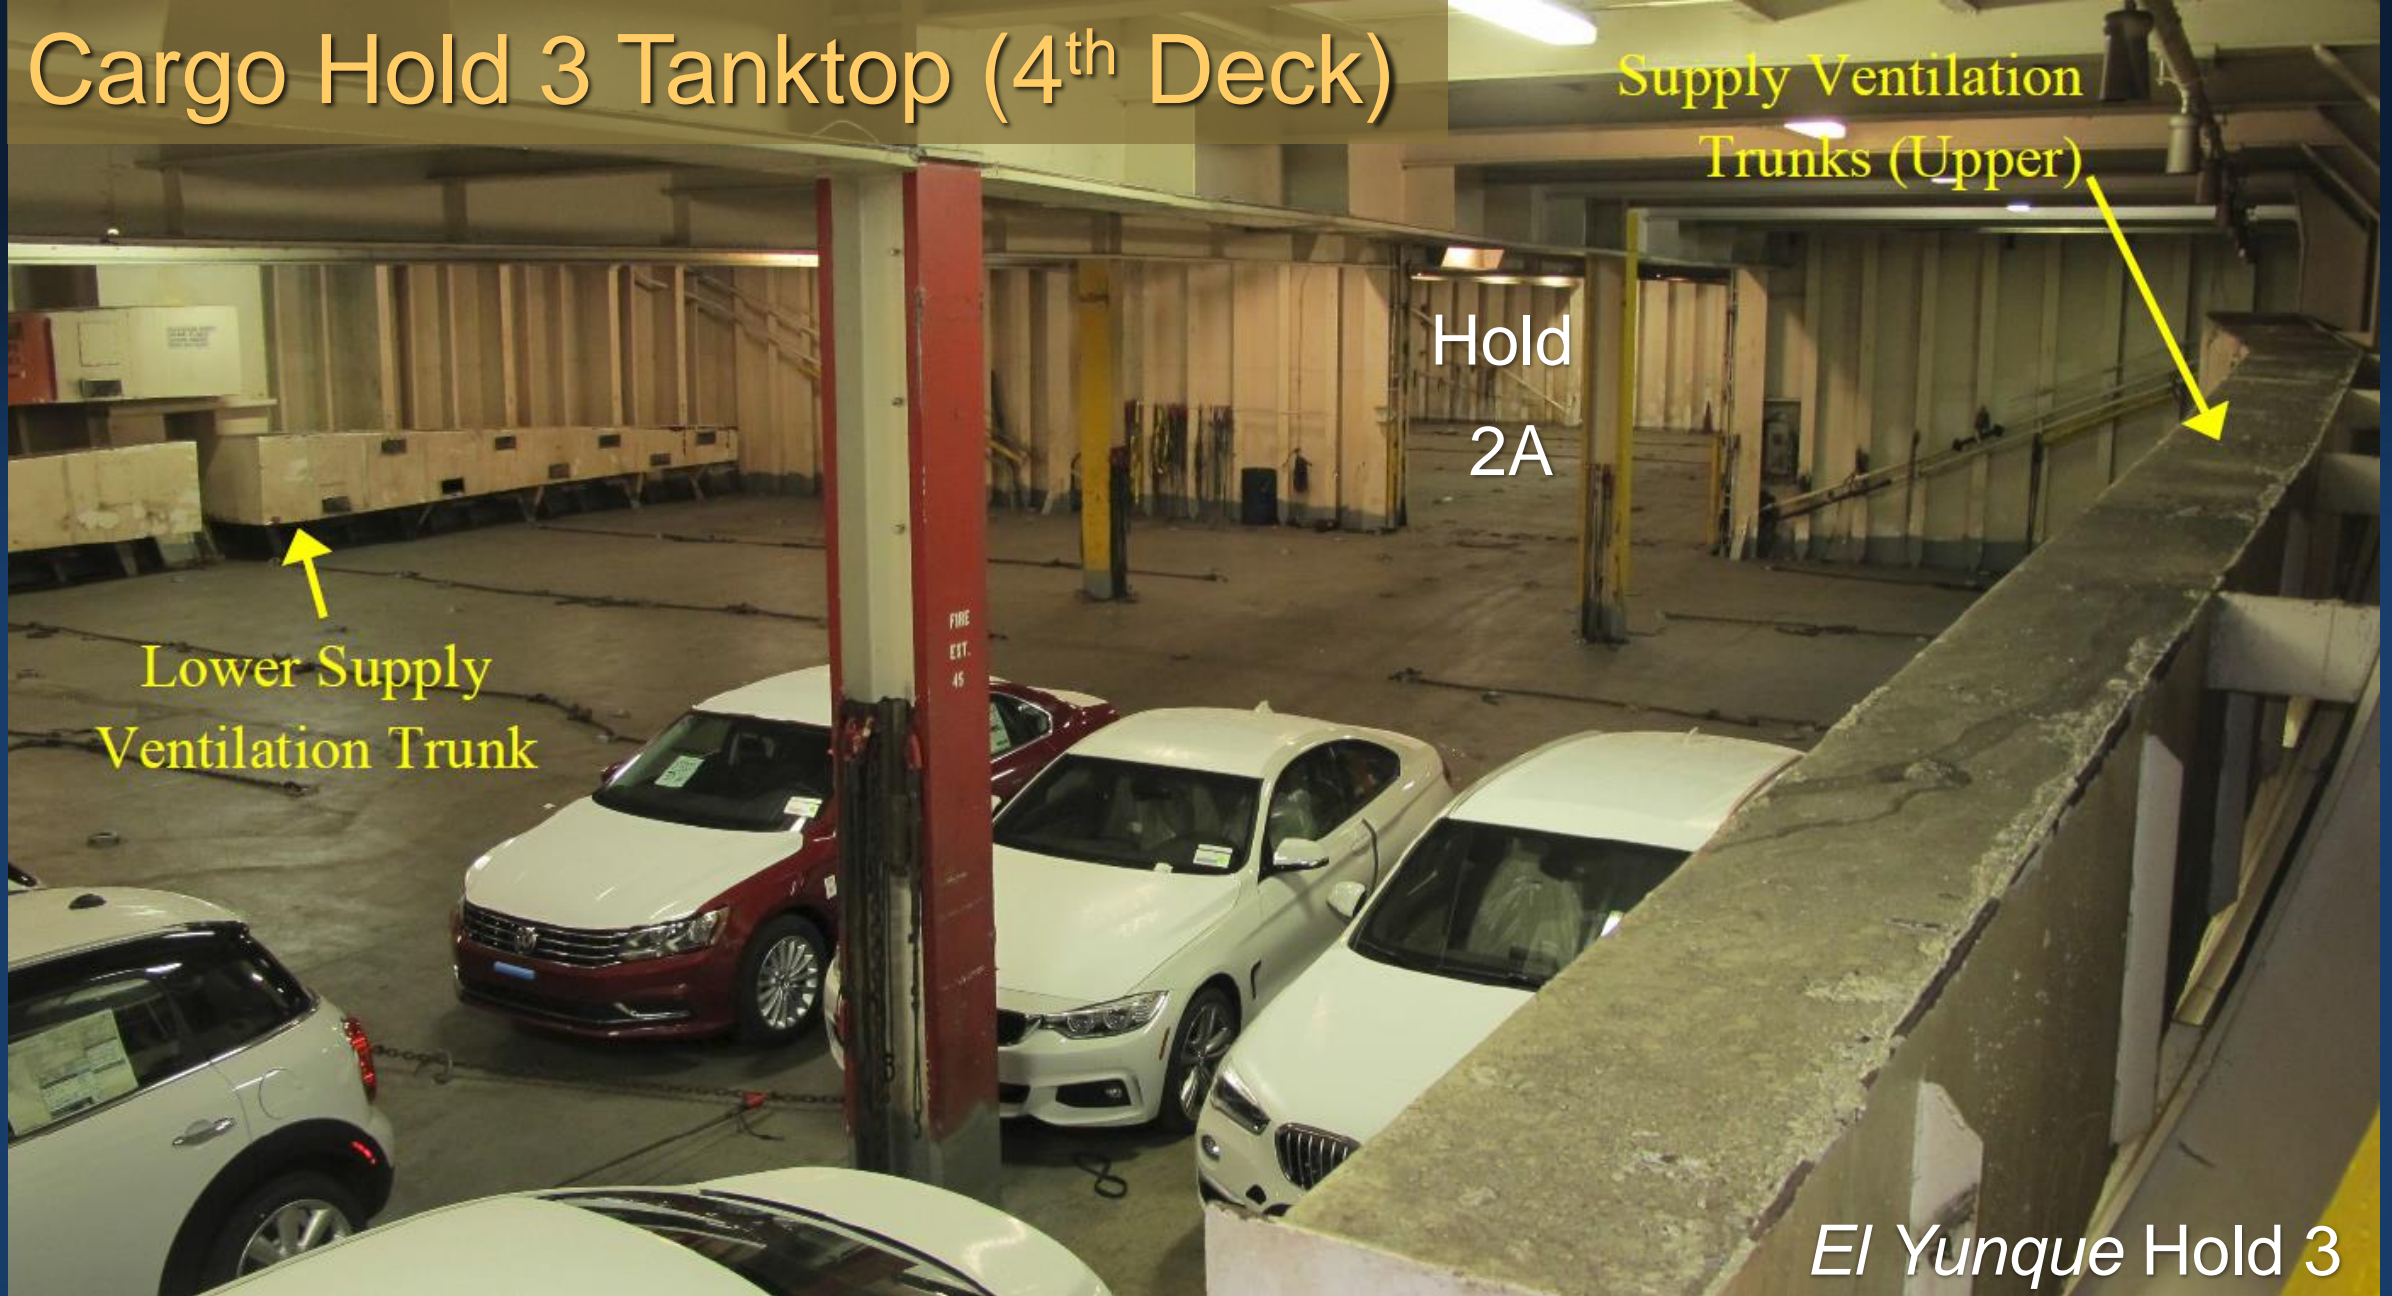
# Cargo Hold 3 Tanktop (4<sup>th</sup> Deck)

Supply Ventilation  
Trunks (Upper)

Hold  
2A

Lower Supply  
Ventilation Trunk

*El Yunque Hold 3*

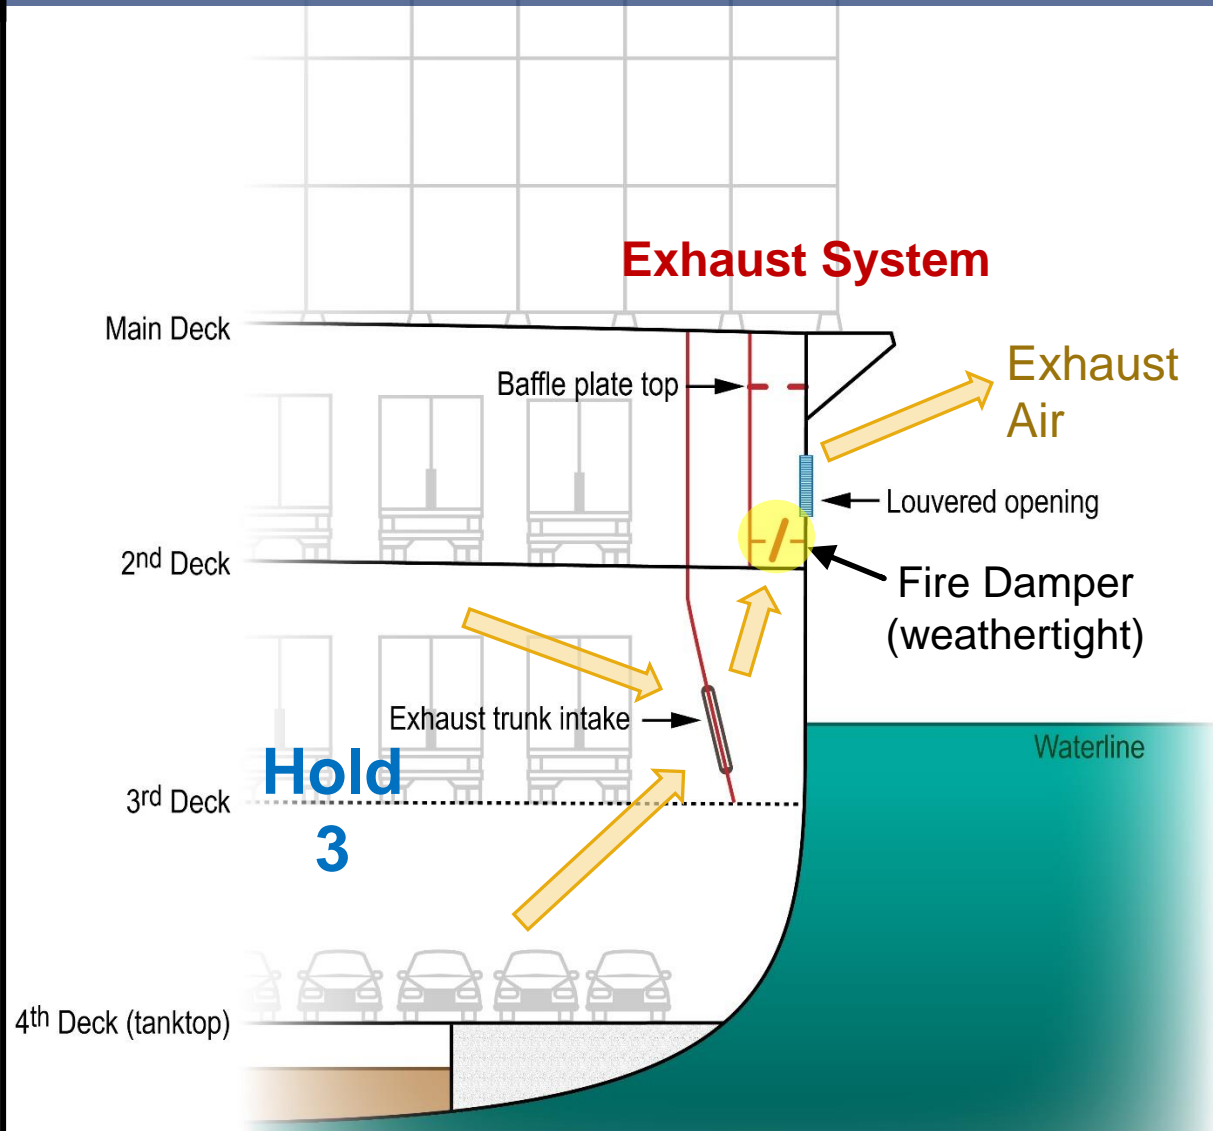
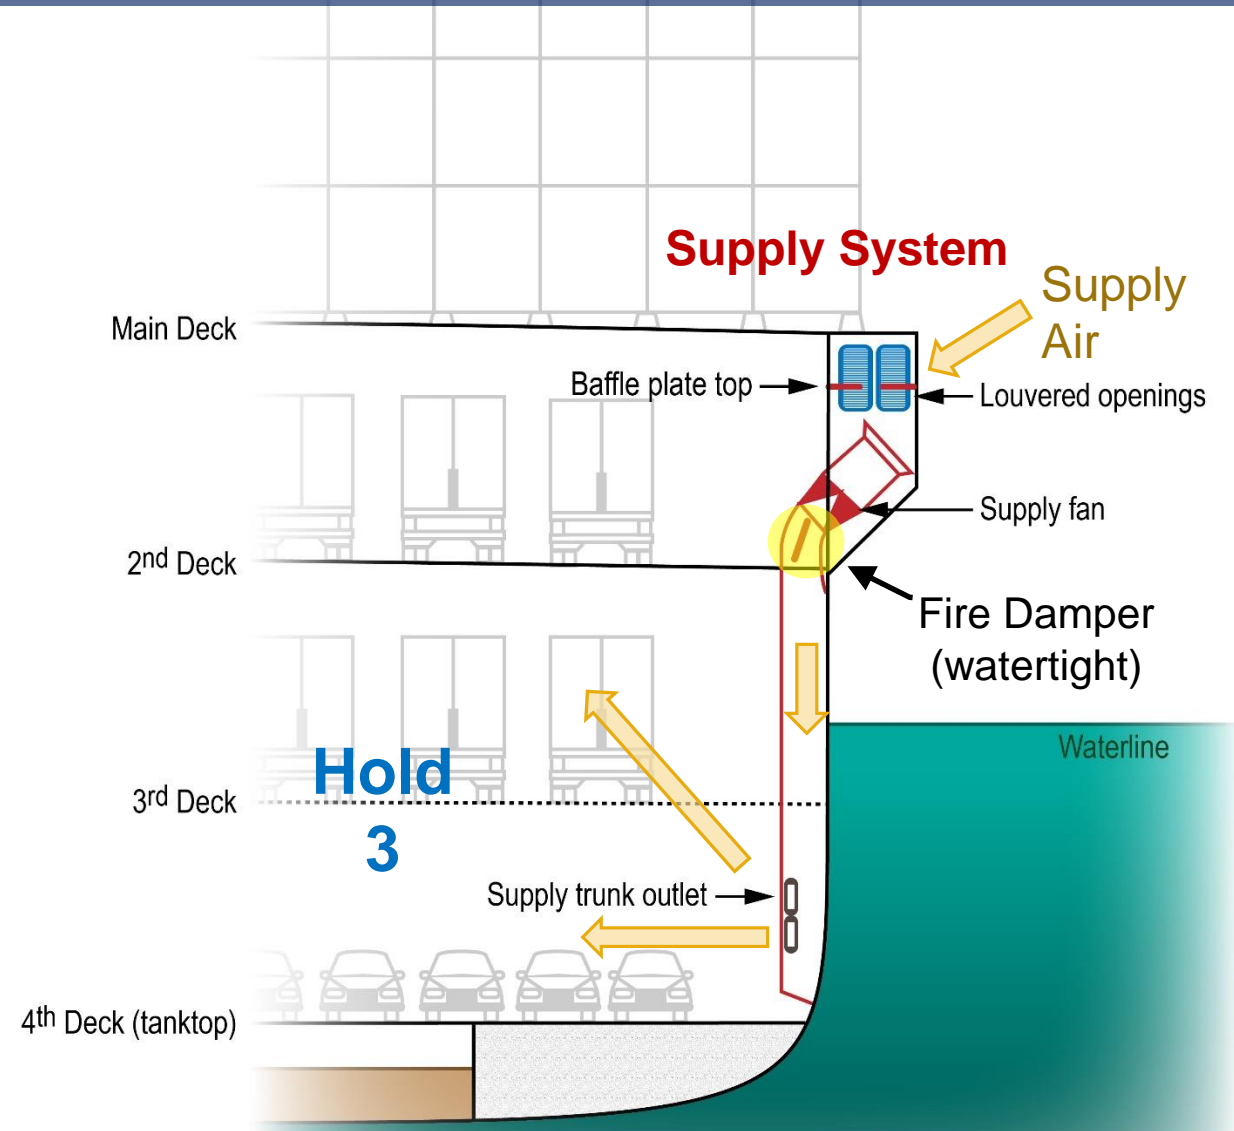
# Cargo Hold Ventilation System

- Ventilation closures most likely remained open throughout sinking
- COI required ventilation of holds at sea
- Intact and damage stability standards consider ventilation openings to be closed
- Vessels should not have conflicting requirements
