Survival Factors

R. Jon Furukawa
Survival Factors Group Chairman

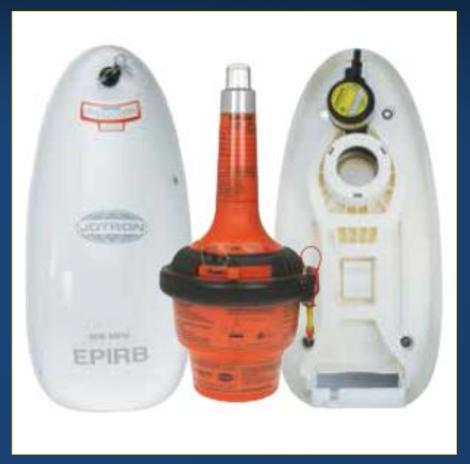
Emergency Position Indicating Radio-Beacon (EPIRB)

- El Faro's EPIRB
 - Detected at 0736
 - Location not determined
- GPS-enabled EPIRB sends an accurate position with the first transmission
- Lady Mary accident in 2009
 - 6 of 7 crew perished
 - Delayed sending SAR assets

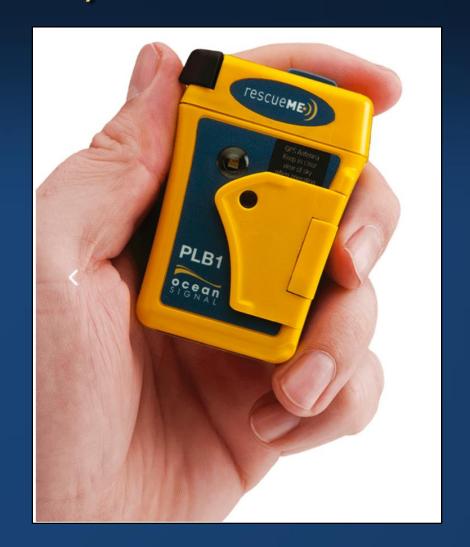
Personal Locator Beacons (PLBs)

- Small manual EPIRB
- GPS input capable
- Trinity II accident in 2011
 - Crew evacuated
 - 3 days to rescue
 - Drifted 150 miles
 - 4 of 10 crew lost

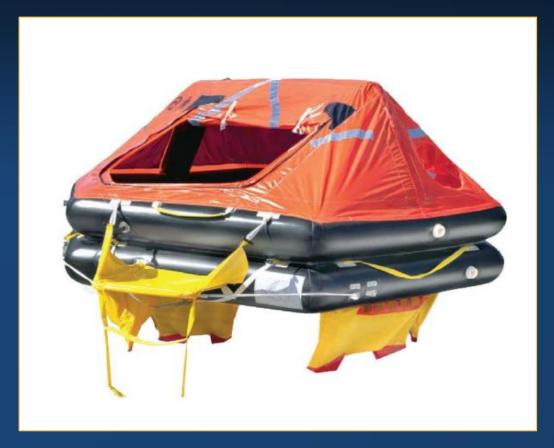
Inflated Liferaft

Inflatable Liferafts

- Survivors swim to liferaft through
 - Floating containers
 - Mountainous seas
 - Sea-foam from winds
- Then board liferaft
