National Transportation Safety Board

Uncontained Engine Failure and Subsequent Fire
American Airlines Flight 383
Chicago, Illinois
October 28, 2016

Investigator-in-Charge
presentation

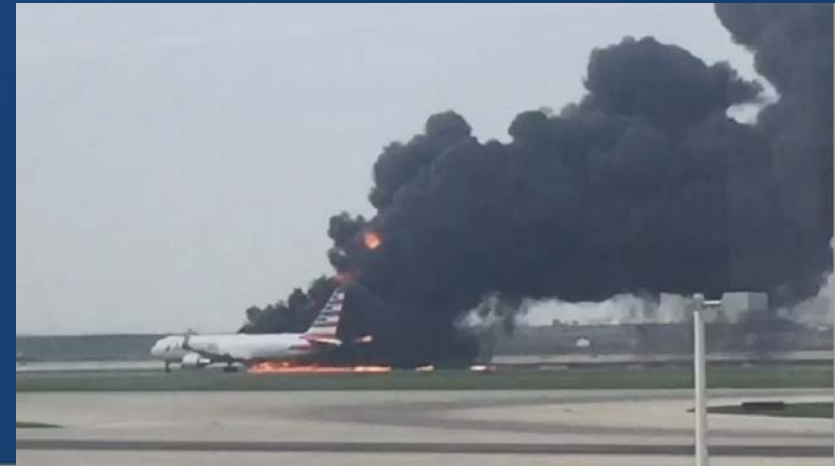
Video of Rejected Takeoff and Evacuation

- Boeing 767-300
- Takeoff ground roll
- Uncontained right engine failure and subsequent fire
- Flight crew rejected takeoff, and flight attendants initiated evacuation

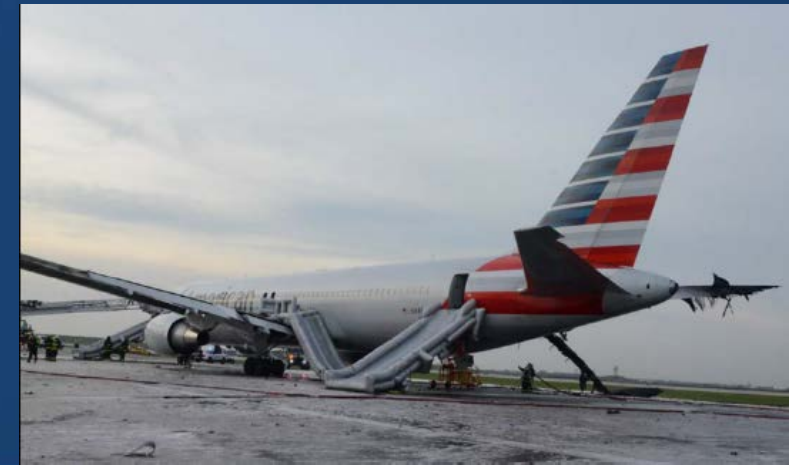
Uncontained Engine Failure

- High-pressure turbine (HPT) stage 2 disk rupture
- HPT stage 2 disk nickel-based alloy
