National Transportation Safety Board

Fire and abandonment of Ro/Ro Passenger Vessel
Caribbean Fantasy
Two Miles Northwest of San Juan Harbor
San Juan, Puerto Rico
August 17, 2016

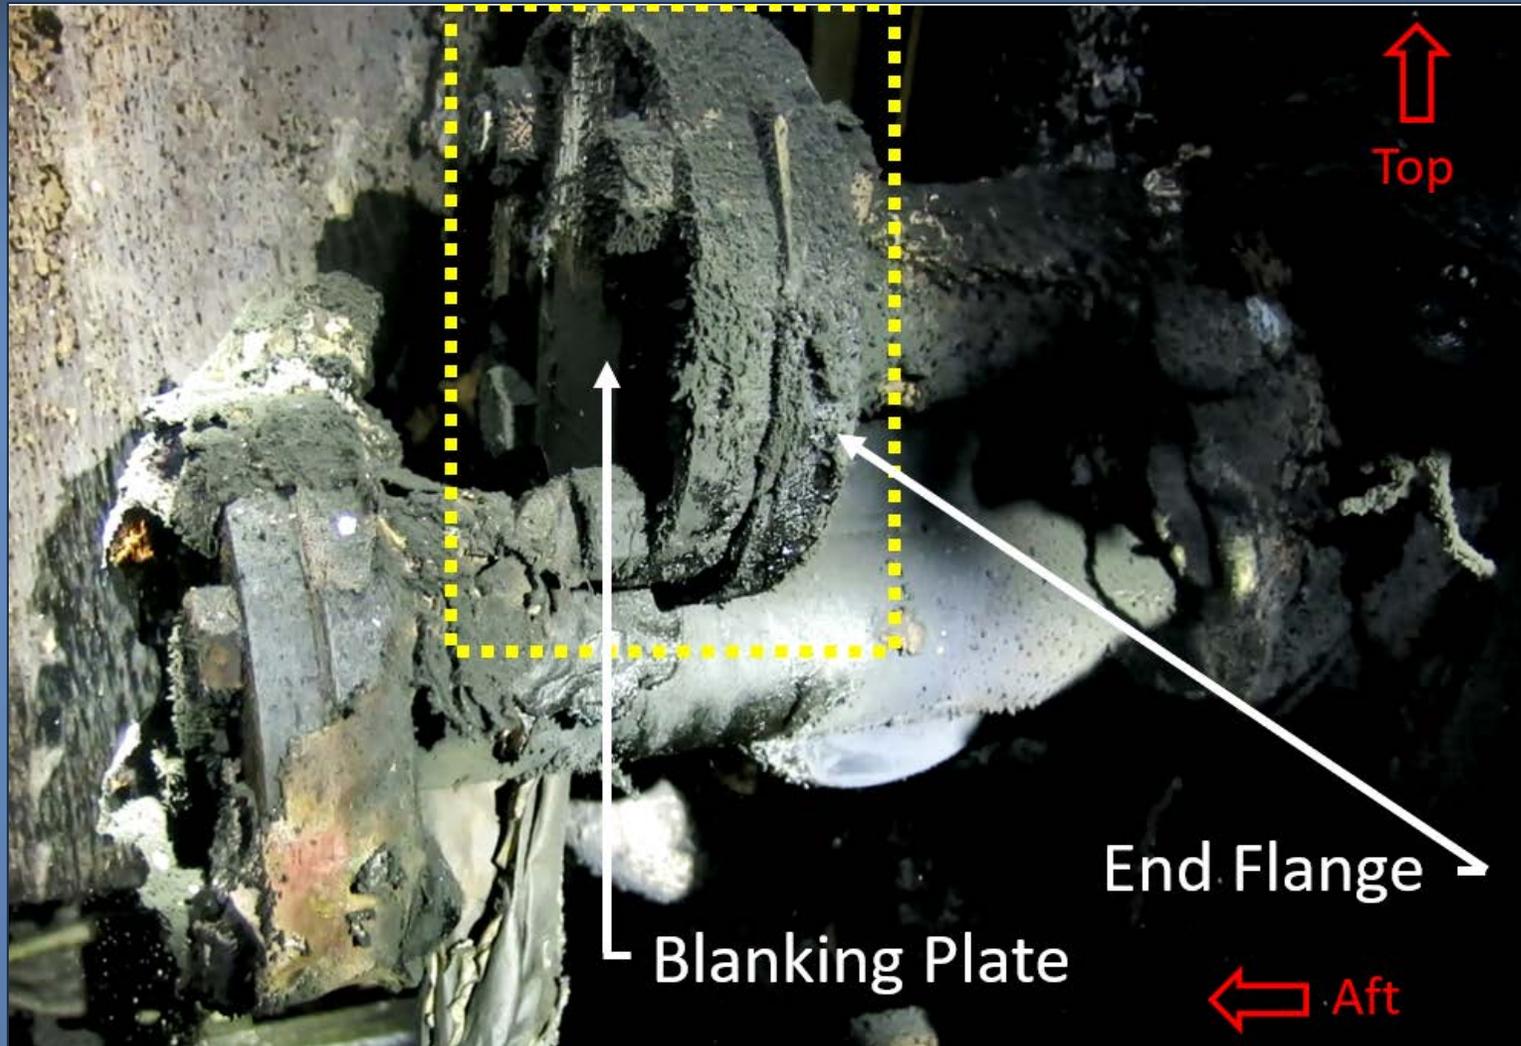
Fuel Supply End Flange Assembly

Improper Gasket Material & Nonstandard Blanking Plate

- End flange
 - Four bolt flange
 - OEM design
- Gasket material
 - Silicone rubber composition
 - Not specified composition
- Blanking plate
 - Not OEM design

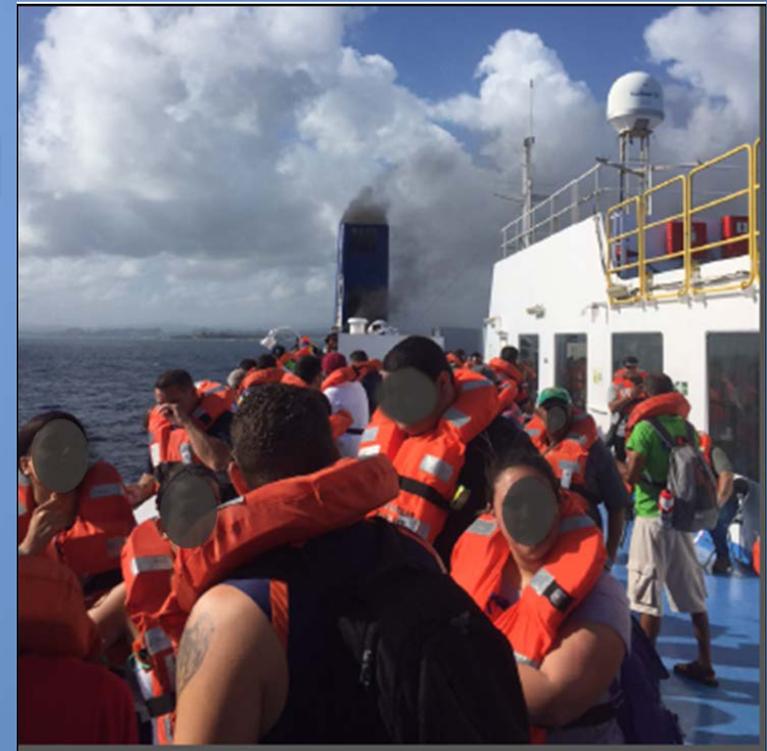
- Fire, smoke, and explosions reported
- Smoke in accommodation areas
- CO₂ system deployed
- Water-mist system operation not verified
- Vessel listing 4 degrees
- Vessel only on emergency power

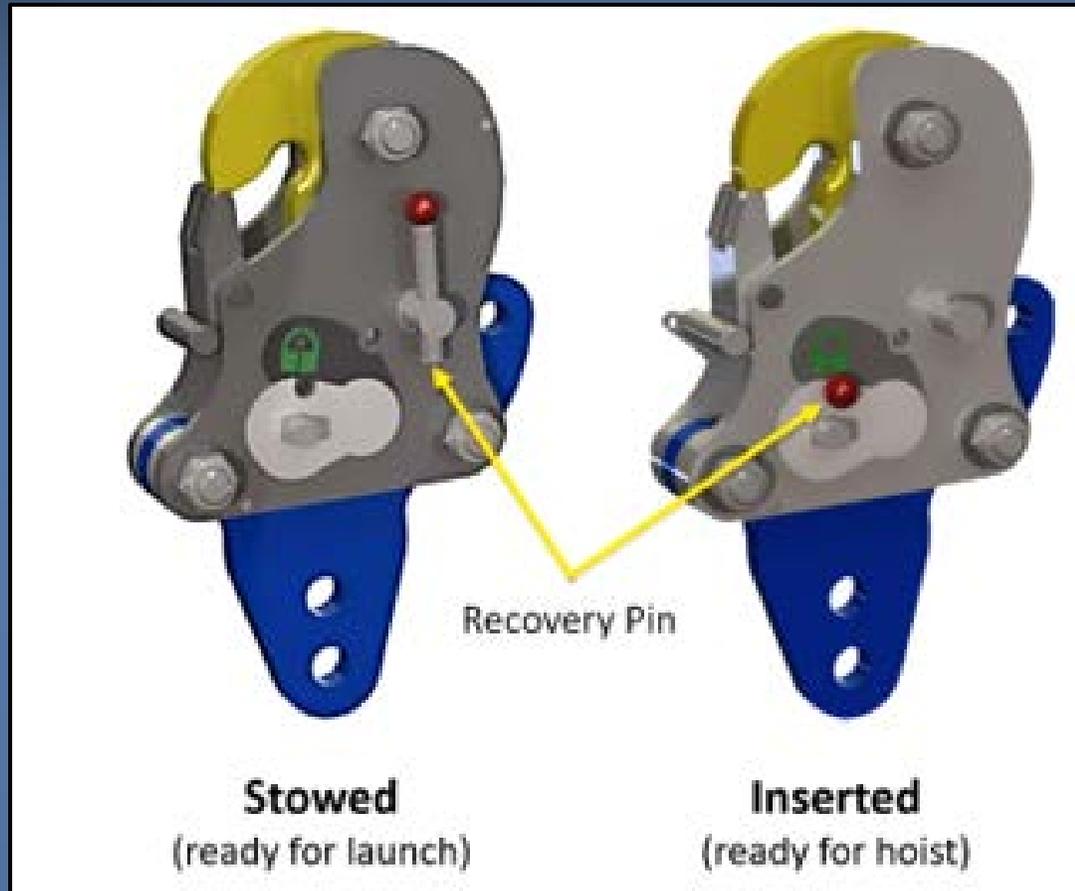
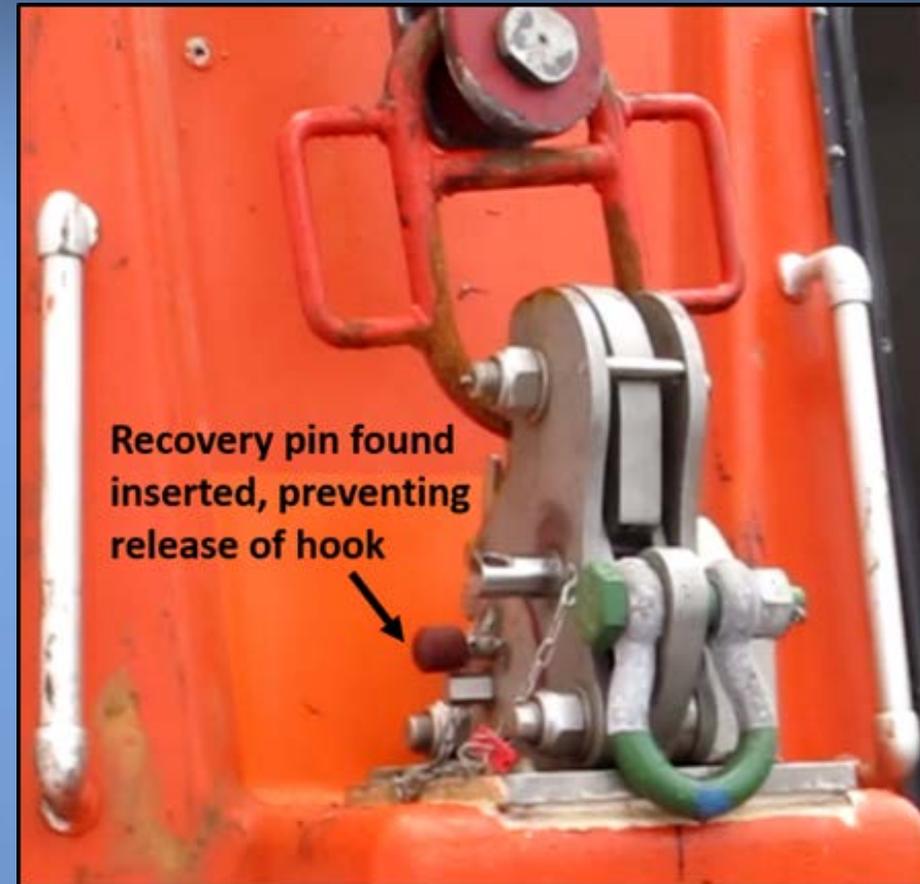
Lifeboat Release Hooks

- Minimal training and familiarization
- Knowledge of lifeboat release hooks lacking
- Increased the risk to crew and passengers

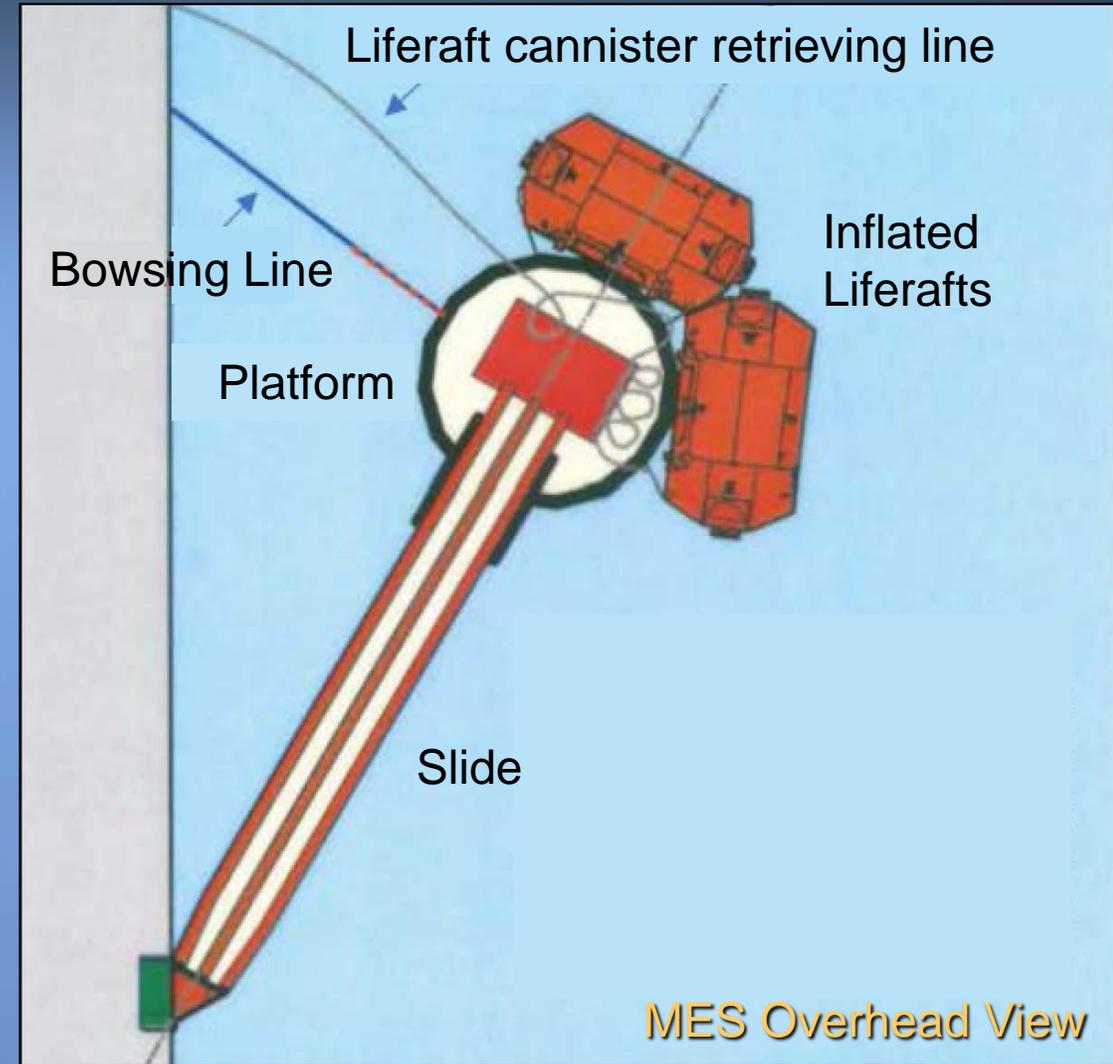
Portside liferaft container stowage rack

- MES liferafts prematurely inflated
 - Containers launched nearly the same time
 - Painters remained attached due to manual launch
 - Tension on painters triggered auto-inflation

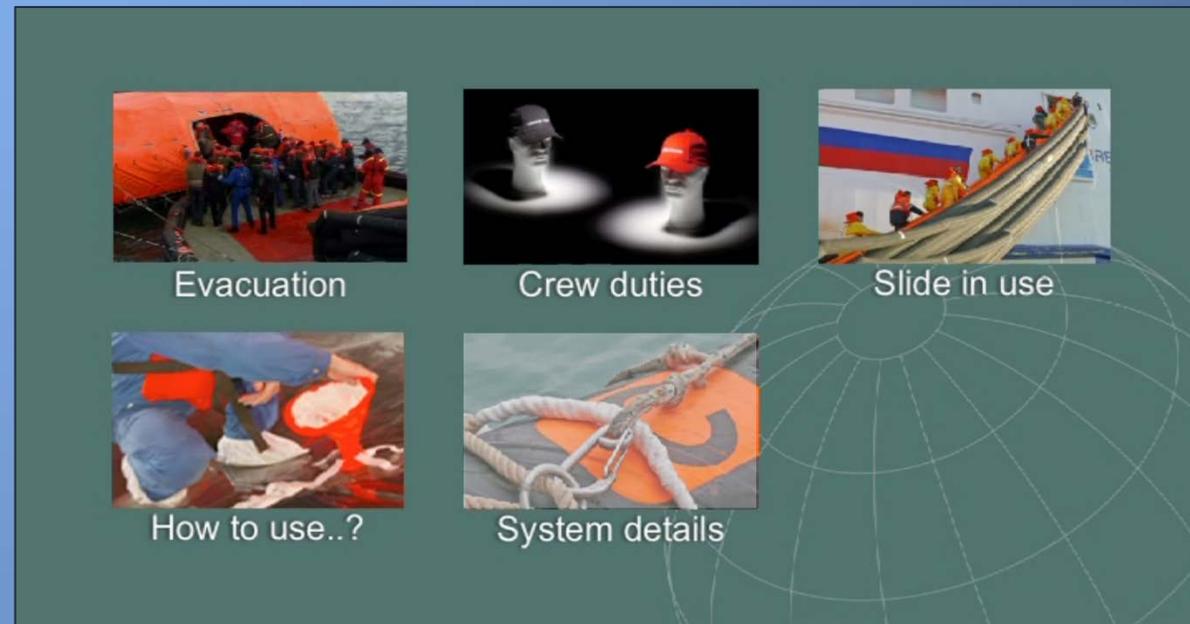
Screen capture from MES Training Video

- Training and familiarization inadequate
 - Deficiency in MES deployment participation
 - MES training video not sufficient
