National Transportation Safety Board

Fire On Board Small Passenger Vessel *Island Lady*
Pithlachascotee River Near Port Richey, Florida
January 14, 2018

Brian Young, IIC
Office of Marine Safety

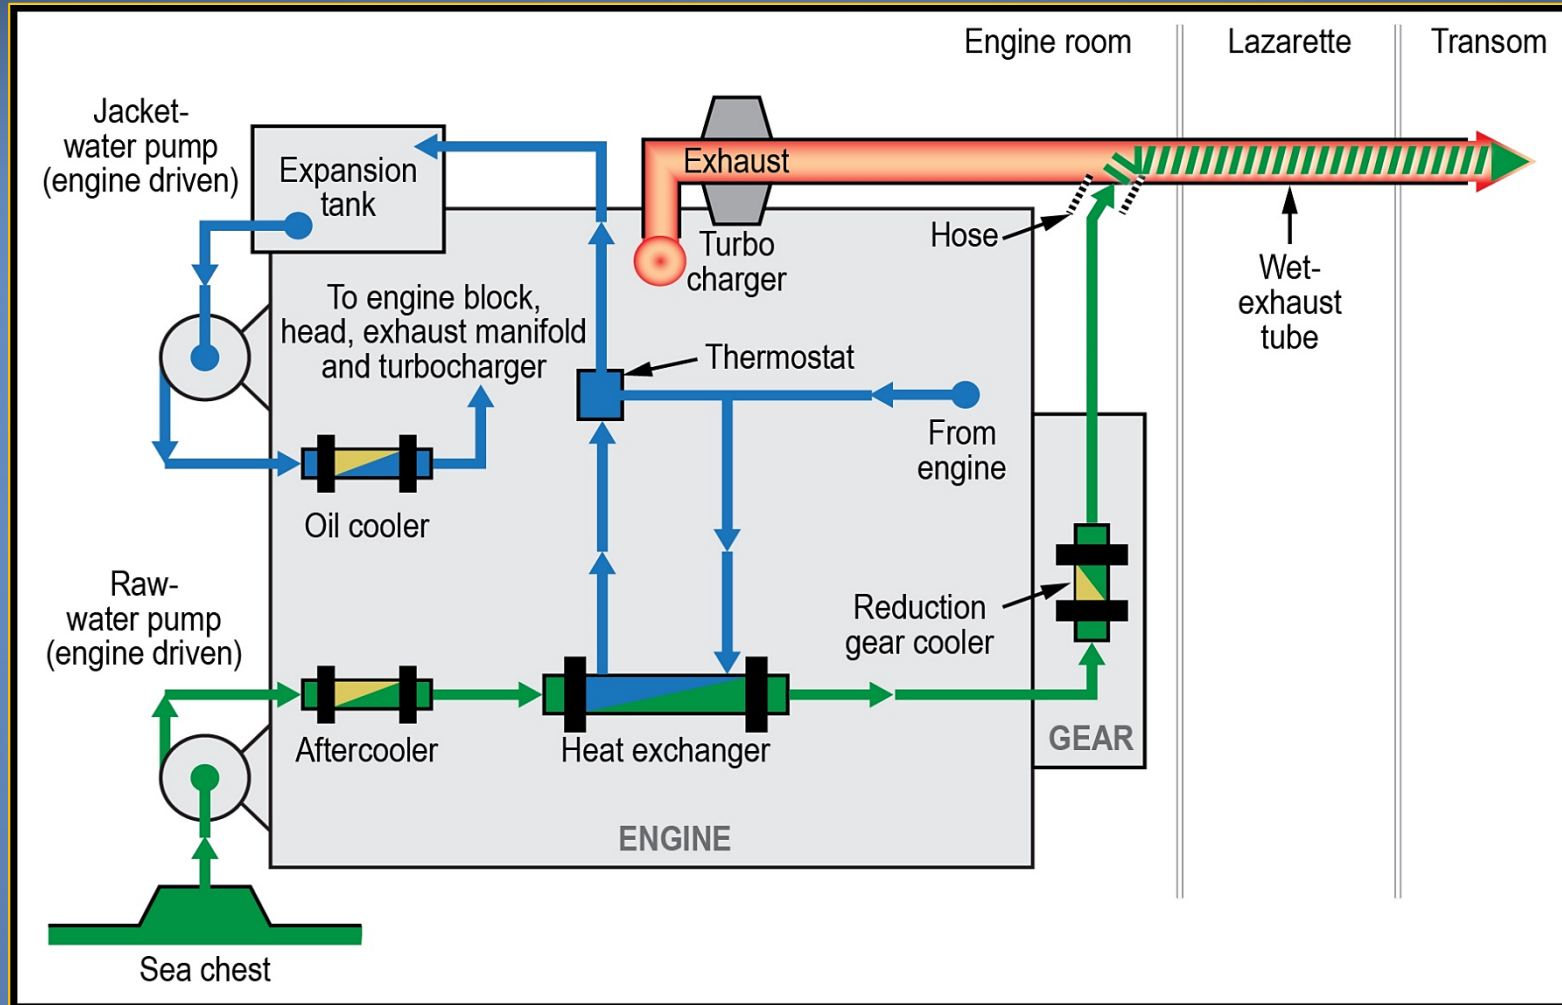
Engine Cooling Water System

- Fire originated in exhaust tubing in lazarette
 - Loss of raw water
 - Elevated exhaust temperatures, leading to degradation of exhaust tube materials and ignition
- Fire spread to surrounding wood supports
