National Transportation Safety Board

High-Profile Grade Crossings

Steven Prouty, PE

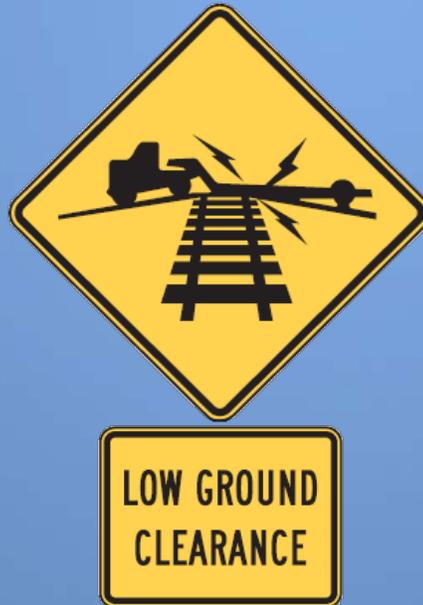
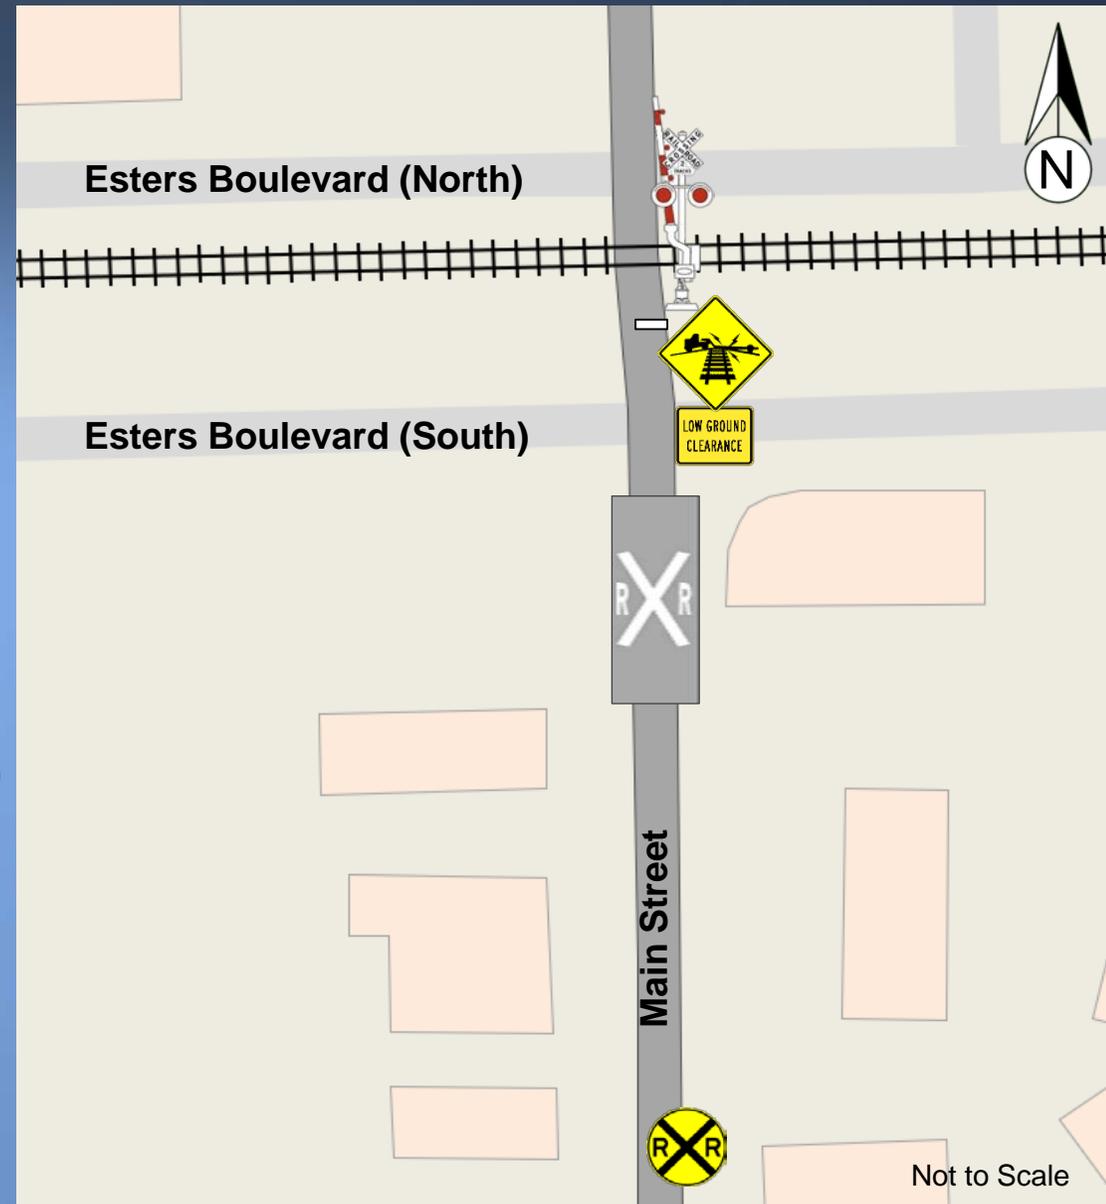
Signage and Markings

- Grade crossing advance warning symbol
- Grade crossing pavement marking symbol
- White stop line
- Grade crossing warning (crossbuck)
- Low ground clearance grade crossing warning sign
