NTSB National Transportation Safety Board

Natural Gas Transmission Pipeline Rupture and Fire

San Bruno, California
September 9, 2010

Opening Statement

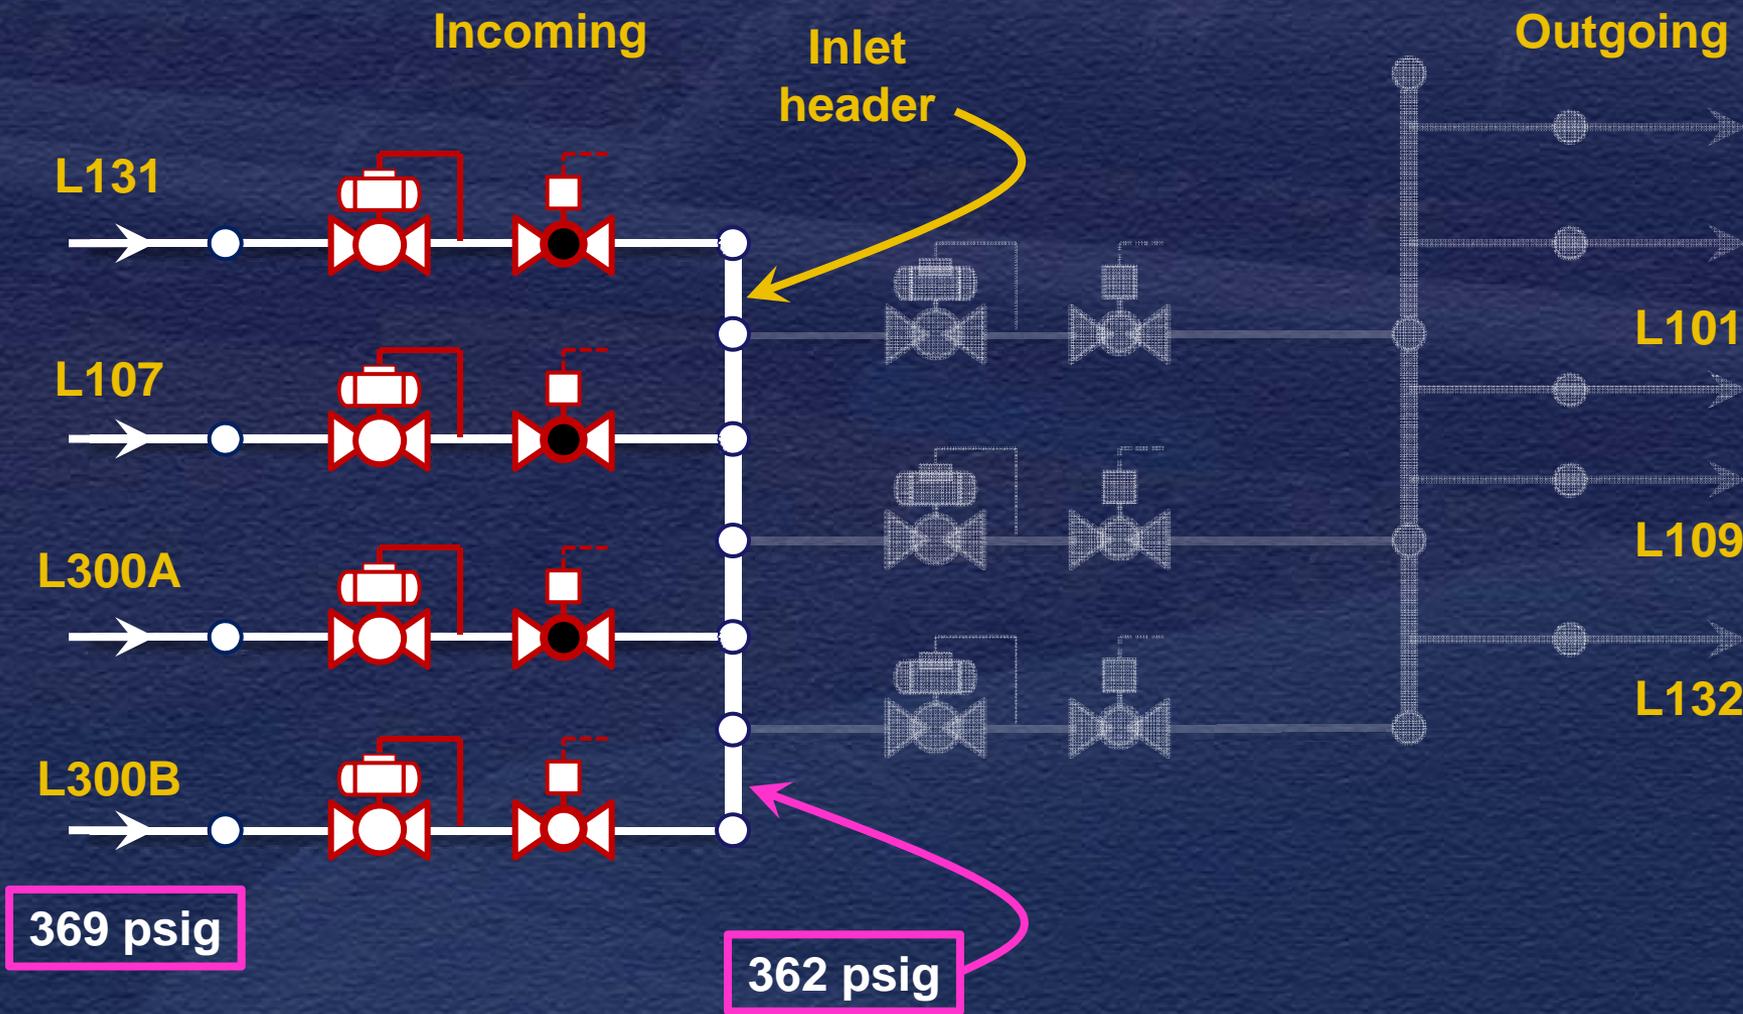
Milpitas Impacts

- 5:22 p.m., primary pressure control lost
- Monitor valves react to control pressure
- Milpitas technician notified at 5:25 p.m. by SCADA center of high pressures
- SCADA center no longer receiving accurate SCADA information
- SCADA center unprepared for loss of Milpitas control

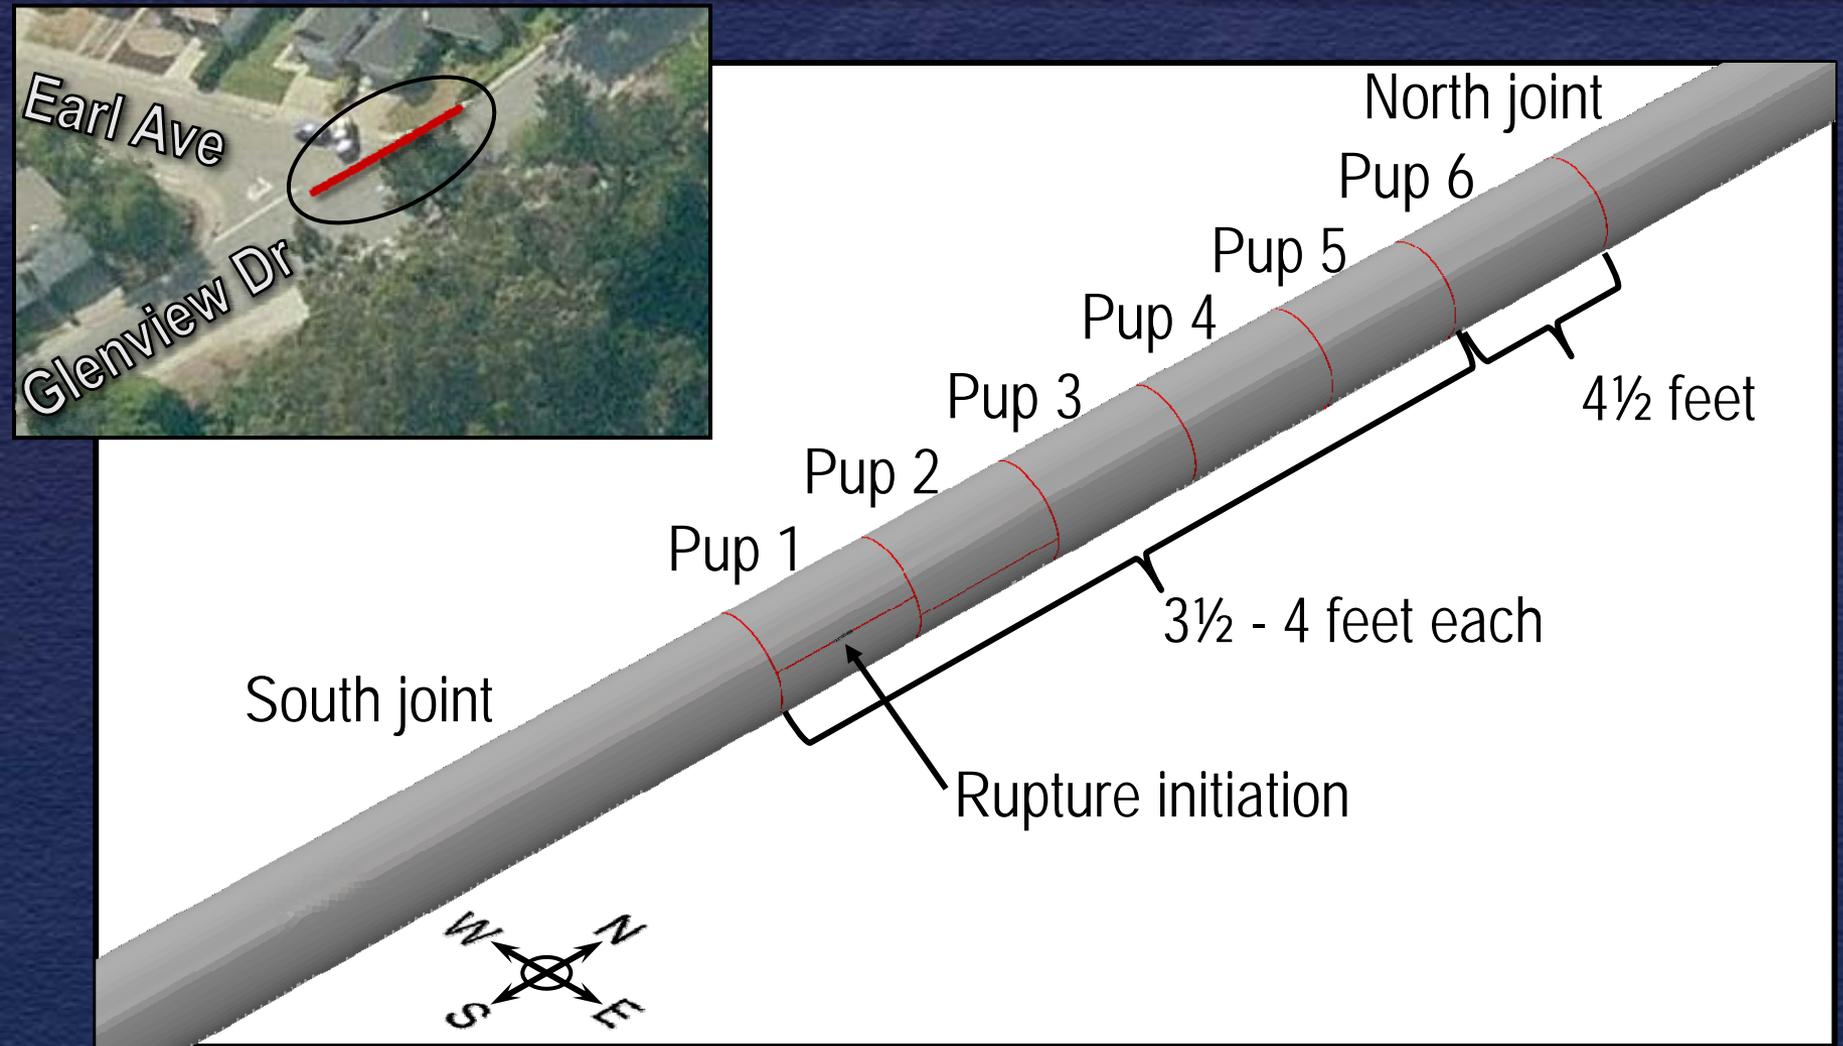
Construction of the Pipe

Pipe at Accident Site

- Pipe listed as X42 seamless
- Postrupture examination indicated presence of seam welded pipe
- PG&E believes pipe came from Consolidated Western Steel Corporation

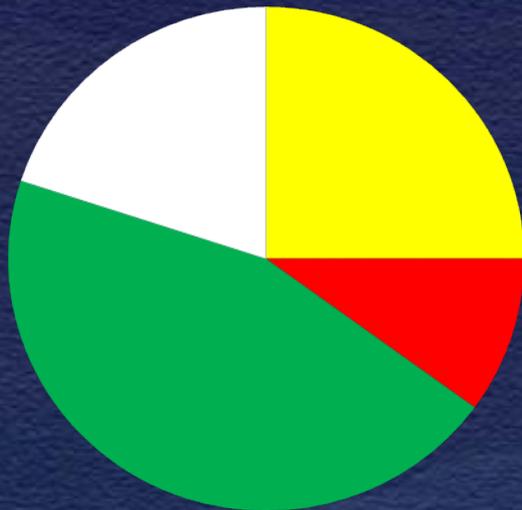
Program

- External corrosion
- Design/manufacturing
- Third-party damage
- Ground movement

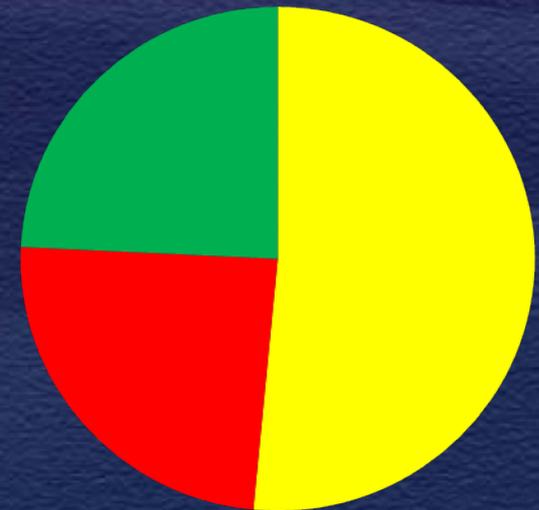
Actual

- Weld seam defects not considered
 - Manufacturing cracks
 - 1988 seam leak
- PG&E incorrectly considered seam defects stable
- Line 132 integrity assessment method could not find seam defects
