The NTSB and Recent Railroad Accidents

Brotherhood of Locomotive
Engineers and Trainmen

April 14, 2010

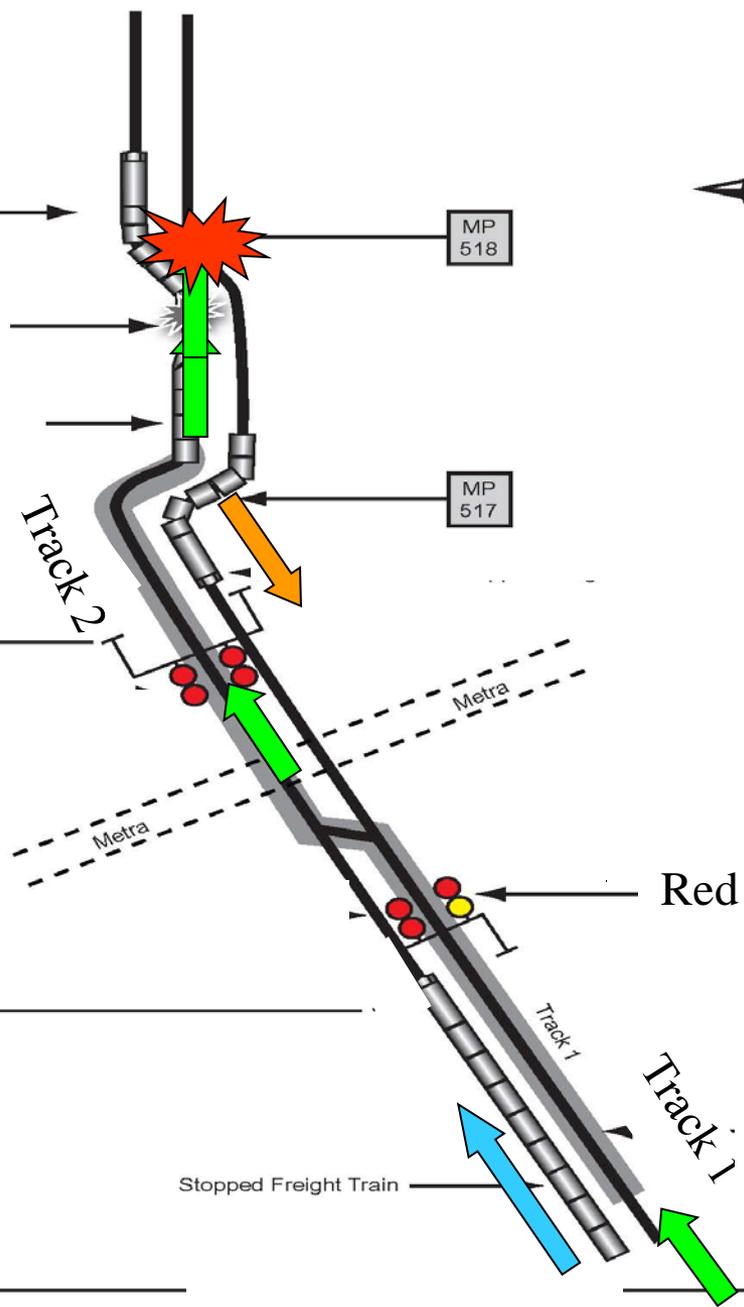
Different Signal Indications

- Norfolk Southern - *Restricting*

- Be prepared to stop in one-half the range of vision
- Expect the track to be occupied

- Amtrak Terminal - *Slow Approach*

- Stop at the next signal
- Expect a clear track

The NTSB determined that the probable cause of the November 30, 2007, collision of Amtrak train 371 with the rear of Norfolk Southern Railway Company train 23M near Chicago, Illinois, was the failure of the Amtrak engineer to correctly interpret the signal at Englewood interlocking and Amtrak's failure to ensure that the engineer had the competency to correctly interpret signals across the different territories over which he operated.

Establish uniform signal aspects that railroads must use to authorize a train to enter an occupied block, and prohibit the use of these aspects for any other signal indication.

Study the different signal systems for trains, identify ways to communicate more uniformly the meaning of signal aspects across all railroad territories, and require the railroads to implement as many uniform signal meanings as possible.

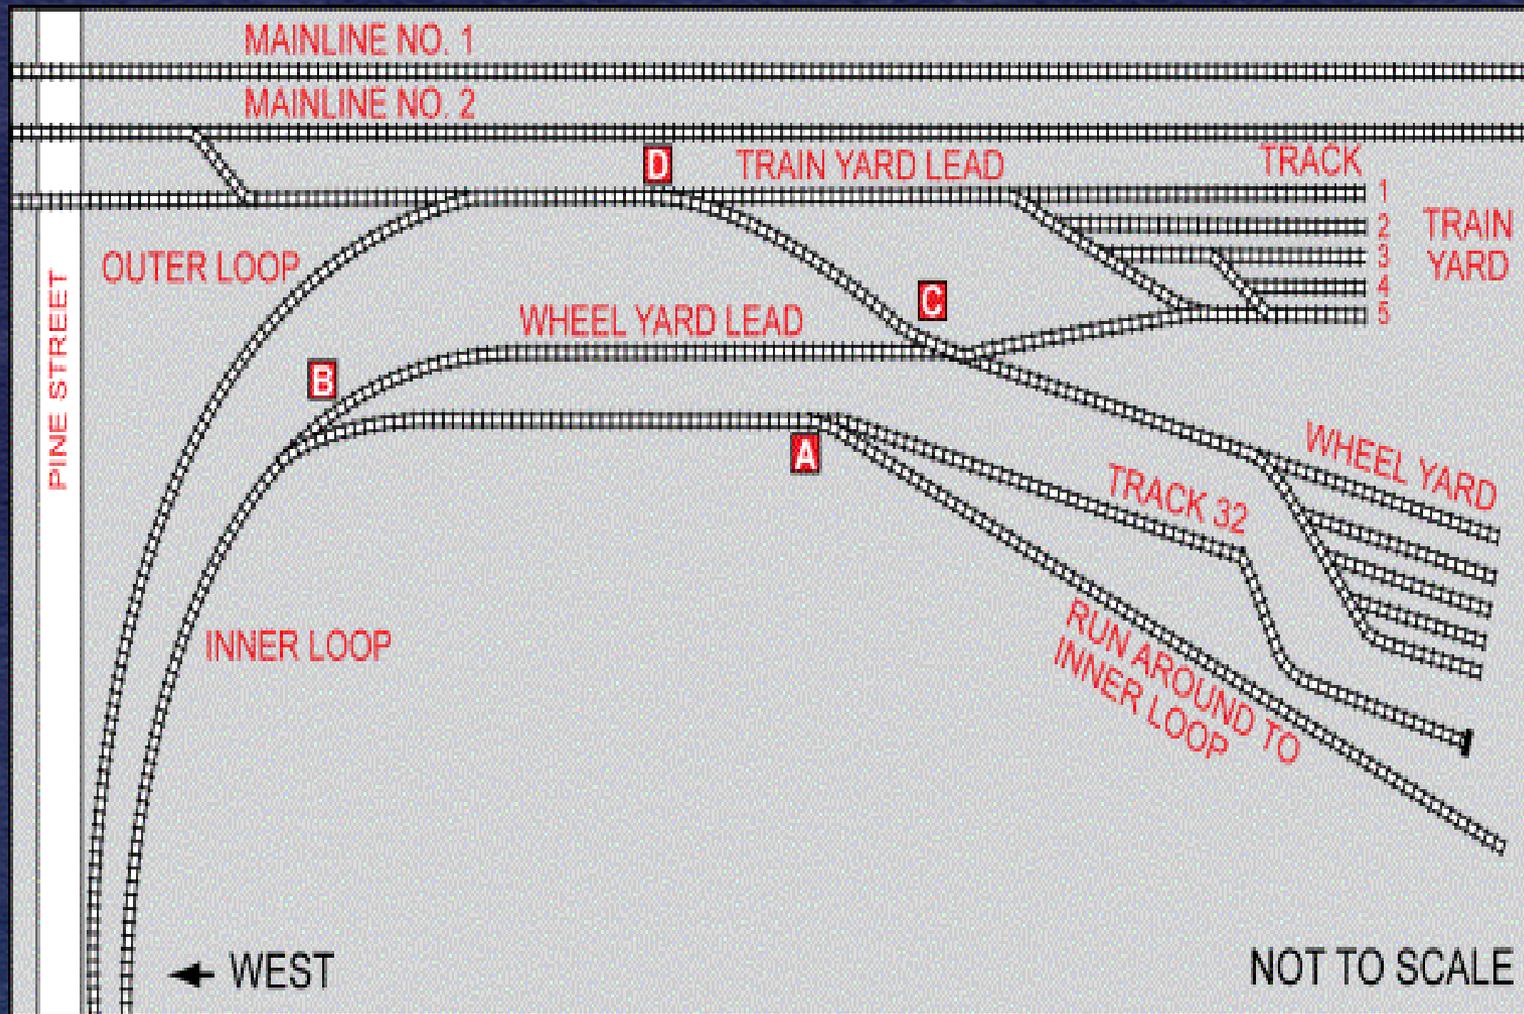
UP East Yard, San Antonio, TX

The NTSB determined that the probable cause of the December 7, 2003, yard accident in San Antonio, Texas, was the foremen's inattentiveness to the location of the locomotives and the switch position and the lack of adequate oversight by the Union Pacific Railroad of power-assisted switch installation, maintenance, and operations at its East Yard.

Require railroads to implement for all power-assisted switch machines, regardless of location, a formal commissioning procedure and a formal maintenance program that includes records of inspections, tests, maintenance, and repairs
