National Transportation Safety Board

Safety Recommendation

In reply refer to: R-14-12

The recommendation is derived from the NTSB's ongoing investigation of the derailment and subsequent collision of two Metro-North passenger trains in Bridgeport, Connecticut, on May 17, 2013. As a result of our investigation to date, the NTSB is issuing two safety recommendations, one of which is addressed to Metro-North. Information supporting this recommendation is discussed below.

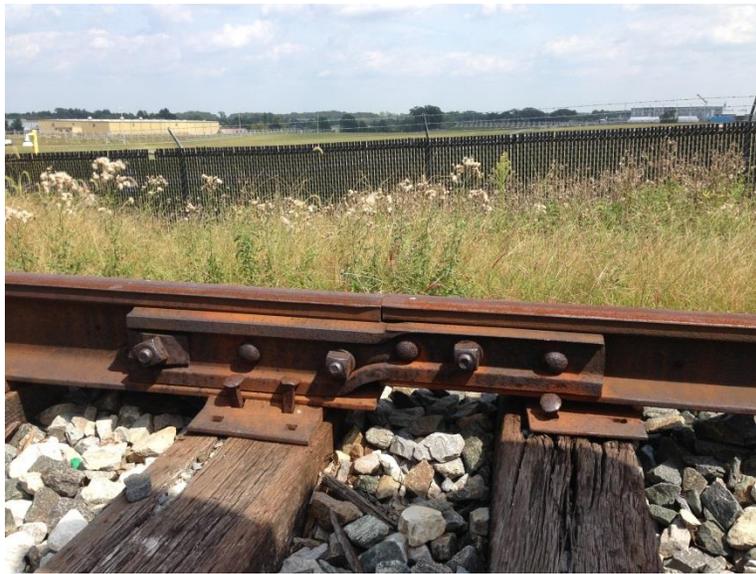
At the point of derailment, investigators found that a pair of 36-inch-long compromise joint bars on the north rail of track 4 were broken. Compromise joint bars are used to join two rails of different sizes to compensate for the different heights of the rail head running surfaces. (See figure 1.) The compromise joint was made up of two separate bars that were bolted to the webs of the two running rails. In this application, the two rails were 136- and 131-pound rails.¹ The compromise joint bars that were found to be broken had been installed on April 4, 2013.

Figure 1. Photograph of an exemplar compromise joint bar
