Railroad Special Investigation Report

**Two Rear-End Collisions
Involving Chicago Transit Authority
Rapid Transit Trains
at Chicago, Illinois
June 17 and August 3, 2001**

**NTSB/SIR-02/01
PB2002-917006
Notation 7488
Adopted September 5, 2002**

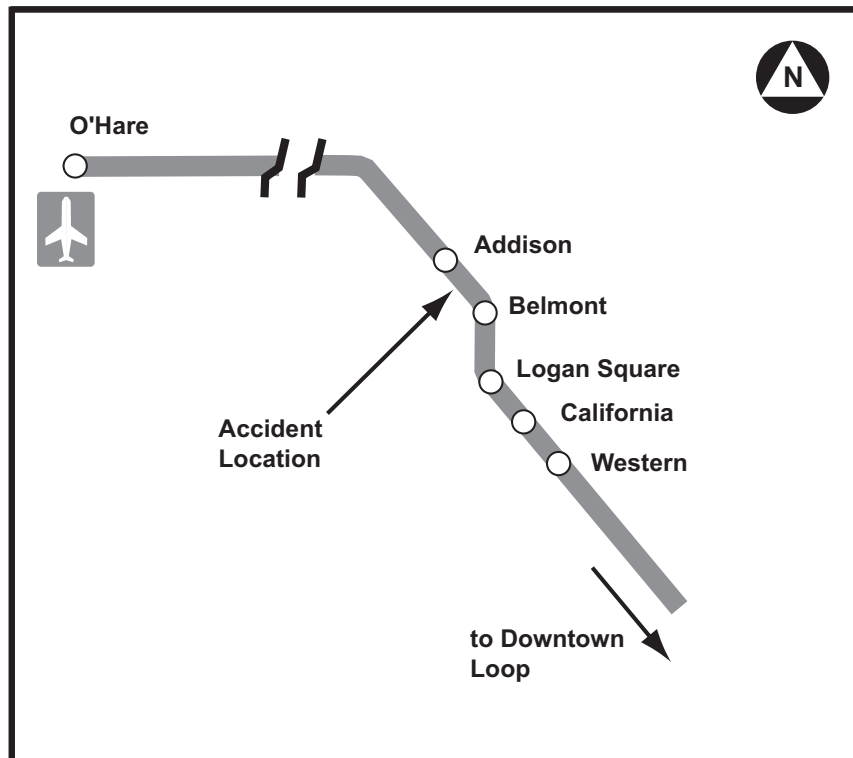
Figure 1. Location of June 17 accident.

The first accident occurred about 11:40 a.m., central daylight time, on Sunday, June 17, 2001, when CTA train 104, en route from downtown Chicago to O'Hare Airport, collided with standing CTA train 207 on the Blue Line near Addison Street Station. Each train consisted of four passenger cars. About 75 passengers were on train 104, and about 40 passengers were on train 207. Eighteen passengers, an off-duty CTA employee, and both train operators sustained minor injuries. The CTA estimated damages at \$30,000.

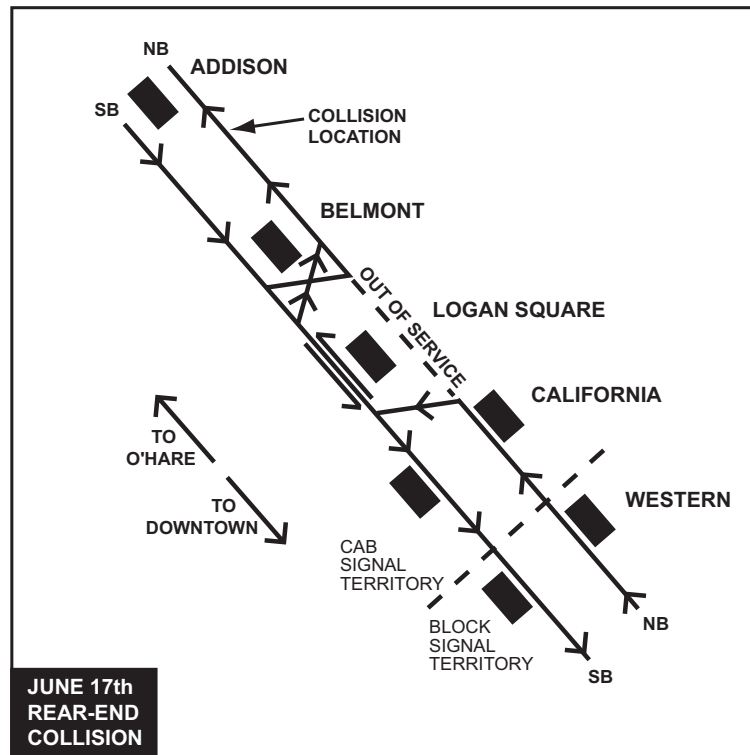
Figure 2. Single-track detour.

As train 104 proceeded northbound, it was following two trains, 210 and 207. When those trains reached the single-track detour at the California Station, the pilot authorized them to proceed northbound through the single-track area. The pilot then operated train 104 through the single-track area. (See figure 2.) The pilot stated that he chose to operate train 104 through the detour area because he was familiar with the operator of train 104 and knew that she was uncomfortable with abnormal operations, such as single tracking.

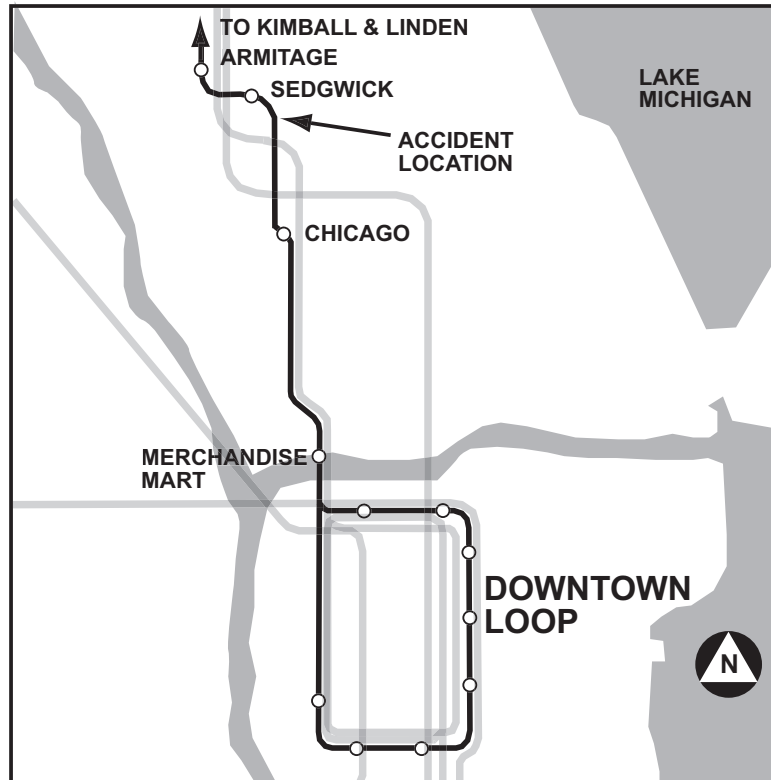
Figure 4. Location of August 3 accident.

The second accident occurred about 9:04 a.m., central daylight time, on Friday, August 3, 2001, when CTA Brown Line train 416, en route from Kimball to downtown Chicago, collided with standing CTA Purple Line train 505 on elevated tracks near Hill Street. Each train consisted of six passenger cars. The accident occurred during morning rush hour, and both trains had standing loads estimated at 90 passengers per car. Chicago Police Department logs indicate that 118 people were transported to area hospitals with minor injuries, none of which were life threatening. The CTA estimated damages at \$136,138.
