SPECIAL INVESTIGATION REPORT

**SEARCH AND RESCUE PROCEDURES AND
ARMING OF EMERGENCY LOCATOR TRANSMITTER:**

**AIRCRAFT ACCIDENT NEAR MICHIGAN CITY,
INDIANA,**

NTSB-SIR-81-2

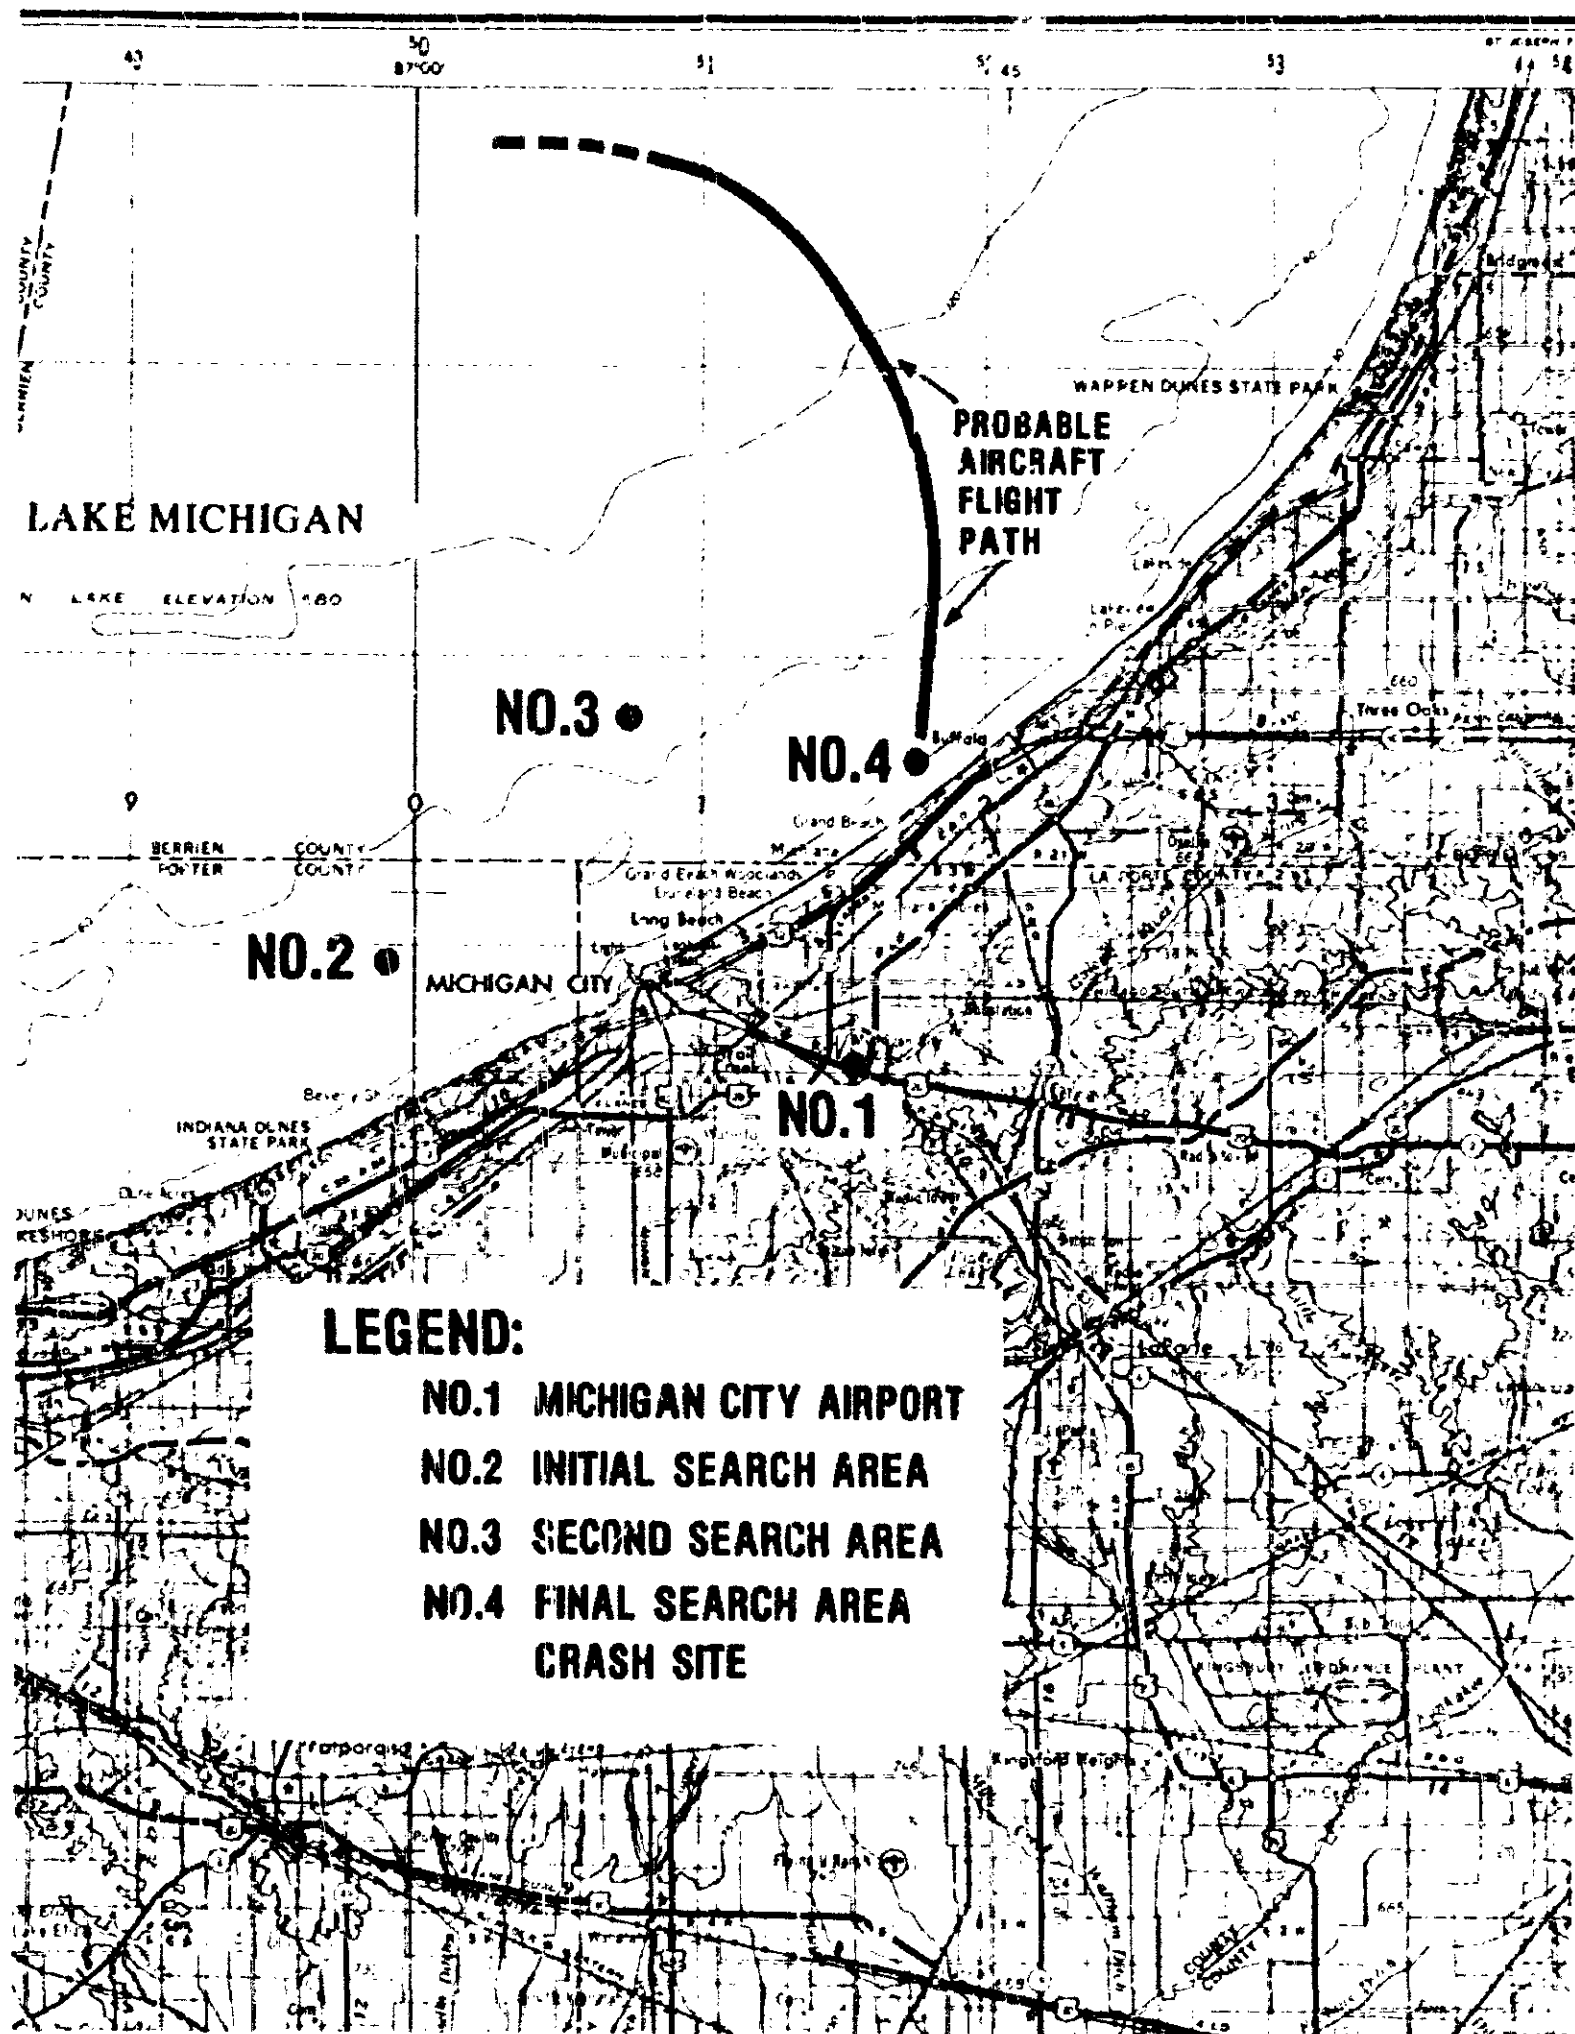
Figure 1.--Map of accident area depicting search sites.

Following 3 1/2 days of search efforts, the wreckage was located in Lake Michigan on December 11, 1980, in 38 feet of water 6 miles northeast of Michigan City Airport. The location of the aircraft was at 41°47' north latitude and 86°48' west longitude. Two pairs of shoes, laces untied, one single shoe, and suit coats were found in the aircraft cabin. No bodies were found in the wreckage. Two bodies were recovered later from the water, and two remain missing and are presumed dead. Pathological examinations revealed that the two persons died from hypothermia. No electronic signal from the ELT was detected during the search, and most smaller USCG vessels do not have the capability to detect ELT signals.

The USCG Center at Cleveland is in overall command of a search and rescue effort and through its computer and other resources suggests the type of search, areas of search, and vessels to be employed. The Center also assigns a SAR mission coordinator, in this case the Muskegon USCG station. The Muskegon unit has a lieutenant commander in charge. The Muskegon unit's responsibility was to relay information to the on-scene commander. The on-scene commander has the option of determining the best procedure to follow, based on his on-site observations. A USCG spokesman stated the USCG was initially advised the aircraft could be down 5 miles from the "light." It interpreted "the light" to mean the lighthouse near the Michigan City harbor. As a result, although a search vessel was dispatched immediately, the initial search was centered at a point about $270^{\circ}12.5$ nmi from the airport, nearly 15 nmi from the aircraft's last known position. (See figure 1.)
