HAZARDOUS MATERIALS SPECIAL INVESTIGATION REPORT
RELEASE OF OLEUM DURING WRECKAGE-CLEARING FOLLOWING
DERAILMENT OF SEABOARD SYSTEM RAILROAD TRAIN EXTRA
8294 NORTH, CLAY, KENTUCKY, FEBRUARY 5, 1984

National Transportation Safety Board
Washington, DC

Apr 85

NTSB/SIR-85/01

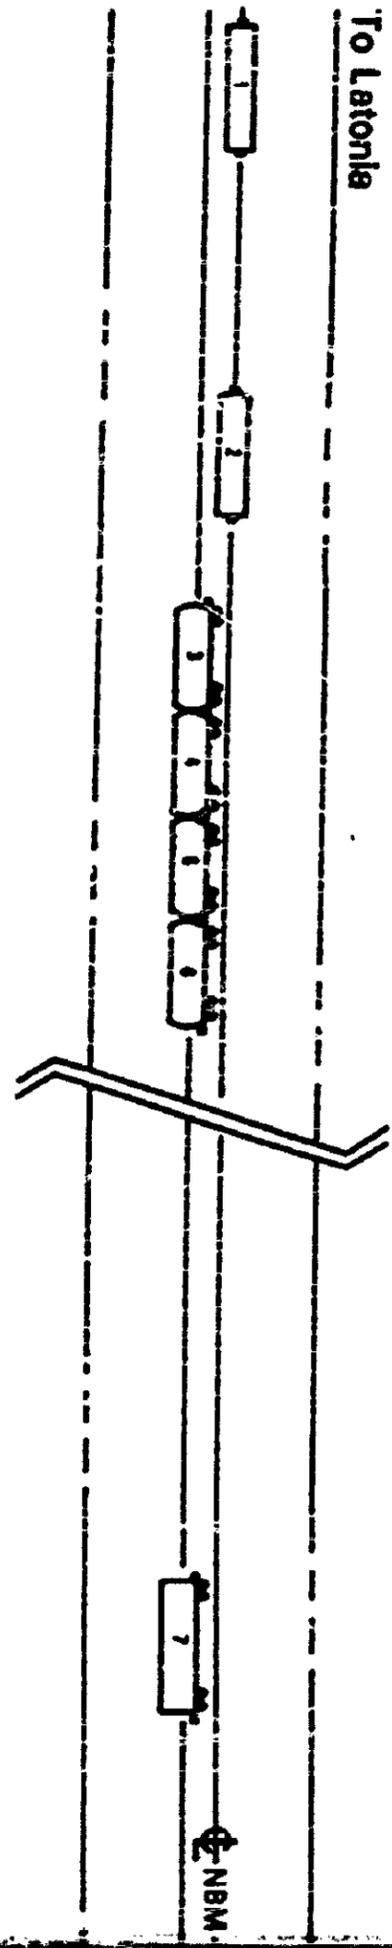
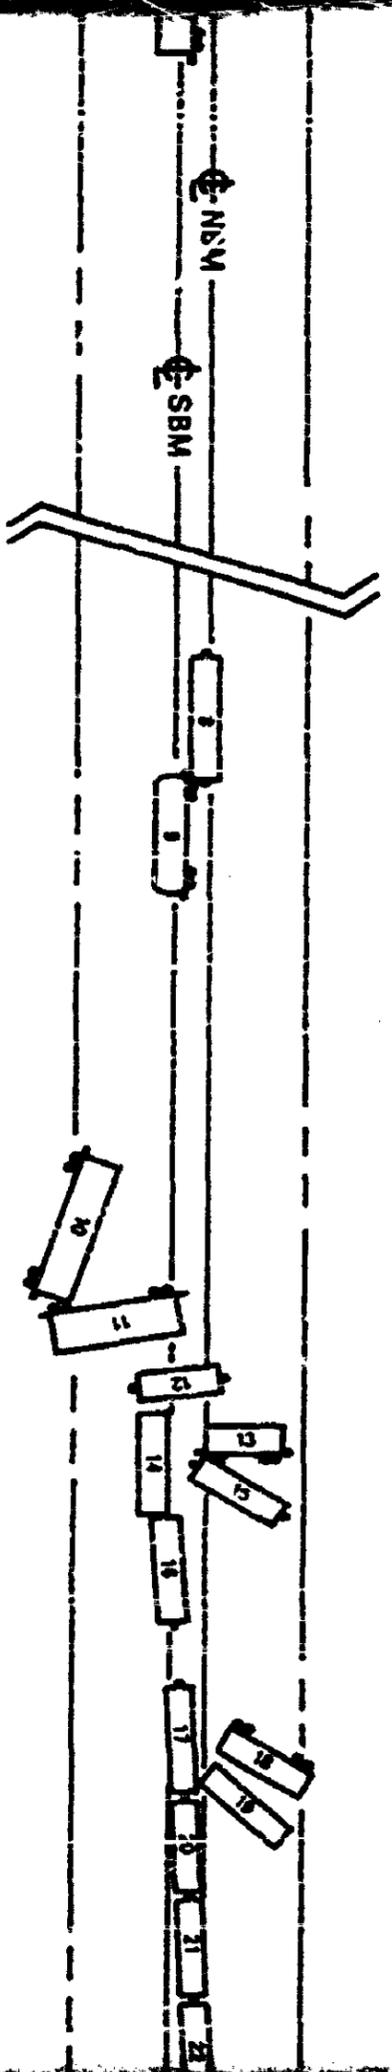
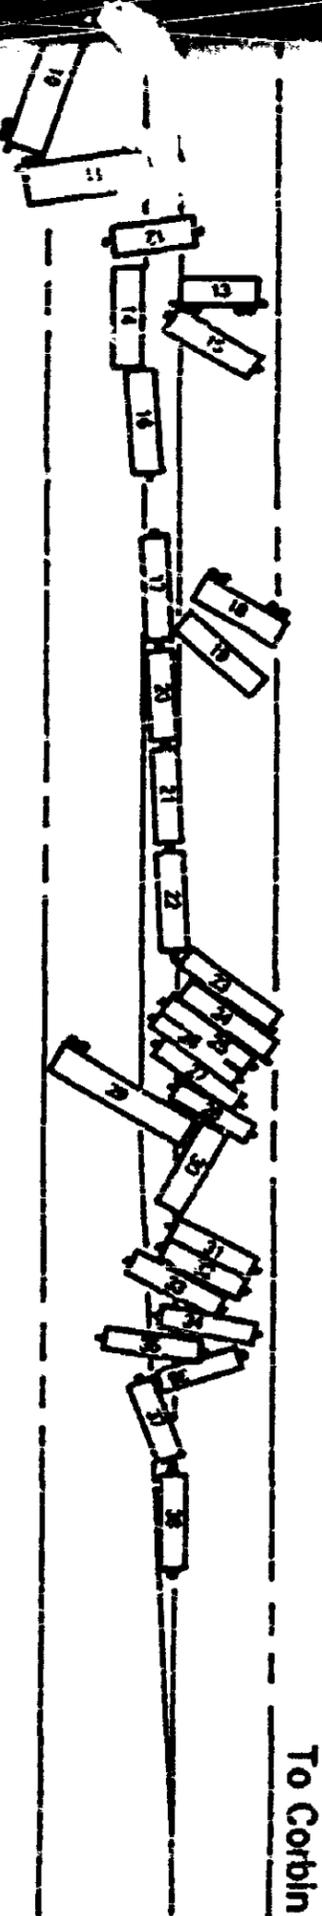
32. a

- 8 - SCL 25551
- 9 - GATX 94350
- 10 - SCL 95510
- 11 - LN 105242
- 12 - DUPX 63006
- 13 - DUPX 90016
- 14 - LN 130676
- 15 - SOO 178202
- 16 - LN 185772
- 17 - LN 76190
- 18 - LN 76611
- 19 - LN 154210
- 20 - LN 510004
- 21 - LN 187380
- 22 - LN 153619

- 10 - SCL 95510
- 11 - LN 105242
- 12 - DUPX 60008
- 13 - DUPX 60016
- 14 - LN 180676
- 15 - SOO 178202
- 16 - LN 186772
- 17 - LN 76190
- 18 - LN 76611
- 19 - LN 154210
- 20 - LN 510004
- 21 - LN 187360
- 22 - LN 153619
- 23 - LN 187791
- 24 - LN 189903
- 25 - LN 521771
- 26 - LN 522061
- 27 - LN 522148
- 28 - TILX 300455
- 29 - LN 521386
- 30 - LN 183434
- 31 - LN 180771
- 32 - LN 155725
- 33 - LN 183216
- 34 - LN 75264
- 35 - LN 520944
- 36 - LN 517008
- 37 - LN 151991
- 38 - LN 183637
