**Special Investigation Report: Design-Induced  
Landing Gear Retraction Accidents in Beech  
Baron, Bonanza, and Other Light Aircraft**

## **SPECIAL INVESTIGATION REPORT**

**DESIGN-INDUCED LANDING GEAR  
RETRACTION ACCIDENTS IN  
BEECHCRAFT BARON, BONANZA, AND  
OTHER LIGHT AIRCRAFT**

**NTSB-SR-80-1**

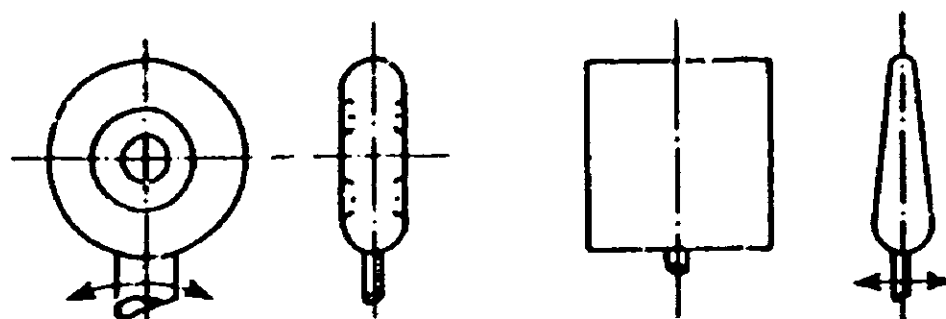
An examination of cockpits of the Bonanza and Baron revealed four design deficiencies with regard to their landing gear and flap controls which can lead to design-induced pilot errors. These deficiencies include: (1) A lack of adequate "shape-coding" of these control knobs to permit the pilot to differentiate between

LANDING GEAR CONTROL KNOB

FLAP CONTROL KNOB
