Crashworthiness of Small Poststandard School Buses: Safety Study

(U.S.) National Transportation Safety Board, Washington, DC

11 Oct 89

1. Report No. NTSB/SS-89/02		2. Government Accession No. PB89-917003		3. Recipient's Catalog No.	
4. Title and Subtitle Safety Study: Crashworthiness of Small Poststandard School Buses			5. Report Date October 11, 1989

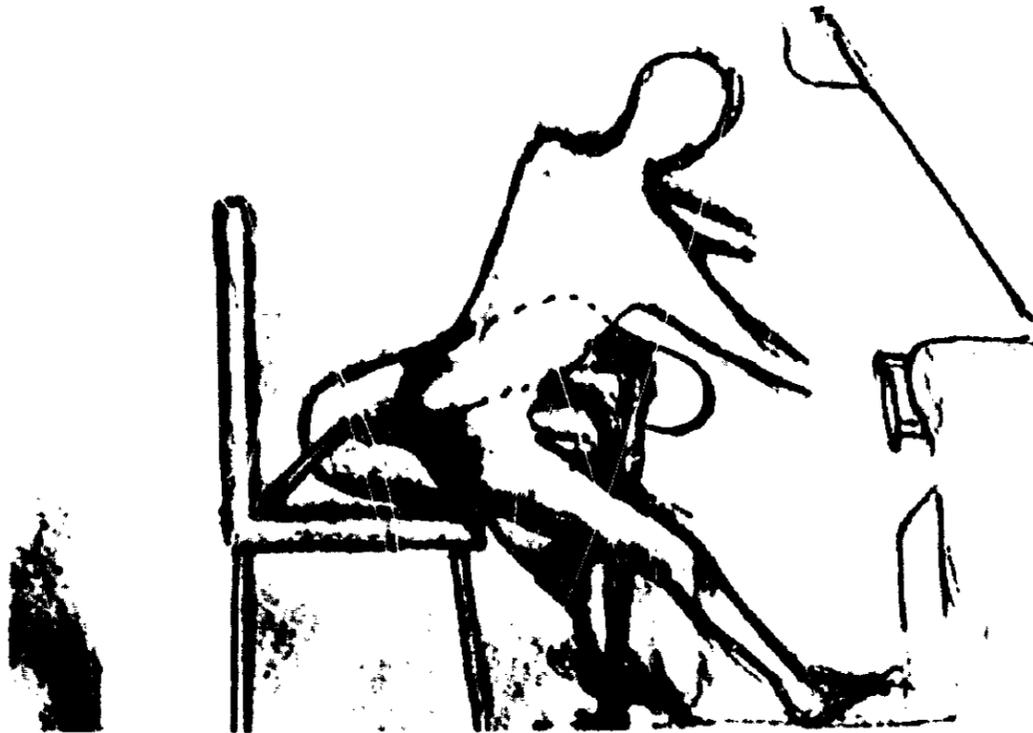
The small school bus had been slowly climbing a hill when it was struck head-on by an out-of-control truck that was overturning at an estimated speed of 40 mph. The bus was struck again on its left side as the truck rotated (fig. 7). During the crash, a 7-year-old in the front seat by the right window jackknifed over his lapbelt and struck the left side of his head and neck on the tubular frame of the modesty panel. He sustained maximum (AIS 6) injuries, including a lacerated larynx, a fractured and dislocated cervical spine, crushed spinal cord, and brain hemorrhage. He died instantly. A 17-year-old boy in the center front seat received critical (AIS 5) injuries, including a head injury and fractured left femur and right tibia. He died several days later. This passenger was found in the stairwell by rescuers; Safety Board investigators determined that he had struck the left side of the restraining barrier while moving forward and to his left, catching his right leg on the abbreviated barrier and pivoting around it. The barrier could not contain him. He then continued forward into the boarding door control, fracturing his left femur, and into the windshield header, where he sustained a fatal head injury (fig. 8).

Figure 8.--Artist's sketch of body movements of the two fatally injured passengers in case 17 at the moment of initial impact.

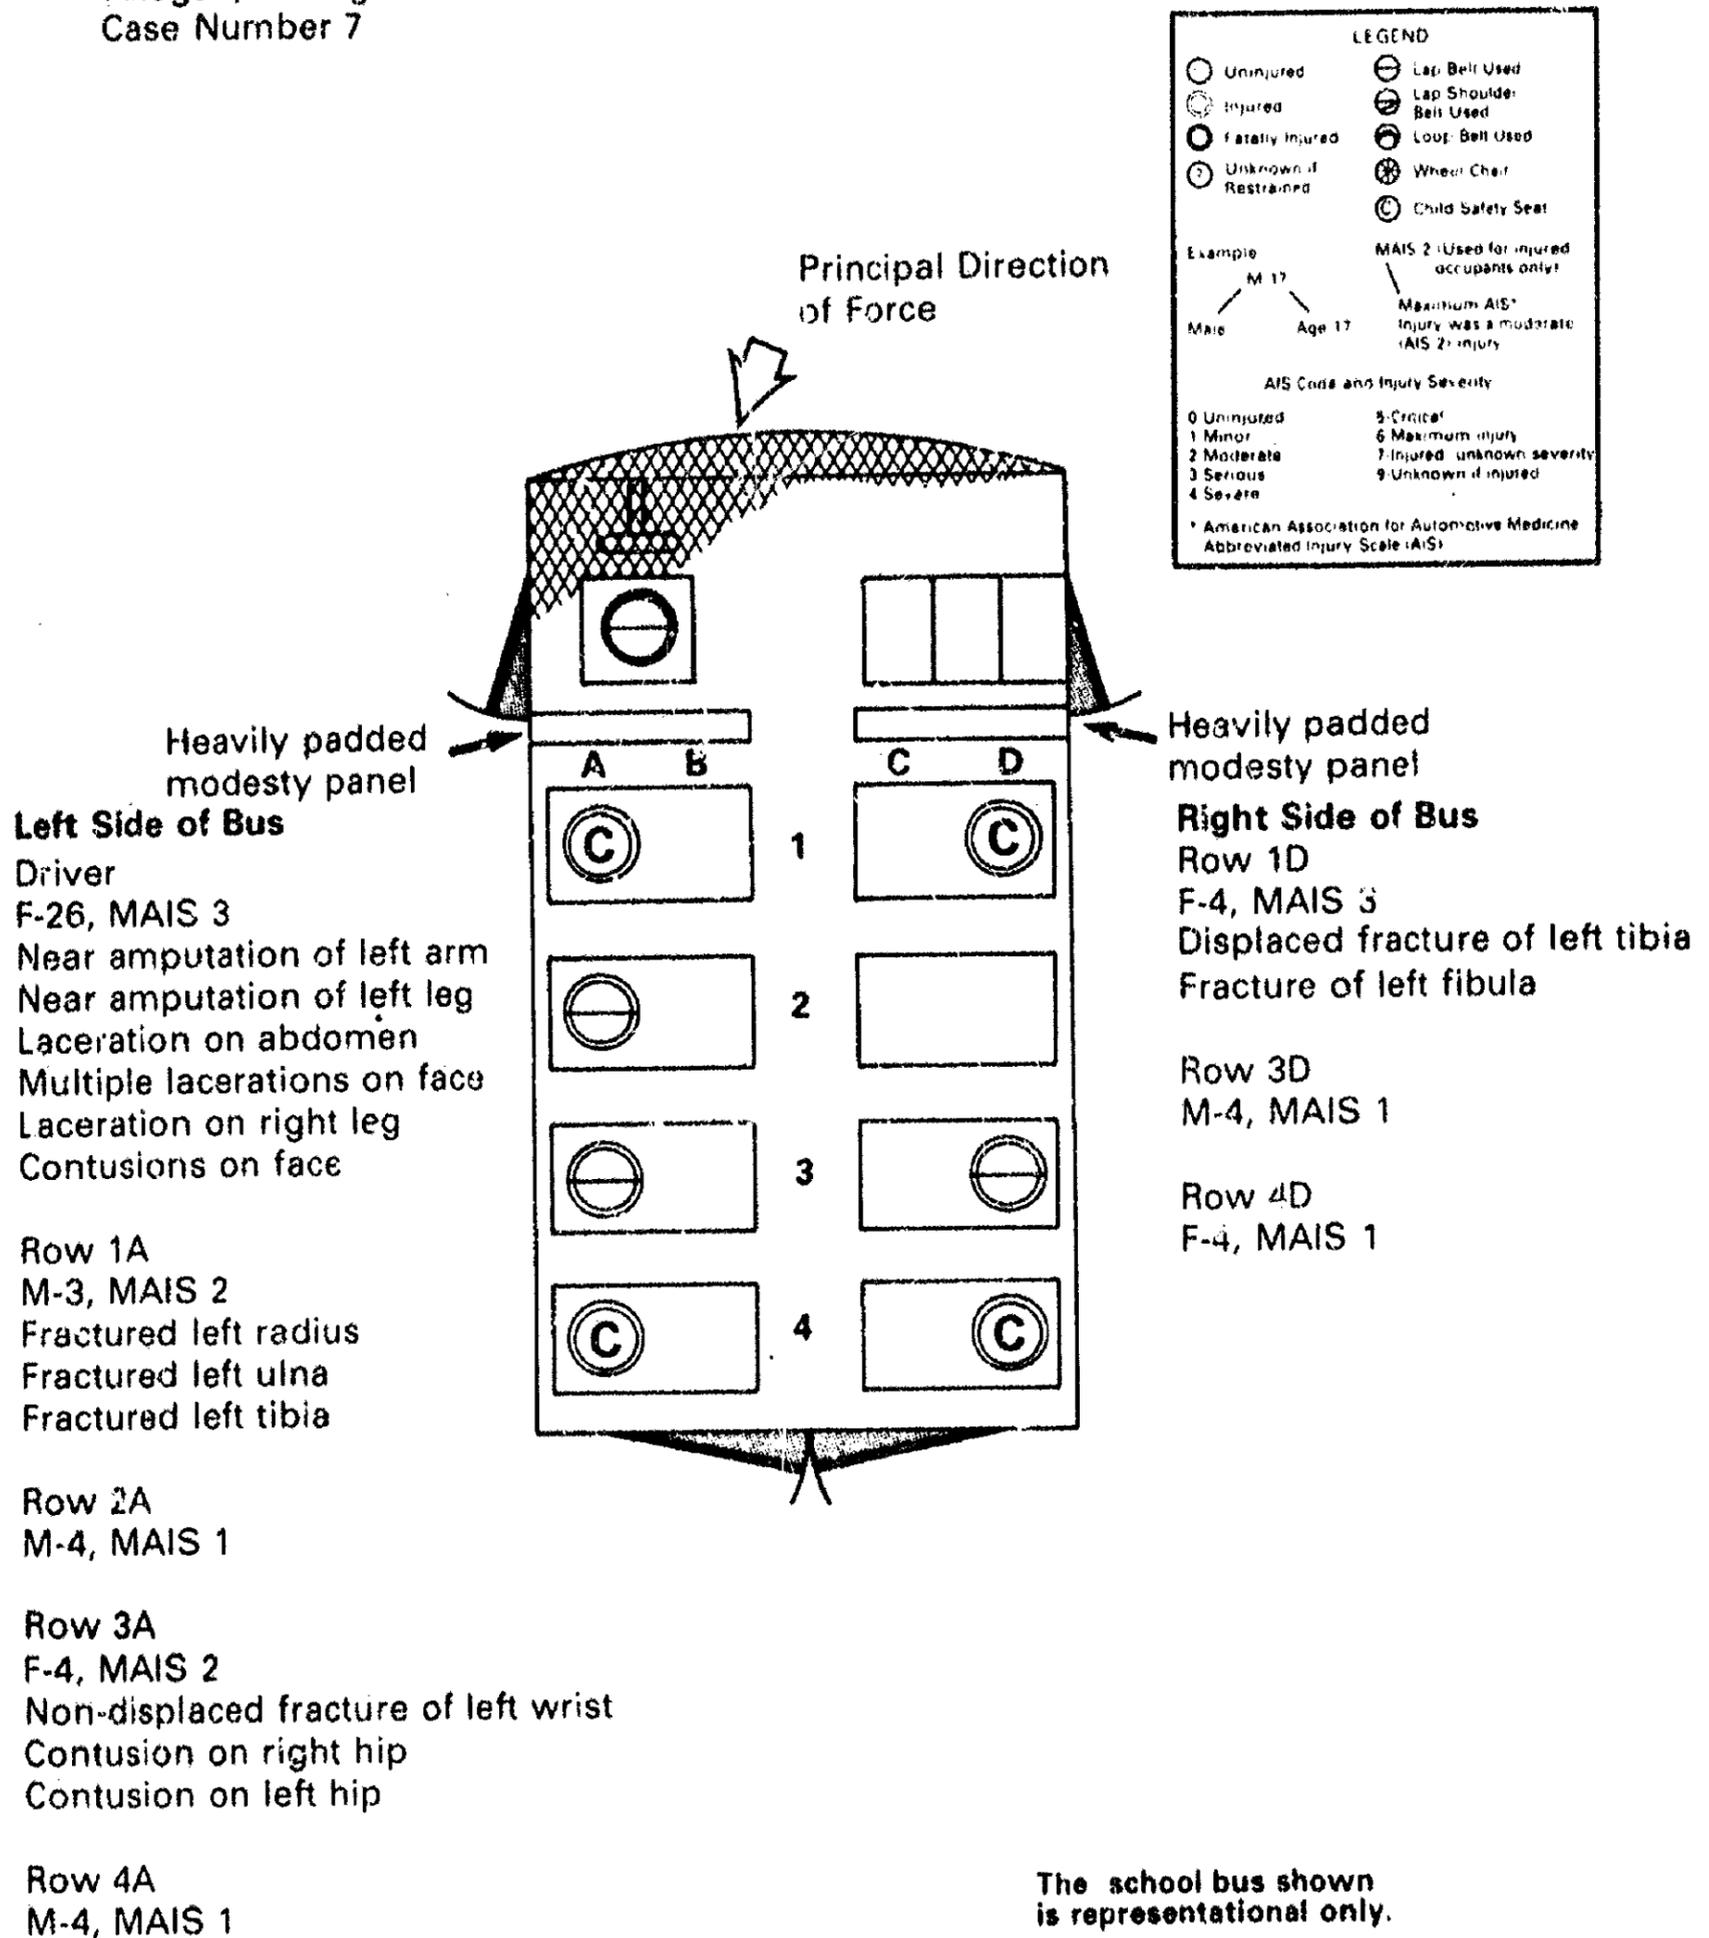
Allegan, Michigan
Case Number 7

This school van was equipped with well-padded restraining barriers forward of both front bench seats.

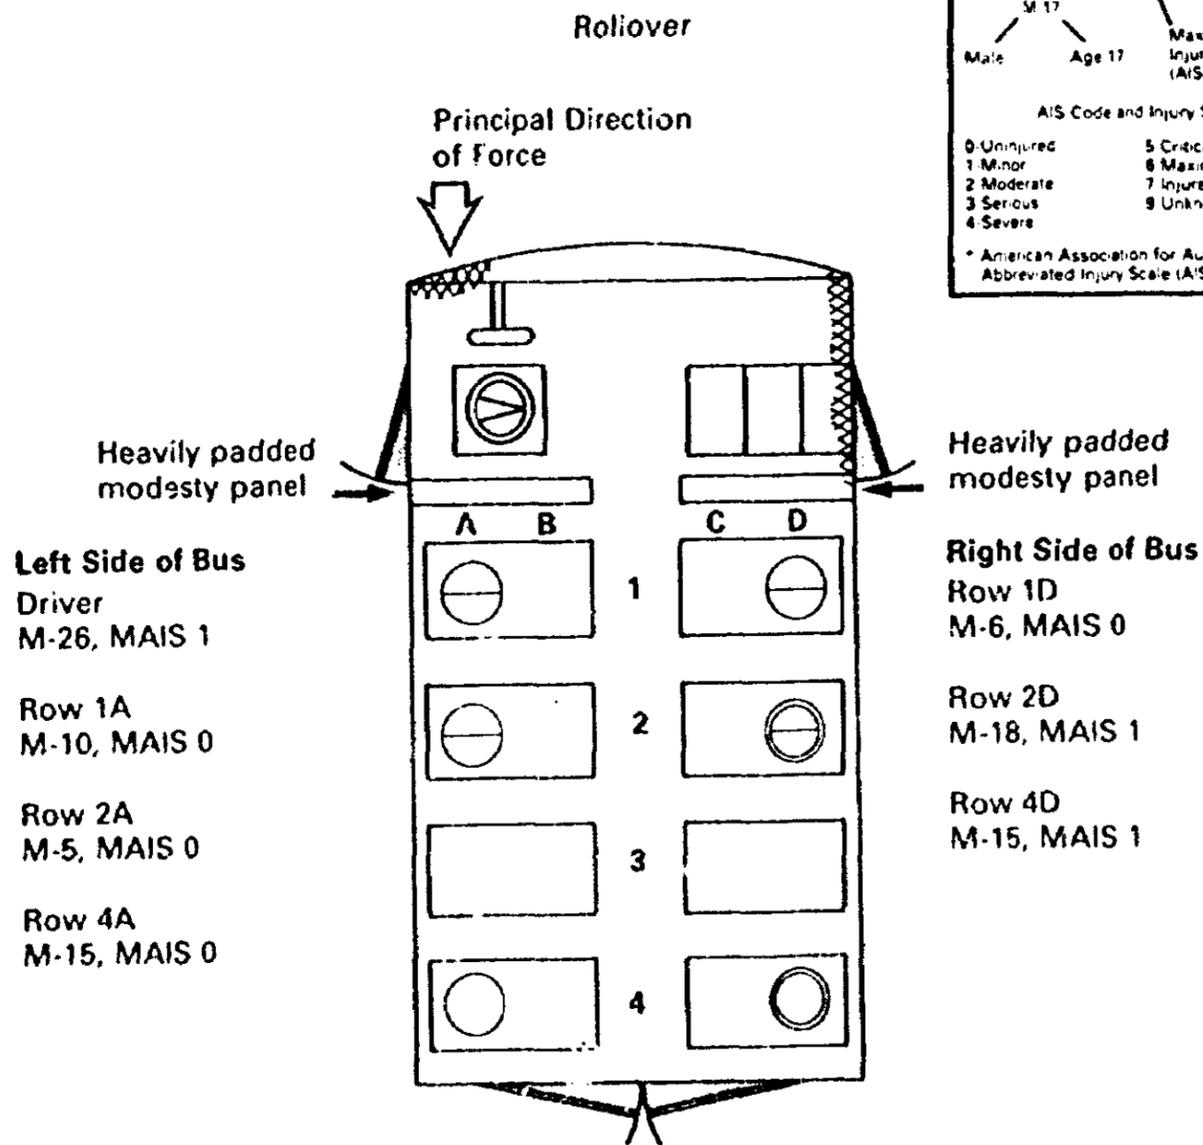
Denville, New Jersey
Case Number 11

It appears that the right side passenger loading door opened during the collision; the door control arm did not have locking mechanism. Although the open door did not result in additional injuries in this accident, it did present a potential hazard by creating an opening through which an occupant could have been ejected. (See case 8, Fort Dodge, Iowa.)

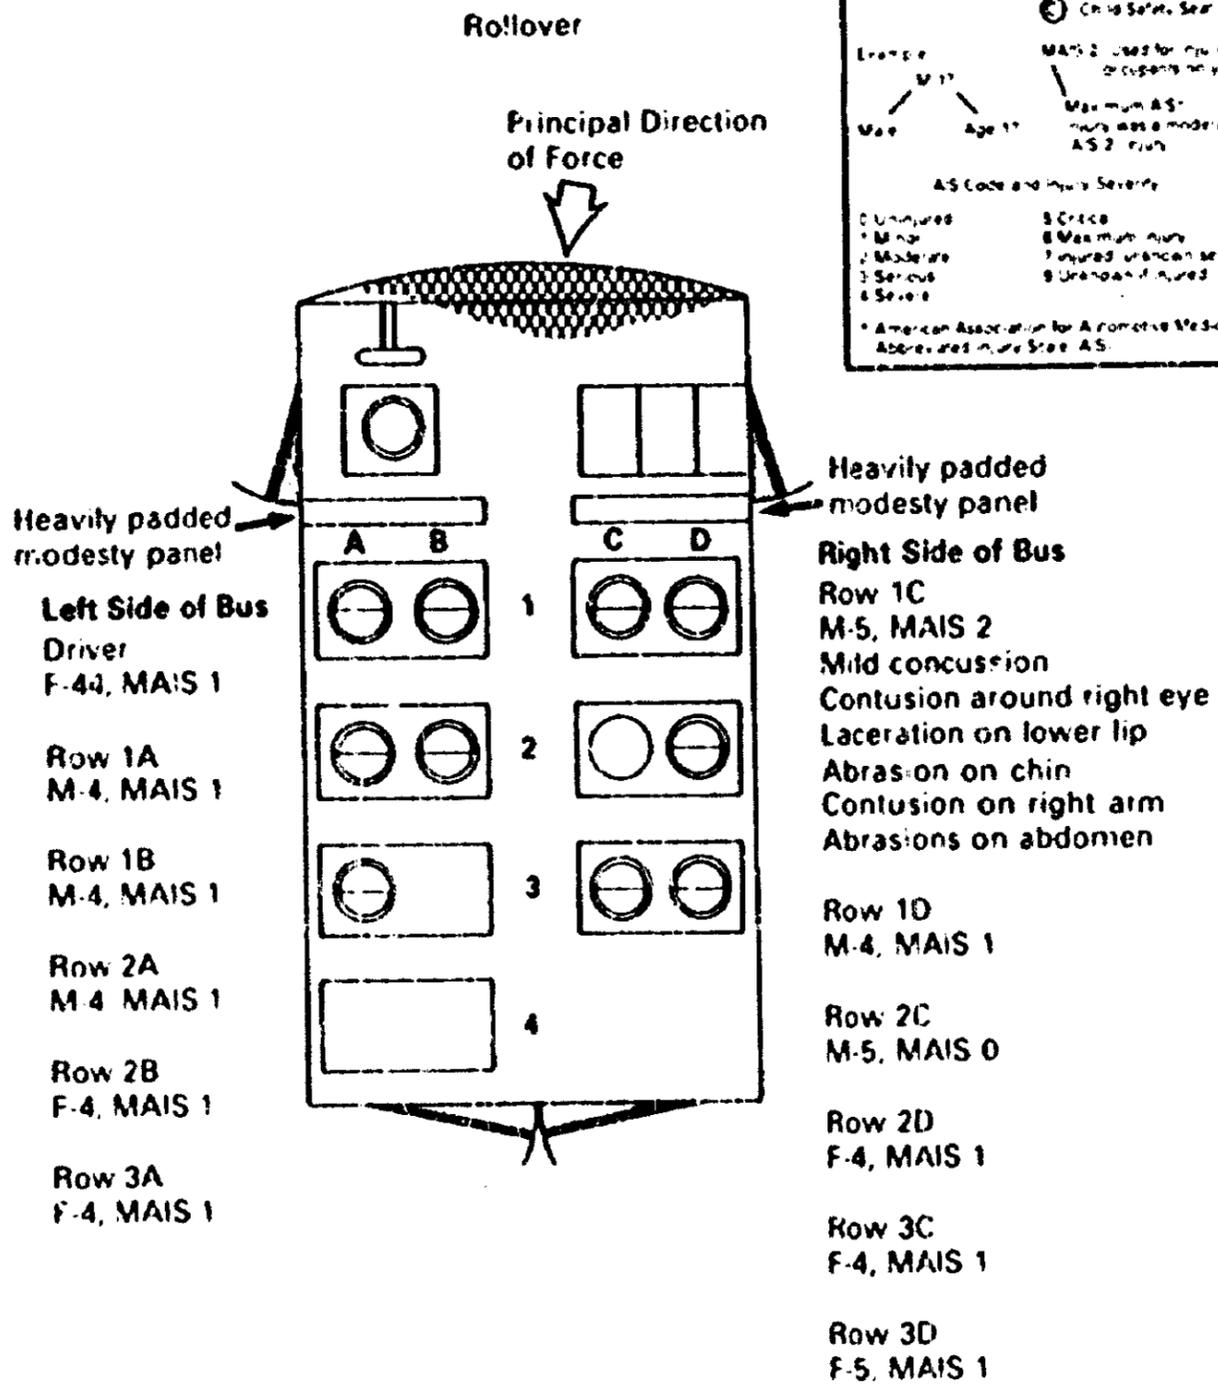
Gresham, Oregon
Case Number 12

The school van was equipped with padded restraining barriers.

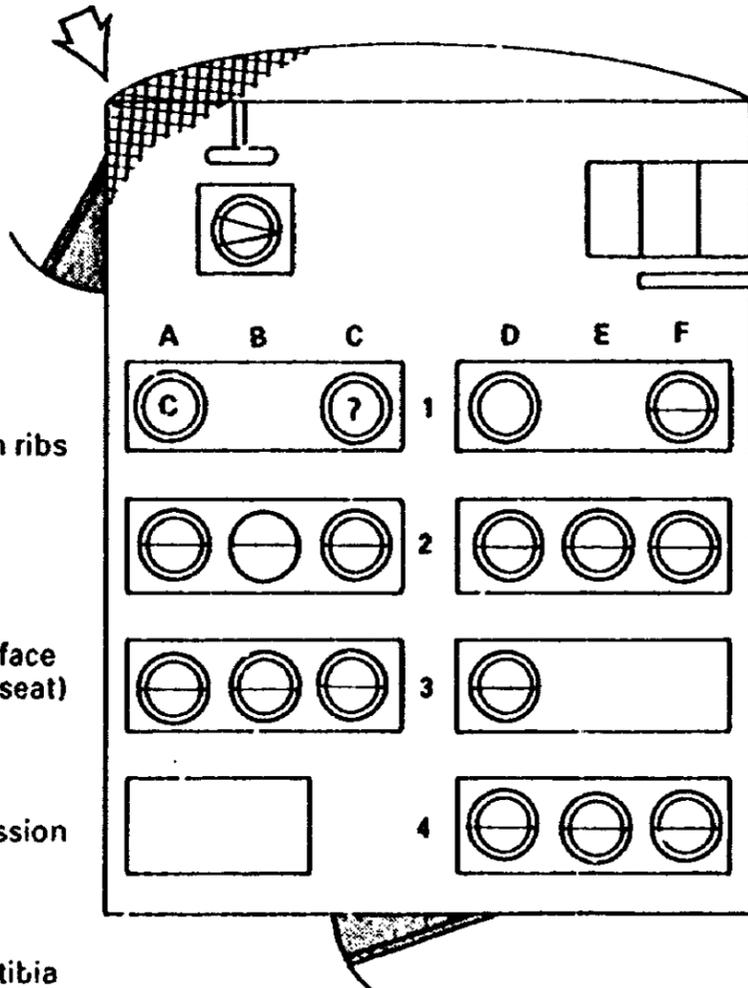
Perrysburg, Ohio
Case Number 15

Left Side of Bus
 Driver
 F-43, MAIS 2
 Fracture, left 7, 8, & 9th ribs
 Maxilla fracture

Row 1A
 F-4, MAIS 3
 Fracture - left femur
 Multiple contusions - face
 (misused child safety seat)

Row 2A
 M-4, MAIS 2
 Fracture - right tibia

Right Side of Bus
 Row 1D
 F-35, MAIS 3
 Fractured pelvis
 Large laceration above left eye
 Laceration above right eye
 Multiple contusions

Special Notes:
 All lapbelts worn, except the one worn by the passenger in 3C, were so loosely adjusted relative to the occupant's size that they provided little restraint.

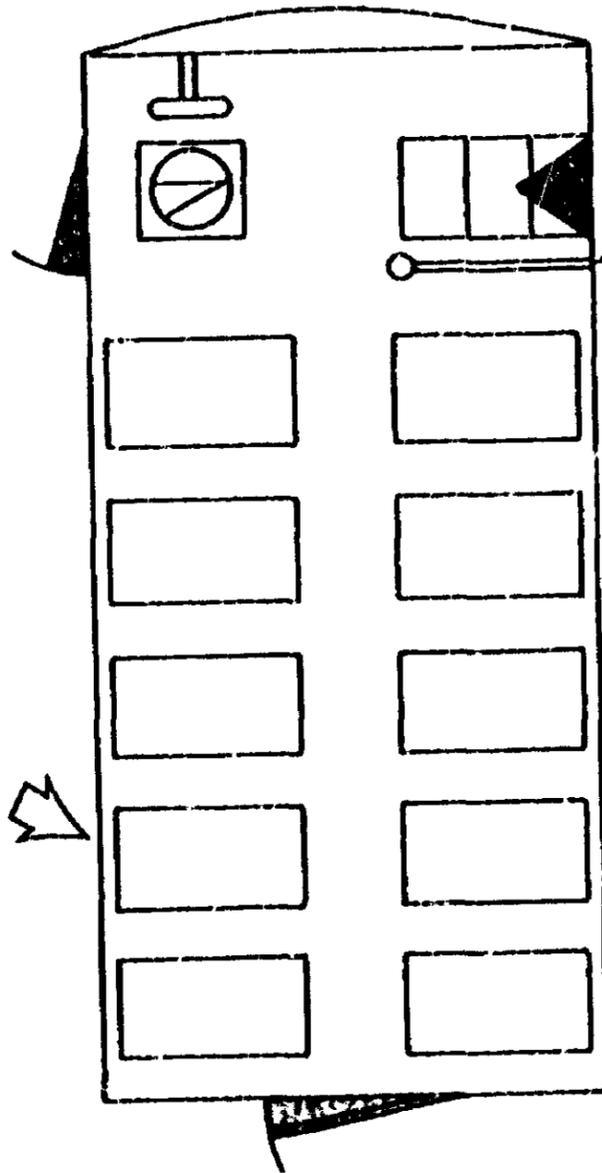
Modesty panel with lightly padded aisle stanchion and cross support; panel was bare metal.

All passengers were wearing lap belts; seating positions unknown. Injury status could be confirmed for only one passenger.

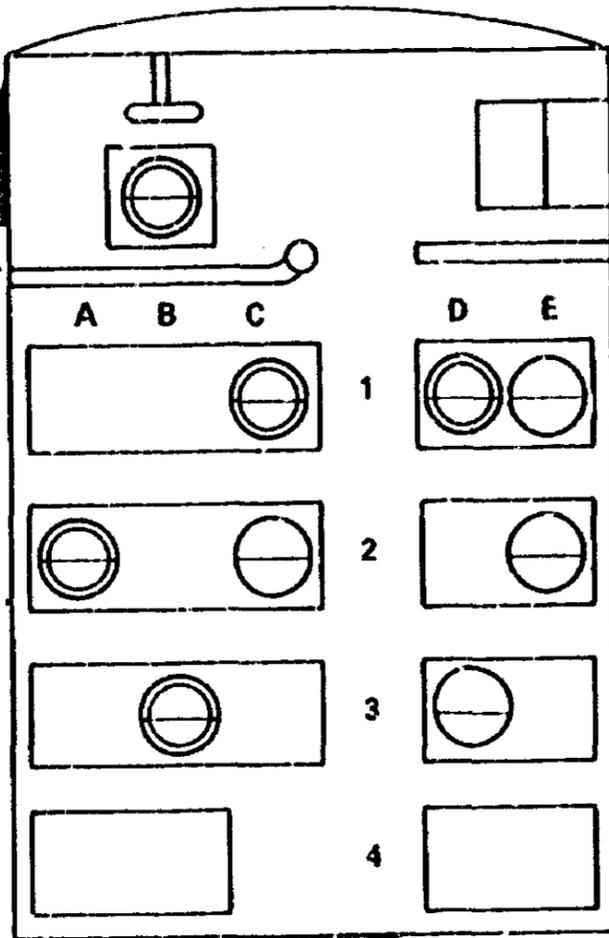
Driver
F-22, MAIS 2
Large facial contusion
Large contusion on abdomen
Contusion on left shoulder
Contusion on left elbow
Abrasion on right lower arm

Row 1D
F-3, MAIS 1

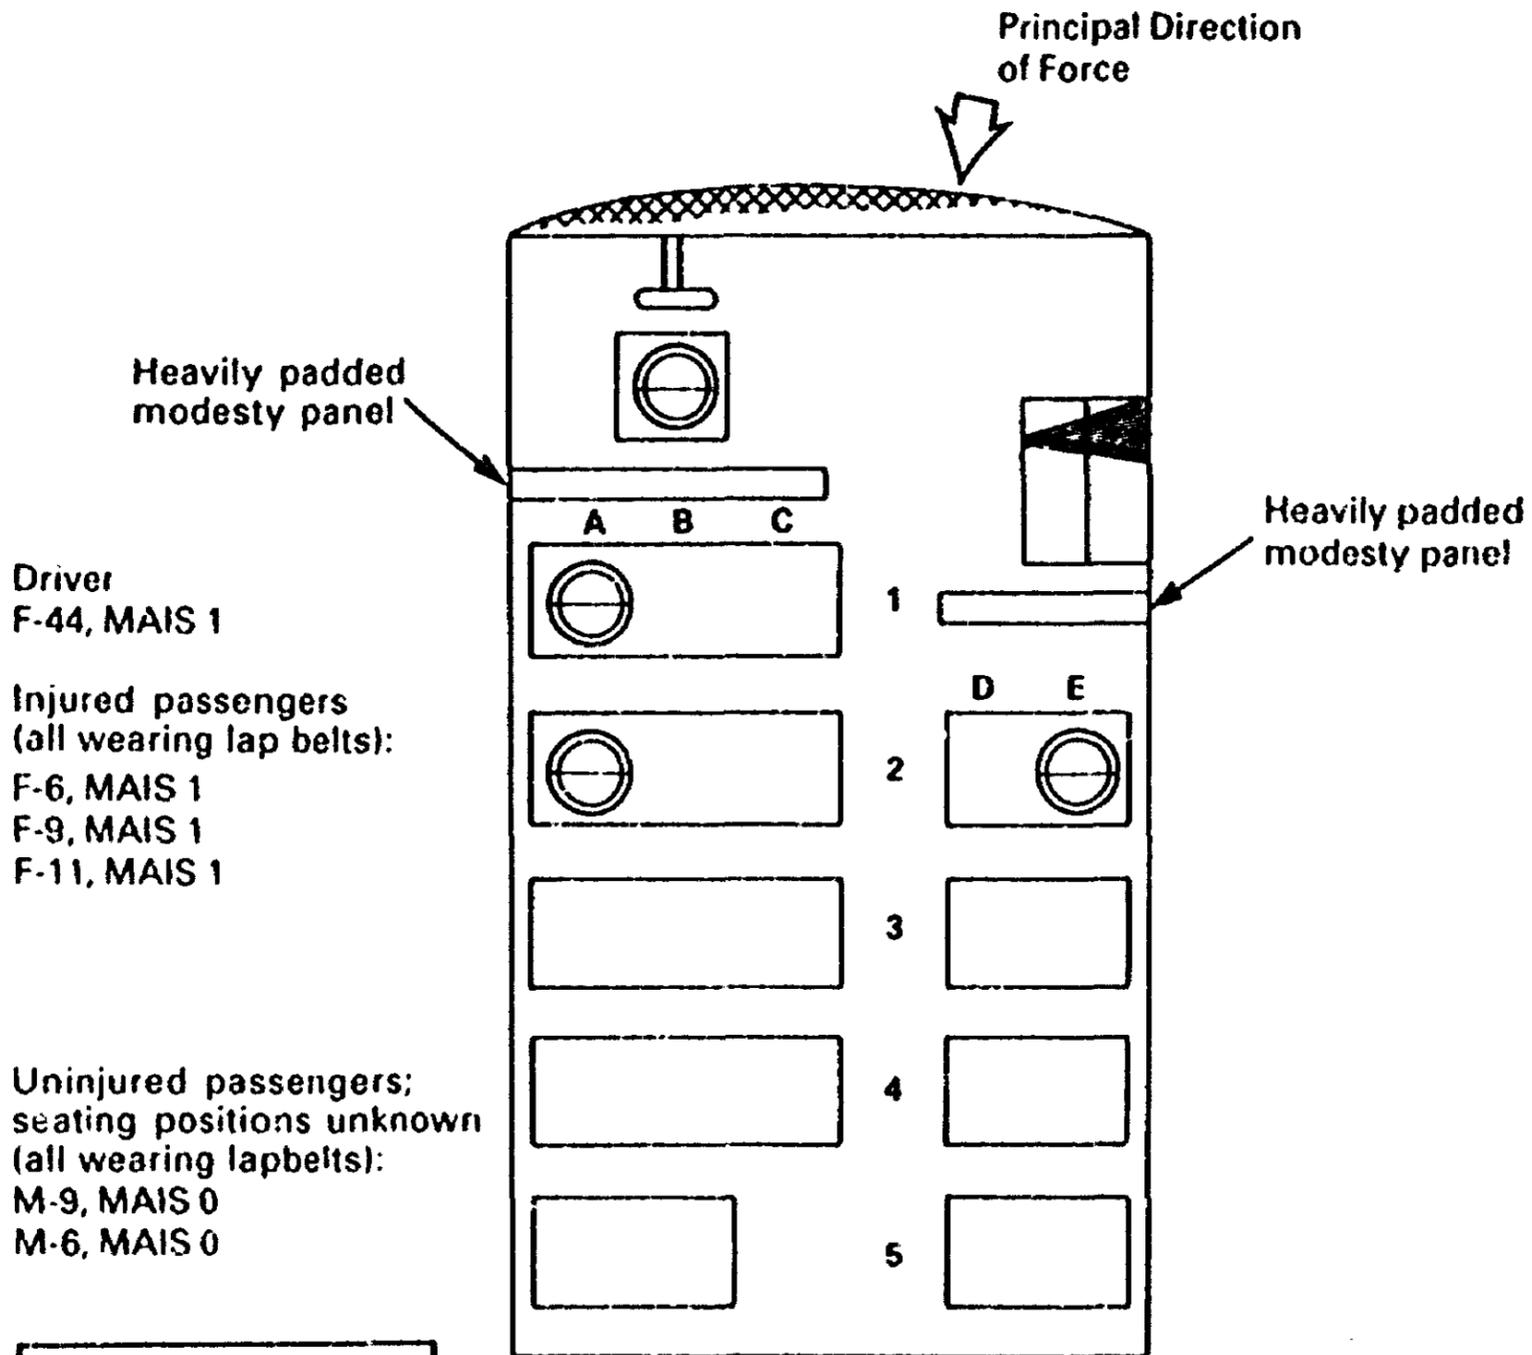
Clarkston, Georgia
Case Number 20

Driver
F-44, MAIS 1

Injured passengers
(all wearing lap belts):
F-6, MAIS 1
F-9, MAIS 1
F-11, MAIS 1

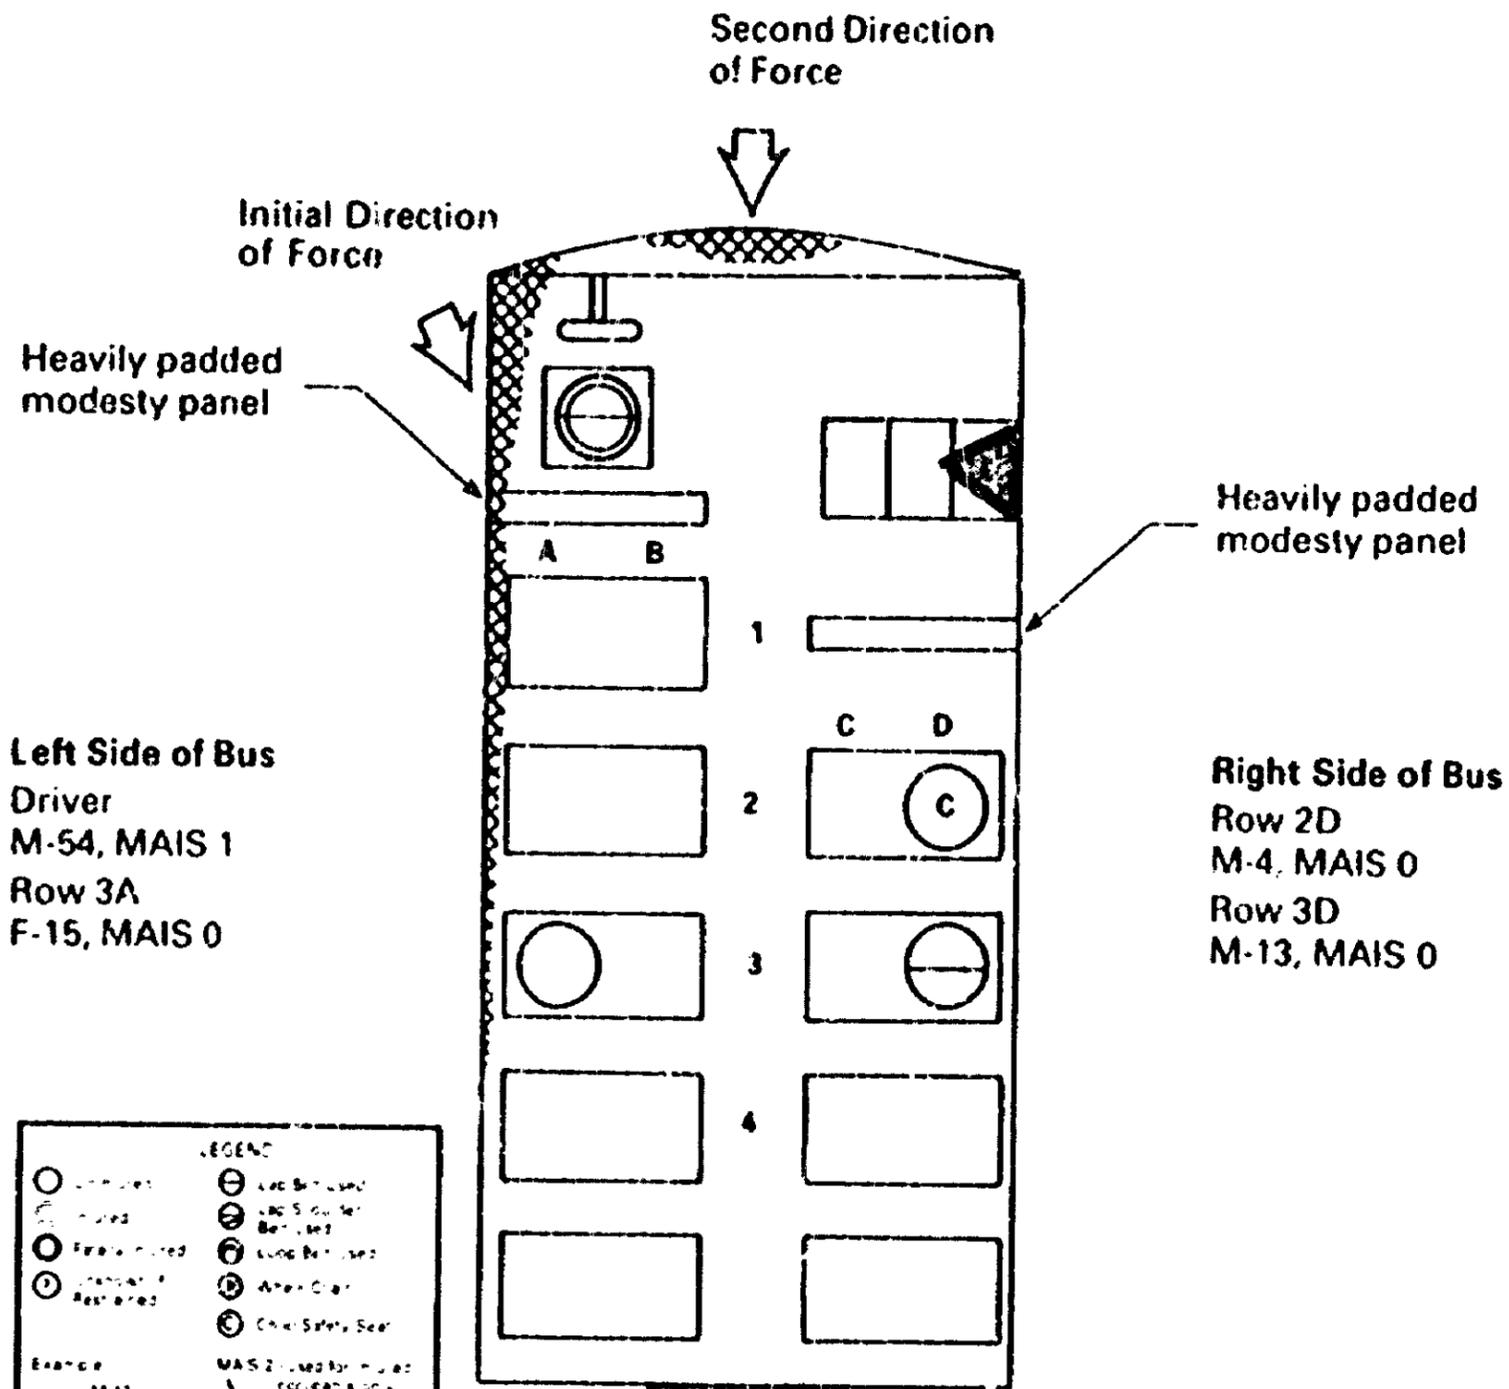
Williston, Vermont
Case Number 21

Left Side of Bus
Driver
M-54, MAIS 1
Row 3A
F-15, MAIS 0

Right Side of Bus
Row 2D
M-4, MAIS 0
Row 3D
M-13, MAIS 0

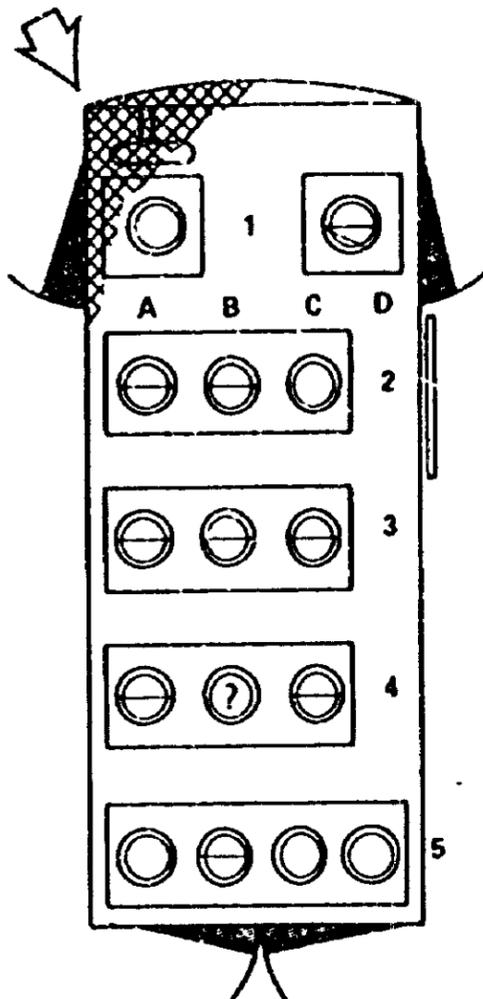
Driver
M-68, MAIS 2
Fracture of left knee
Fracture of five adjacent ribs on left.
Kidney injury, unknown severity
First degree burns on both hands, left forearm, lower back, and left thigh

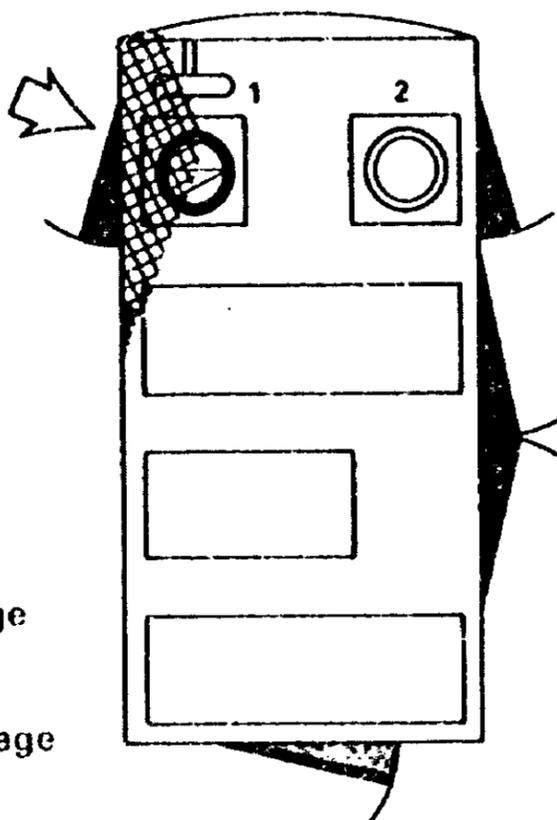
Bedford, New Hampshire
Case Number 27

Driver
F-40, MAIS 4
Subdural hematoma
(right cerebral)
Laceration of liver
Laceration of left kidney
Subarachnoid hemorrhage
Laceration of spleen
Collapsed left lung
Retroneritoneal hemorrhage
Fracture of right femur
Skull hairline fracture
(left temporal)
Skull hairline fracture
(right temporal)
Fractured pelvis (left ischium)
Fractured pubis
Fractured left 7th and 8th ribs
Fractured left tibia

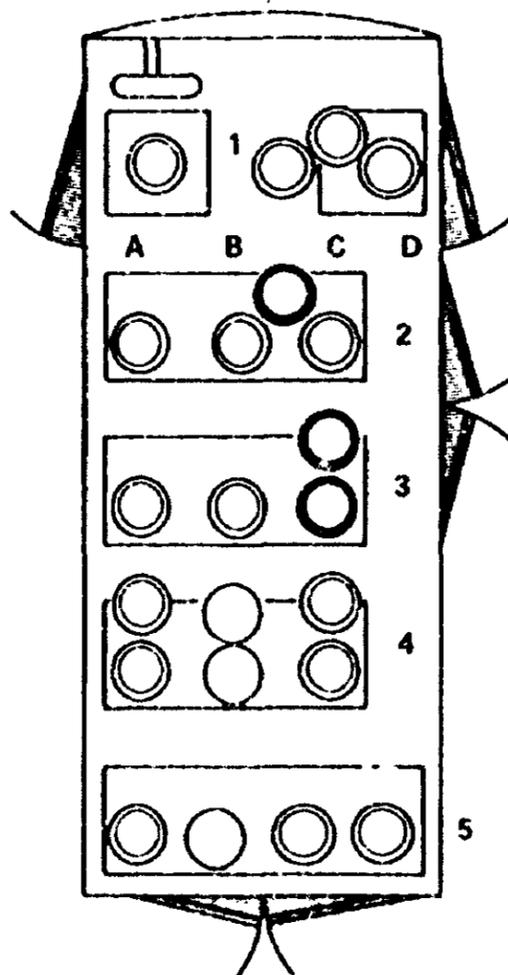
Driver
M-20, MAIS 7
Row 1B
F-16, MAIS 1
Row 1C
F-9, MAIS 1
Row 1D
F-21, MAIS 1
Row 2A
M-18, MAIS 1
Row 2B
F-21, MAIS 1
Row 2C
M-32, MAIS 1
Row 2 B C
F-29, MAIS 7
Specific injuries unknown
Row 3A
M-8, MAIS = 3
Specific injuries unknown
Row 3B
F-11, MAIS = 3
Specific injuries unknown
Row 3C
F-40, MAIS 7
