National Transportation Safety Board Safety Study  
Locomotive Fuel Tank Integrity

### **LOCOMOTIVE FUEL TANK INTEGRITY**

Safety Study NTSB/SS-92/04  
Notation 5884

Washington, D.C.  
October 1992

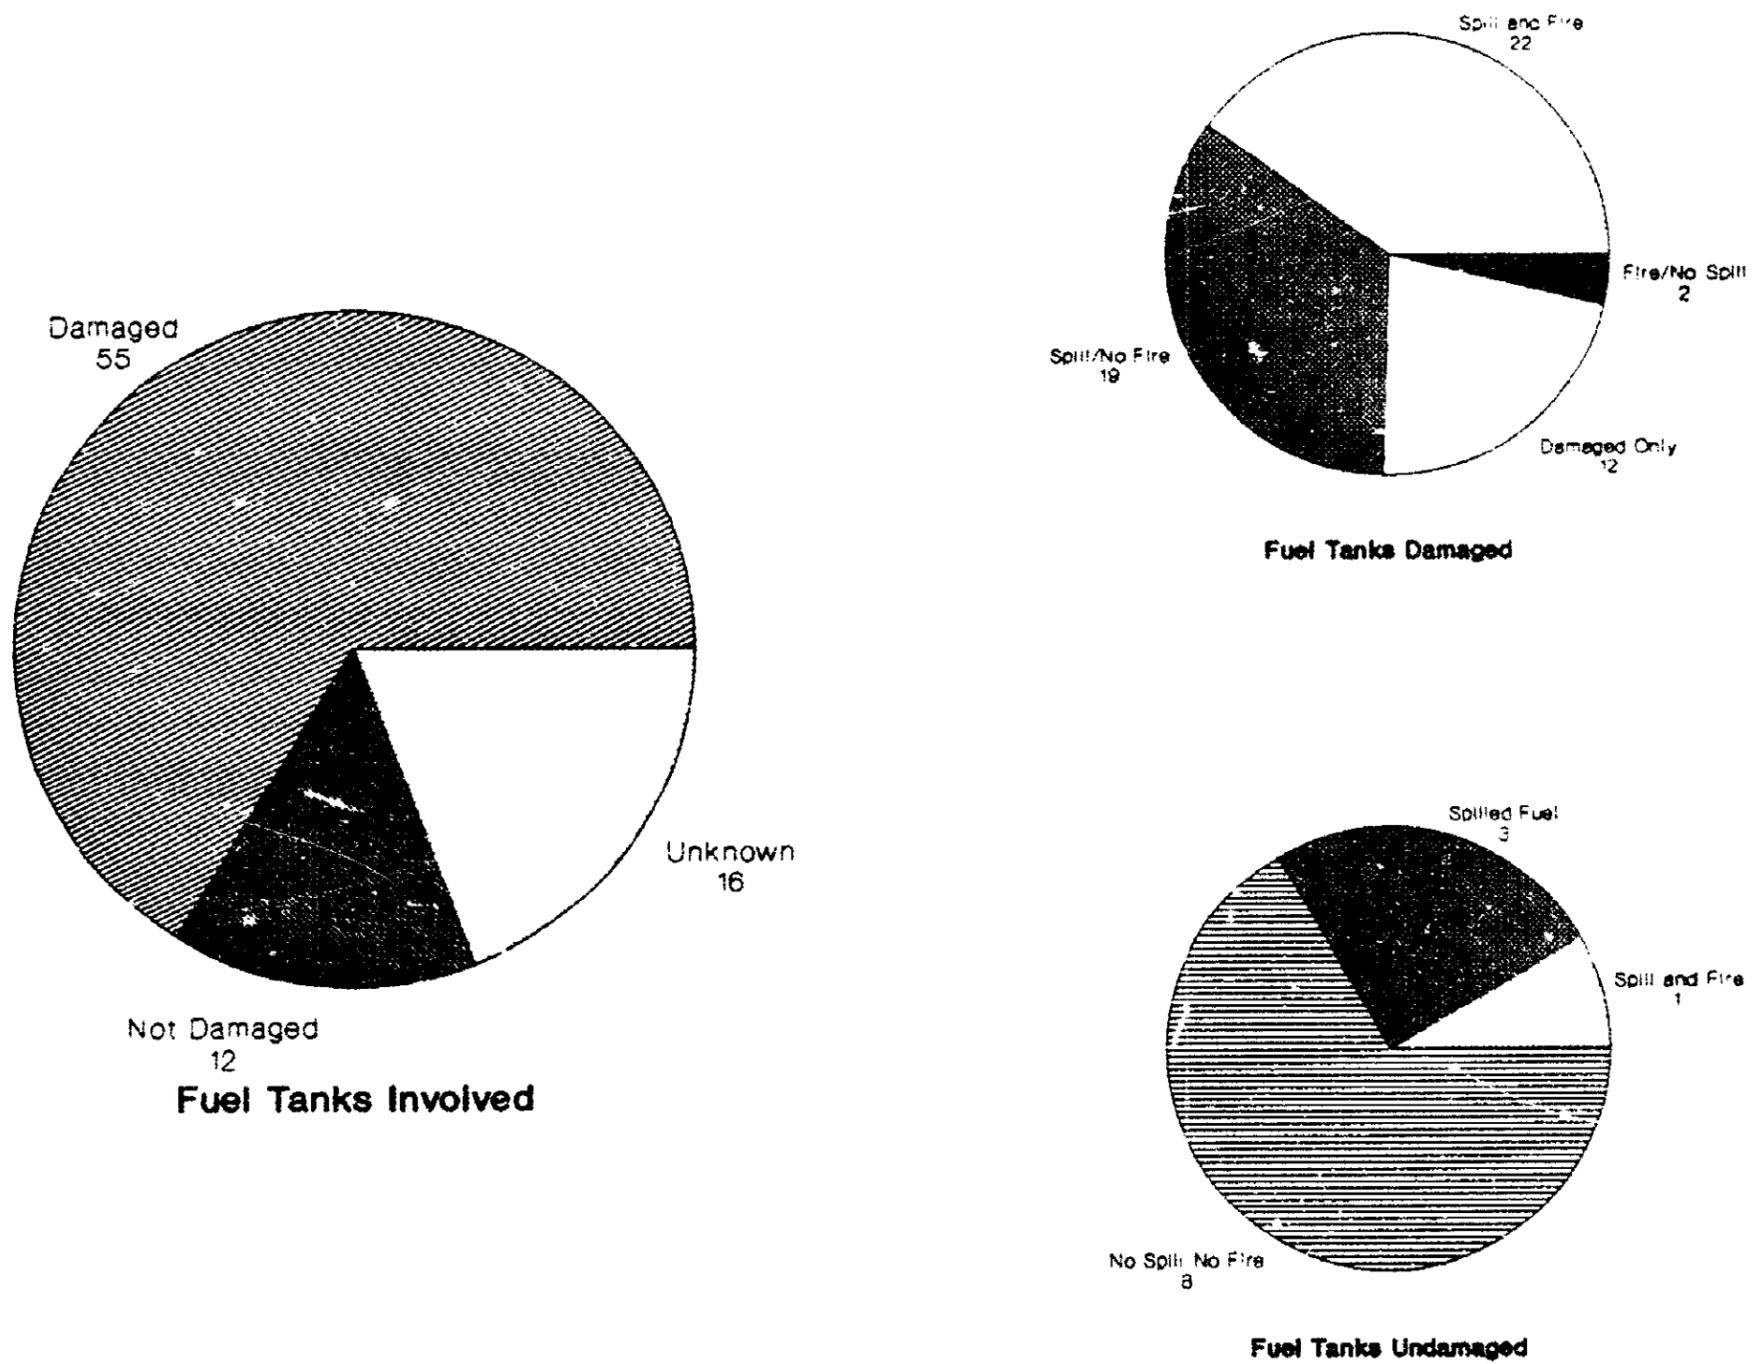
The Safety Board examined various factors with respect to the derailed locomotives, including tank damage, fuel spillage, and fire. Of the 83 locomotive units that derailed, the fuel tanks on 55 of these locomotives (66 percent) sustained various degrees of damage.<sup>11</sup> (The fuel tank on only 1 of the 23 locomotive units that did not derail was also documented as damaged.) The fuel tanks on 12 of the 83 locomotive units that derailed were known not to have sustained damage. The condition of the fuel tanks on the remaining 16 locomotives that derailed was not known. (See figure 5.) Again, in some instances, the locomotive was removed from the scene

Figure 5.—Status of fuel tank damage on the 83 locomotives that derailed.

before Safety Board investigators arrived. In other instances, the fuel tank was either partially or deeply buried, and, consequently, the condition of the fuel tank could not be ascertained. In most instances, however, if fuel was not spilled and fire was not involved, the condition of the tank was not documented. Based on the assumption that none of the tanks on the undocumented locomotives was breached, it can be conservatively concluded that at least two-thirds of the fuel tanks on the locomotives that derailed were damaged.

Of the 83 locomotives that derailed, fuel was documented as having spilled from 47 tanks (56 percent). (Fuel also spilled from one locomotive that did not derail.)<sup>12</sup> Of the 55 damaged tanks, 41 (76 percent) spilled fuel (fig. 5). (Fuel spilled from four tanks that were not damaged and from two tanks, the damage of which was not known. (See table 3 in appendix B.)

Of the 83 locomotives that derailed, 23 units (28 percent) caught fire from the ignition of spilled diesel fuel from their tanks. (See figure 5.) Two additional locomotive units were documented as having caught fire, but fuel spillage was unknown. (In these two instances, the locomotive units were believed to have caught fire as a result of leaking fuel from the tanks of adjacent locomotive units that ignited.)

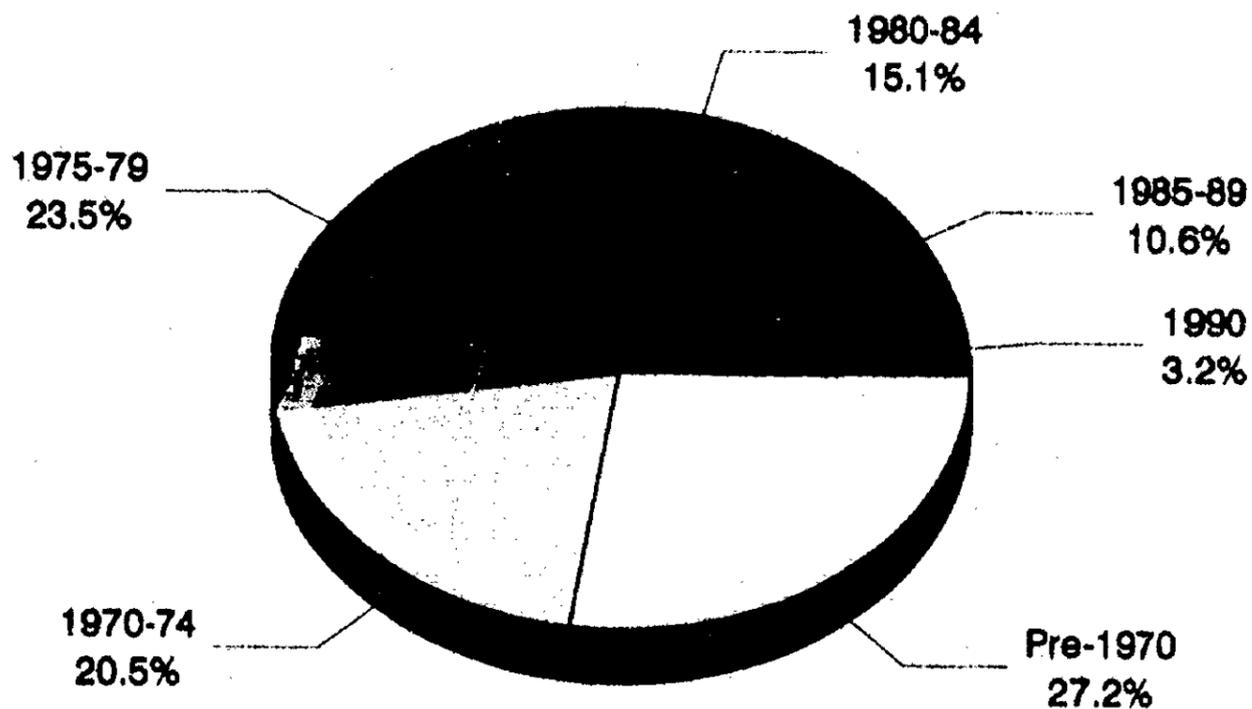
The Safety Board received information from the Association of American Railroads (AAR) regarding the Nation's locomotive fleet size. Figure 16 illustrates the number of locomotives in service and the age distribution of the locomotive fleet, as of December 31, 1990.

Figure 16.—Age distribution of U.S. locomotive fleet, as of December 31, 1990. (Source: Association of American Railroads.)

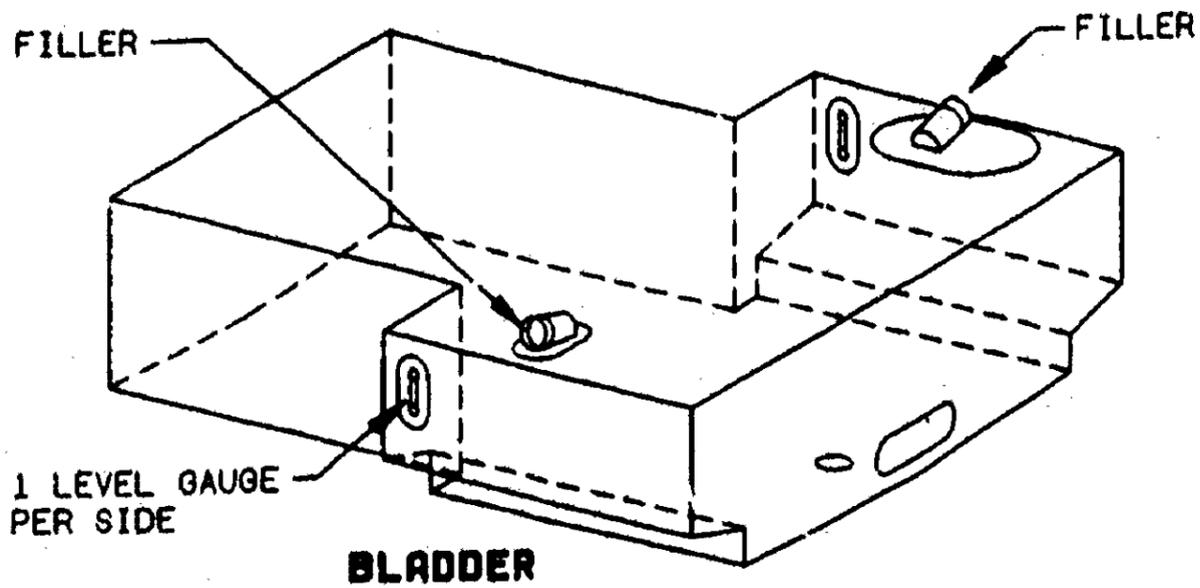
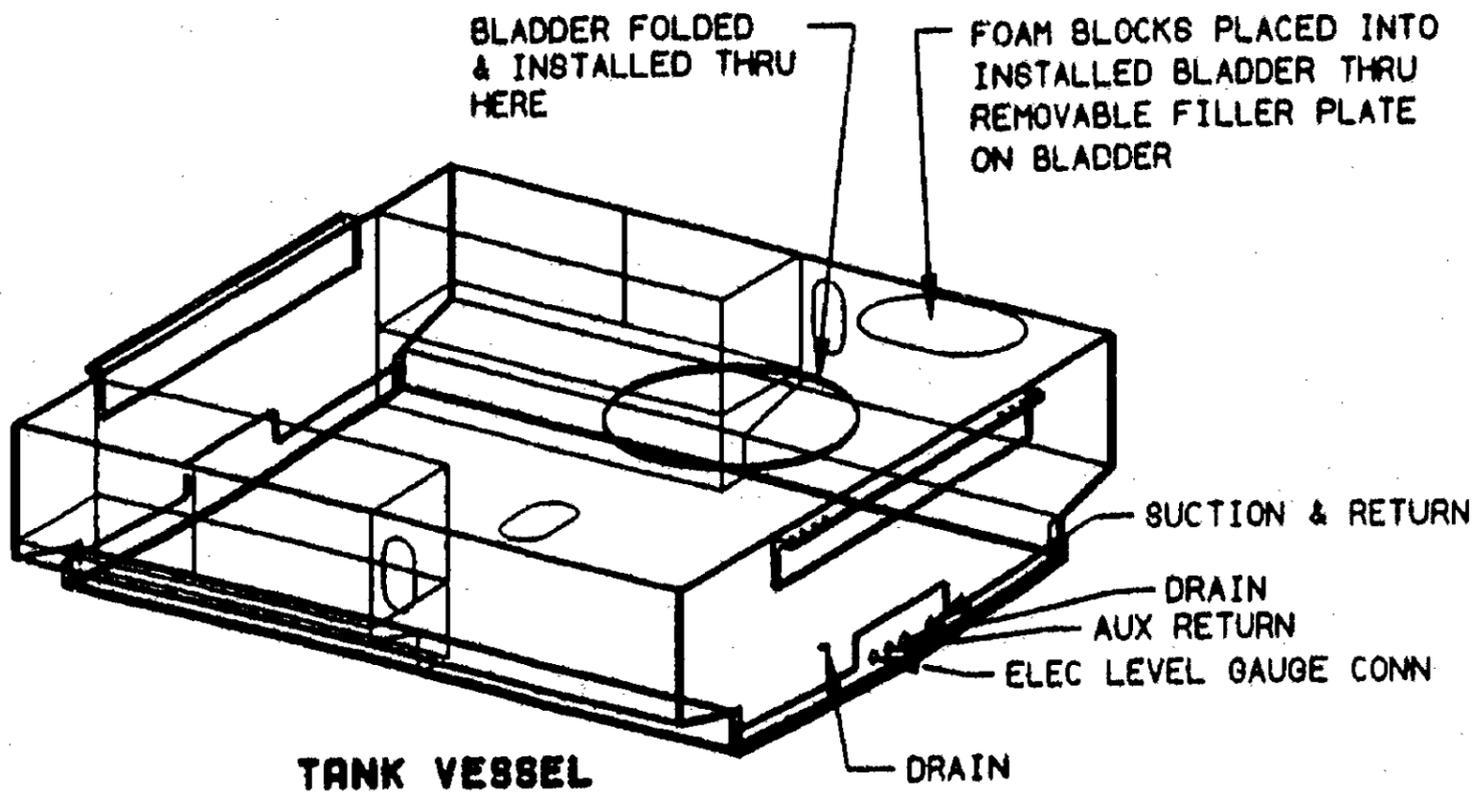
of the LIRR, fuel tank technology, as applied to military aircraft and race cars, was reviewed and was the basis for the specifications used to build the locomotive fuel tanks. According to the LIRR, features of the spill resistant fuel tank that distinguish it from a conventional locomotive tank are: (1) a structural steel outer tank with greater strength than the conventional tank, (2) a composite carbon fibre (kevlar) bladder of the same shape as the steel tank and inserted inside the steel tank, and (3) a set of open-celled foam blocks inserted inside the bladder; the foam blocks completely fill the inside space to prevent fuel sloshing and to reduce the rate of fuel leakage. (See figure 19.) The LIRR provided the following information with respect to the three features described above:

The bladder installed in the spill resistant tank has high tear and puncture resistance. Therefore, in addition to providing a secondary container for the fuel, it provides a second line of defense against puncture and resultant leaking should the steel tank be penetrated.

The foam inserts inside the spill resistant tank provide slosh resistance for the fuel. The foam will reduce the fuel leak rate over that resultant from a puncture in a conventional steel tank. The foam also reduces the risk of explosion associated with pockets of vaporized fuel.

Figure 19.—Schematic of the Long Island Rail Road "spill resistant locomotive tank." (Courtesy: The Long Island Rail Road.)
