Safer Seas 2014

LESSONS LEARNED FROM MARINE
ACCIDENT INVESTIGATIONS

Office of Marine Safety Investigations

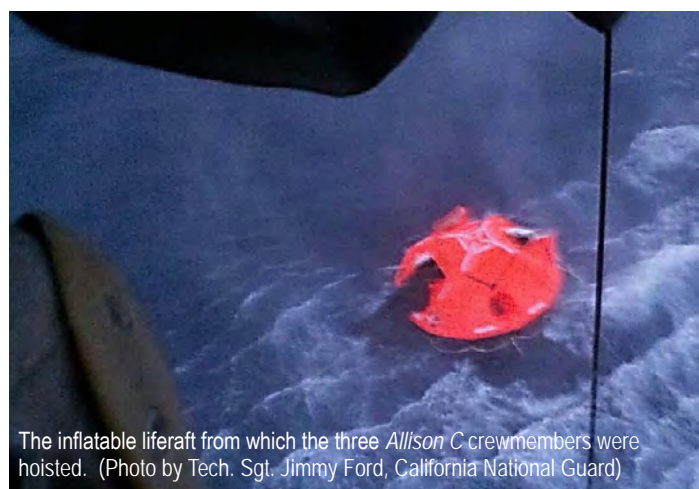
The inflatable liferaft from which the three *Allison C* crewmembers were hoisted. (Photo by Tech. Sgt. Jimmy Ford, California National Guard)

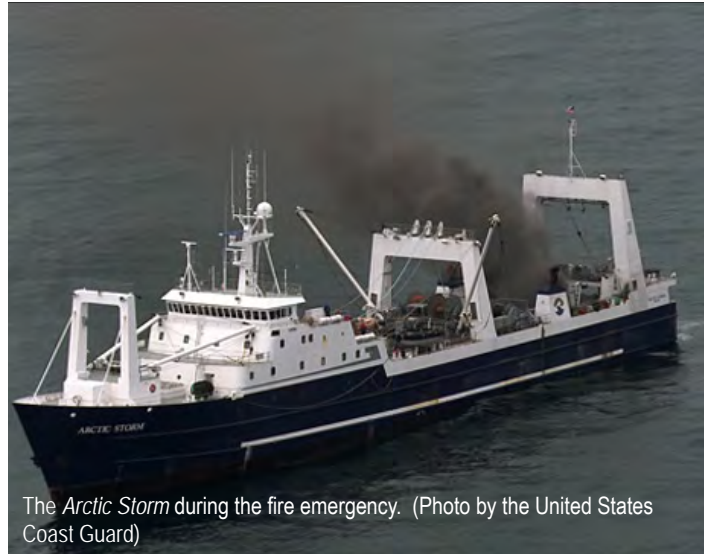
The *Arctic Storm* during the fire emergency. (Photo by the United States Coast Guard)

The National Transportation Safety Board determines that the probable cause of the fire on board fishing vessel *Arctic Storm* was a fractured fitting on a fuel oil vent valve, located on the main propulsion engine, which resulted in fuel oil spraying onto a hot engine surface and igniting.

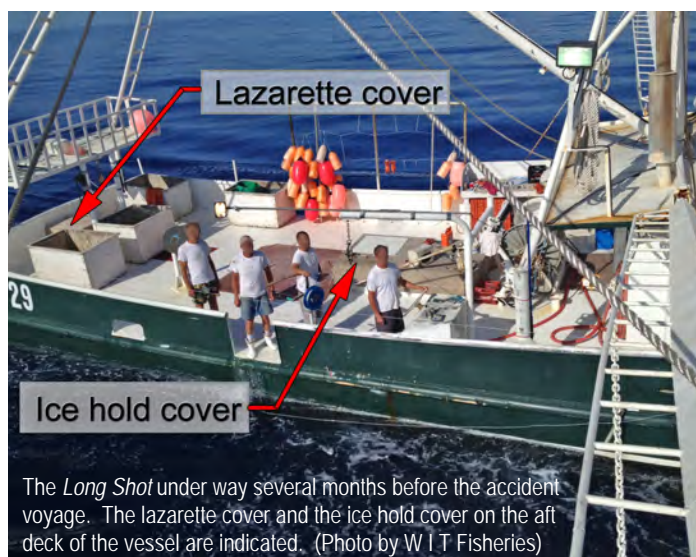
As the *Long Shot* was on its return voyage on the 9th day of the trip, a leak was discovered in the lazarette compartment, the aftmost compartment in the boat, which contained steering gear and the rudder post. This post was attached to the rudder at its lower end and penetrated the hull through a packing gland at its upper end. The leak increased in severity, and on the morning of November 14, about 2 feet of water had accumulated in the lazarette. The crew was continuously pumping water out of the lazarette as the *Long Shot* continued toward port.

The *Long Shot* under way several months before the accident voyage. The lazarette cover and the ice hold cover on the aft deck of the vessel are indicated. (Photo by W I T Fisheries)

The National Transportation Safety Board determines that the probable cause of the sinking of fishing vessel *Long Shot* was water contamination of its fuel oil storage tanks, which led to failure of the propulsion and electrical generator engines and flooding of the lazarette compartment in heavy seas. Contributing to the sinking was excessive water leakage at the rudder post packing gland, which led to the initial flooding of the lazarette compartment.

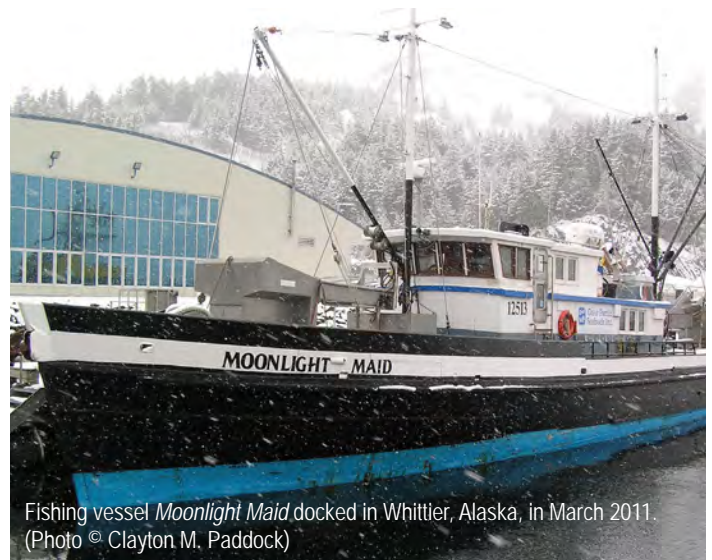
Fishing vessel *Moonlight Maid* docked in Whittier, Alaska, in March 2011.
(Photo © Clayton M. Paddock)

The National Transportation Safety Board determines that the probable cause of the foundering of the wooden-hulled fishing vessel *Moonlight Maid* was the detachment of portside hull planking in heavy weather, which resulted in uncontrolled flooding. Contributing to the hull failure was inadequate maintenance of the aging wooden vessel.

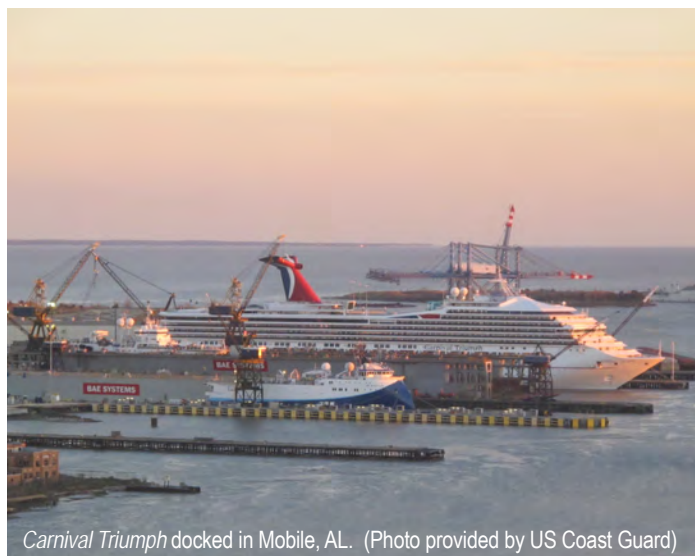
Carnival Triumph docked in Mobile, AL. (Photo provided by US Coast Guard)

The National Transportation Safety Board determines that the probable cause of the breakaway of the *Carnival Triumph* from its moorings and the subsequent collision with the dredge *Wheeler* and the towing vessel *Noon Wednesday* was the successive failure of multiple mooring bollards, which were known by BAE Systems to be in poor condition with an undetermined mooring load capability.

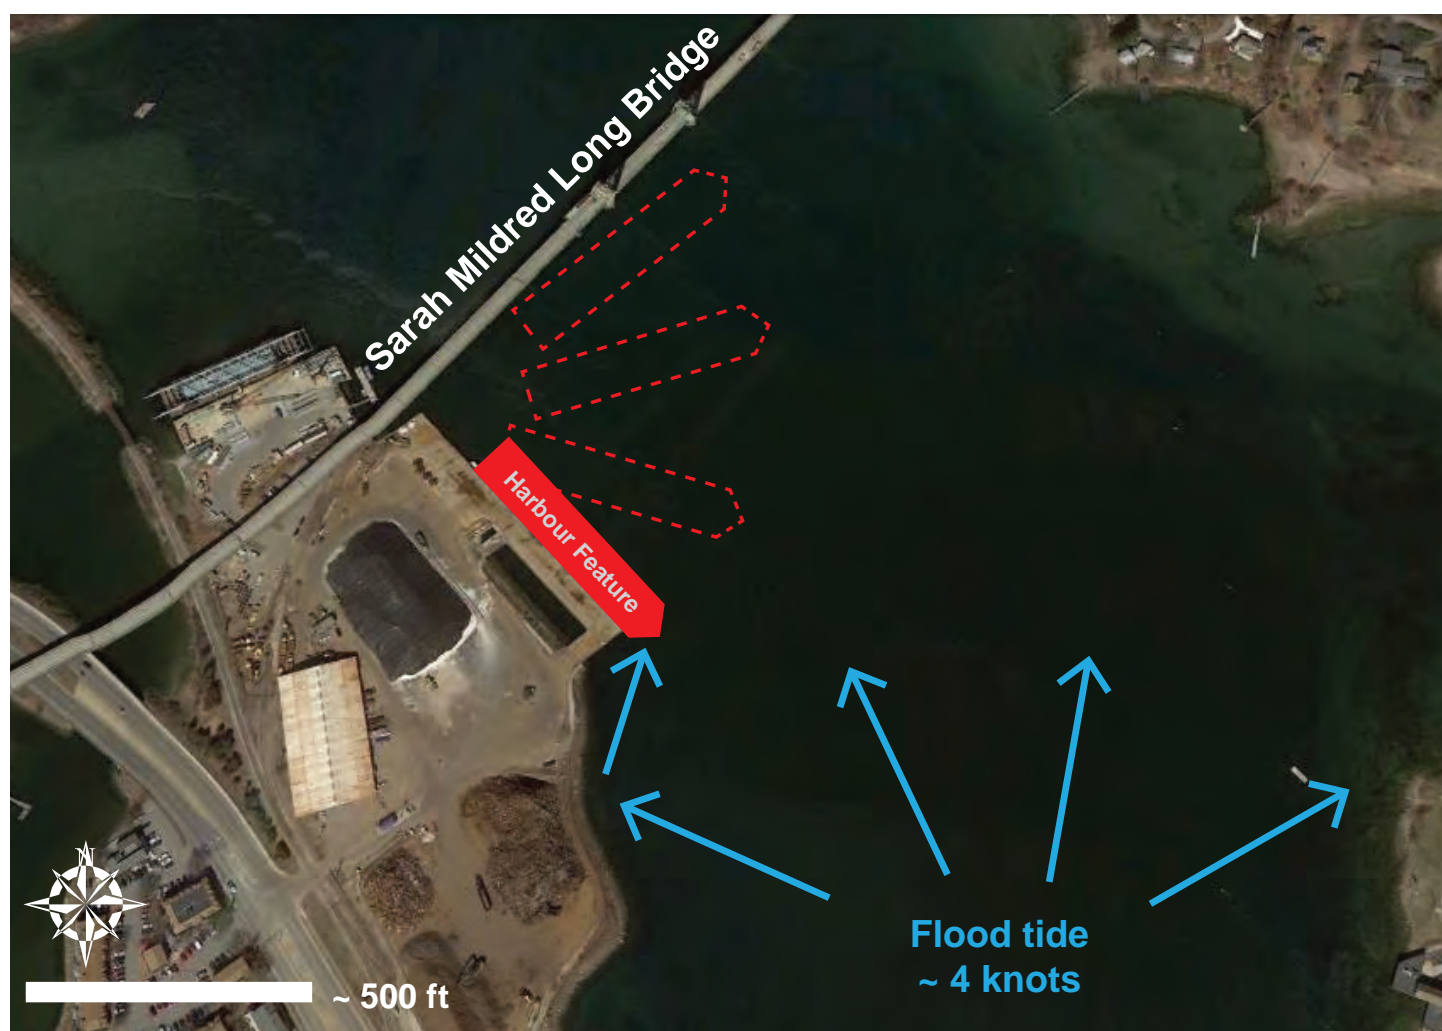
Wharf had been timed so that the ship would be under way during slack water at 1153. During flood tide, water rushes up the river and deflects off the river banks causing hazardous crosscurrents. About 1300, because the *Harbour Feature*'s bow extended beyond the eastern end of the wharf, the deflecting flood current pushed the bow away from the dock and increased the strain on the vessel's mooring lines.

The National Transportation Safety Board determines that the probable cause of the breakaway of the *Harbour Feature* from its moorings and subsequent allision with the Sarah Mildred Long Bridge was the inadequate mooring arrangement made by the master and the pilot for the vessel's location and the prevailing tidal conditions.

Aerial view of the Marine Terminal Wharf on the Piscataqua River. The overlaid blue arrows illustrate the direction of the strong flood current. The overlaid orange-red icons illustrate how the *Harbour Feature* moved toward the bridge after the mooring lines parted. (Background by Google Earth)

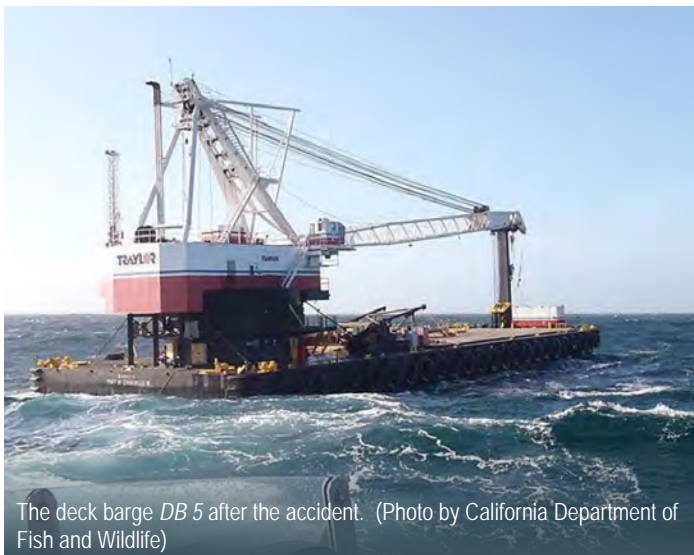
The deck barge *DB 5* after the accident. (Photo by California Department of Fish and Wildlife)

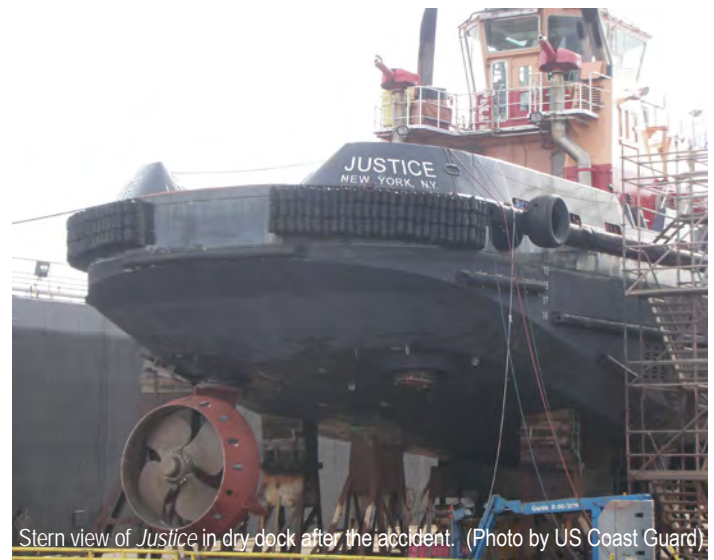
Stern view of *Justice* in dry dock after the accident. (Photo by US Coast Guard)

The lower portion of the integrated nozzle and propeller of the starboard ASD was sheared off in the accident, and the mate used the port ASD to maneuver the vessel back into the channel. The *Justice* immediately took on a 2- to 4-degree port list due to the lost weight of the sheared-off starboard ASD. The master coordinated a vessel assessment by the crew, relieved the mate, and docked the vessel.

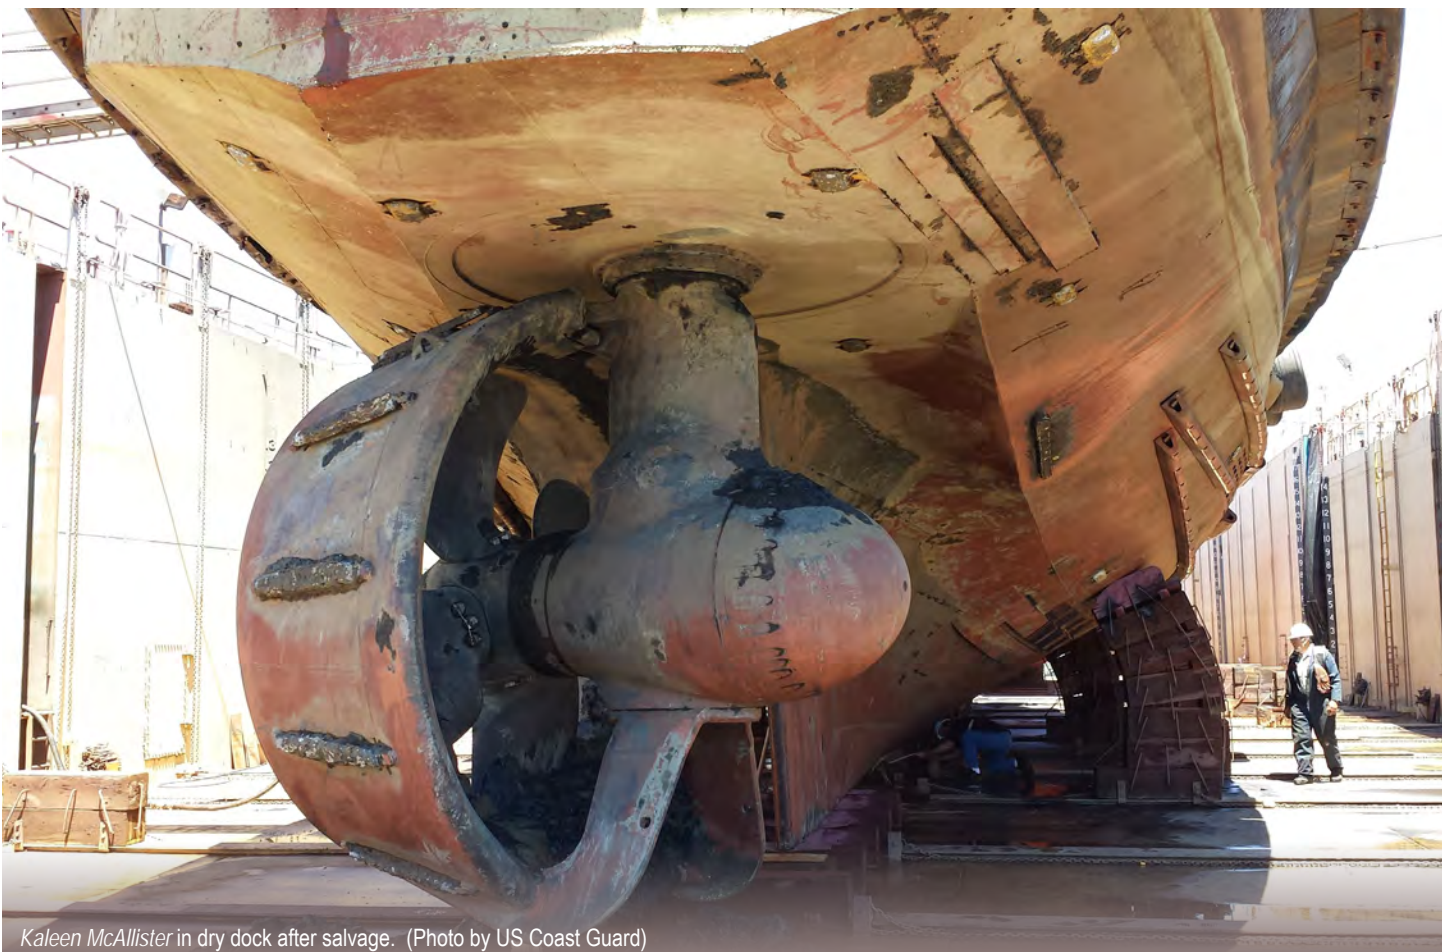
By about 2030, the tug had sunk and an oil sheen was observed. The vessel settled on the bottom with a port list and its wheelhouse top just above the surface of the water. An estimated 2,400 gallons of diesel fuel were discharged into the harbor.

The vessel was underwater for 3 weeks, and the owner estimated \$1.5 million in repairs would be required to return the tug to service.

Kaleen McAllister in dry dock after salvage. (Photo by US Coast Guard)
