# AIRCRAFT ACCIDENT REPORT

CAPITOL INTERNATIONAL AIRWAYS, INC.

DC-8-63F, N4909C  
Anchorage, Alaska  
November 27, 1970

REPORT NUMBER: NTSB-AAR-72-12

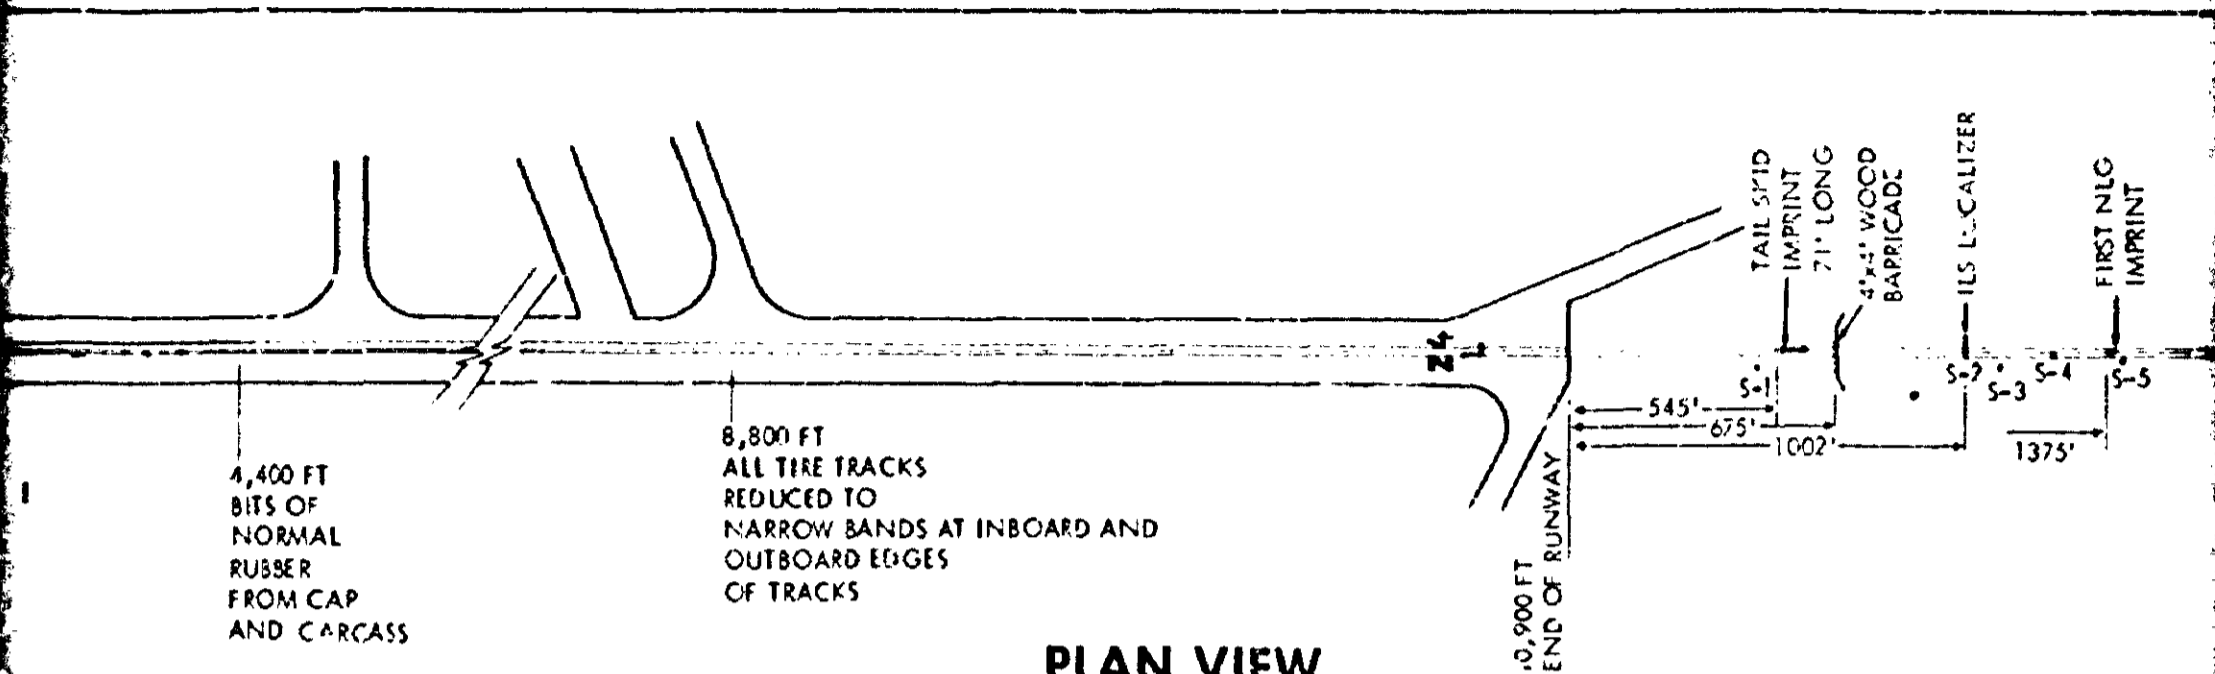
**PLAN VIEW**

APPROX. WIDTHS OF TIRE TRACKS

LHOB	LHIB	RHIB	RHOB
LINE-UP	12"	12"	13"	12"
1000 FT.	12"	13"	16"	14 1/2"
3000 FT.	12"	-	18"	14"
4400 FT.	BEAD MARKS	-	-	-
8800 FT.	BEAD MARKS & RIM MARK ON	-	-	-
	☉ LIGHTS

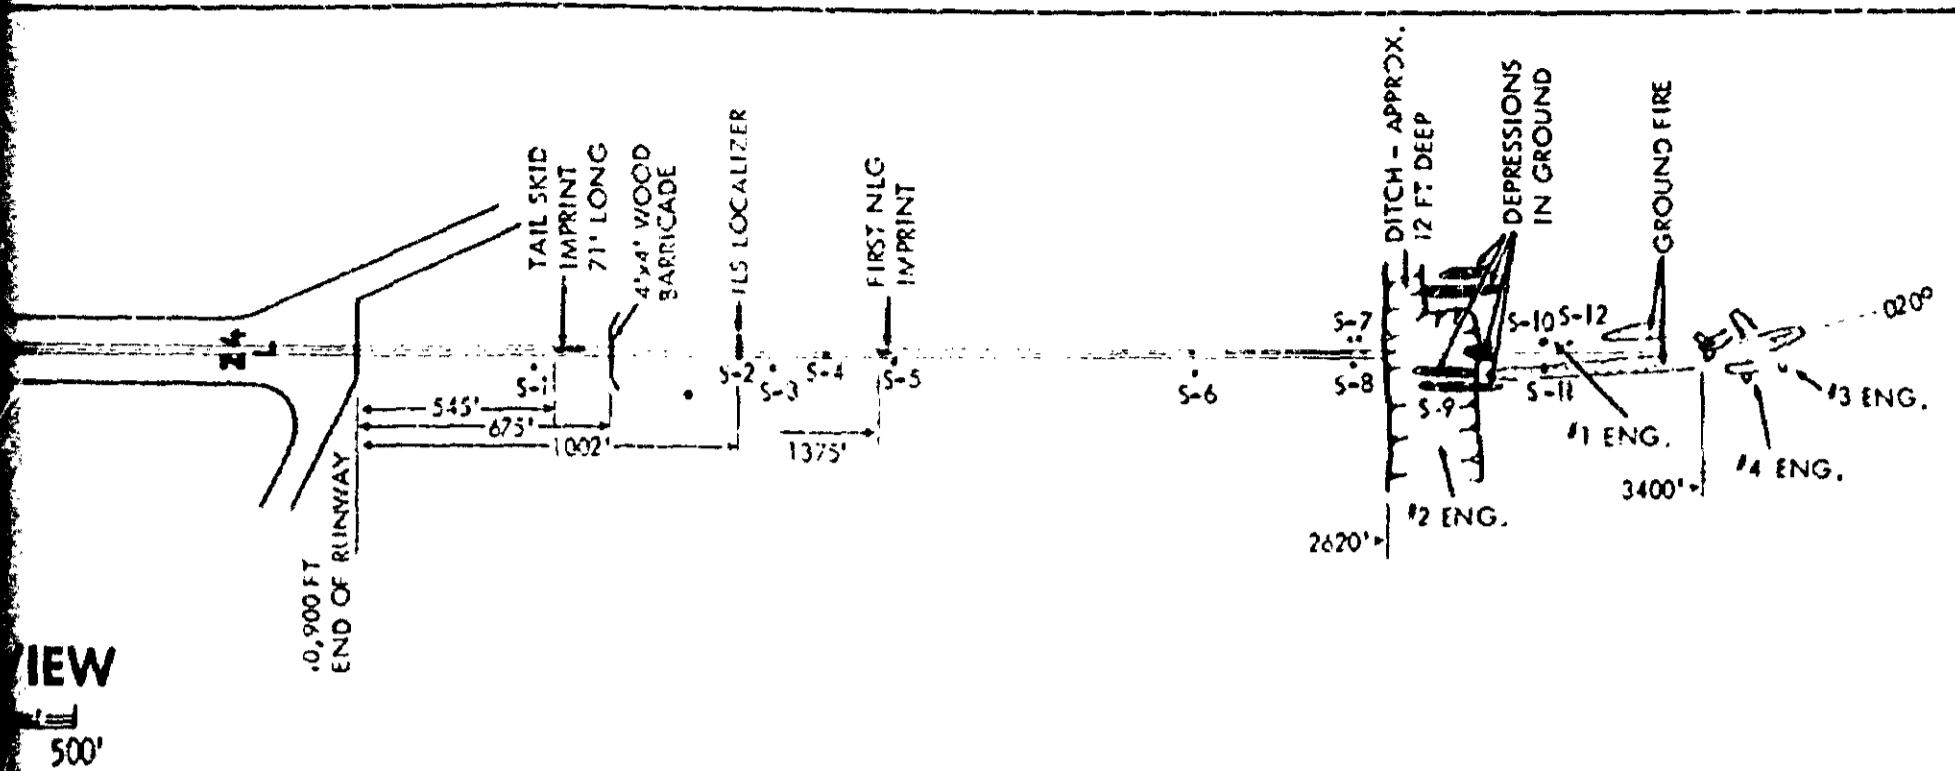
- S-1 FRAGMENTS OF A WHEEL WHICH EXHIBITED GROUND SURFACES
- S-2 PIECES OF WHEELS, AIRCRAFT FAIRINGS, ETC. SCATTERED AROUND LOCALIZER
- S-3 PIECE OF WING FLAP
- S-4 ENGINE COWLING
- S-5 LANDING GEAR DOOR
- S-6 MAIN LANDING GEAR WHEEL
- S-7 MAIN LANDING GEAR TIRES NOS 2 AND NO 6
- S-8 PIECE OF MAIN LANDING GEAR WHEEL NO 7
- S-9 NO 2 ENGINE LANDING GEAR PARTS, ENGINE COWLINGS, ETC., SCATTERED ABOUT AREA
- S-10 PIECE OF LEFT-HAND OUTBOARD FLAP
- S-11 NO 1 WHEEL AND TIRE
- S-12 BRAKE ASSEMBLY
