AIRCRAFT ACCIDENT REPORT - WIEN AIR ALASKA, INC.,  
FAIRCHILD F-27B, N4904  
GAMBELL, ST. LAWRENCE ISLAND, ALASKA

Bureau of Aviation Safety  
Washington, D. C.

January 1976

1. Report No. NTSB-AAR-76-1	2. Government Accession No.	3. Recipient's Catalog No.	
4. Title and Subtitle Aircraft Accident Report - Wien Air Alaska, Inc. Fairchild F-27B, N4904 Gambell, St. Lawrence Island, Alaska		5. Report Date January 7, 1976

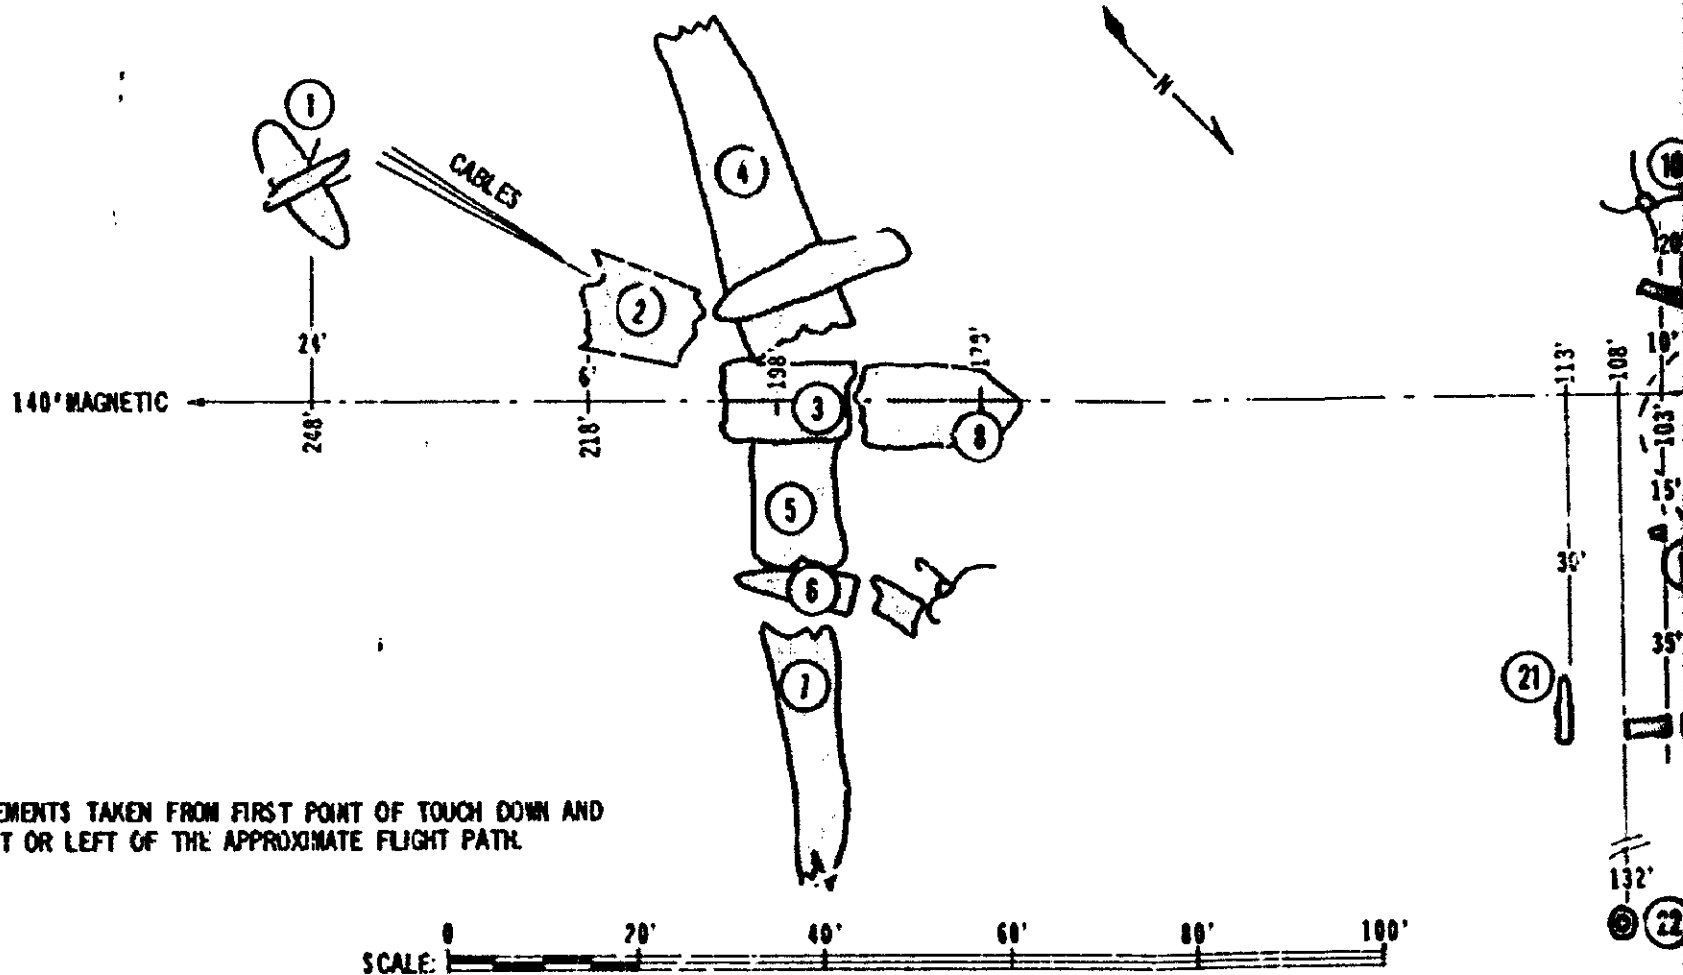
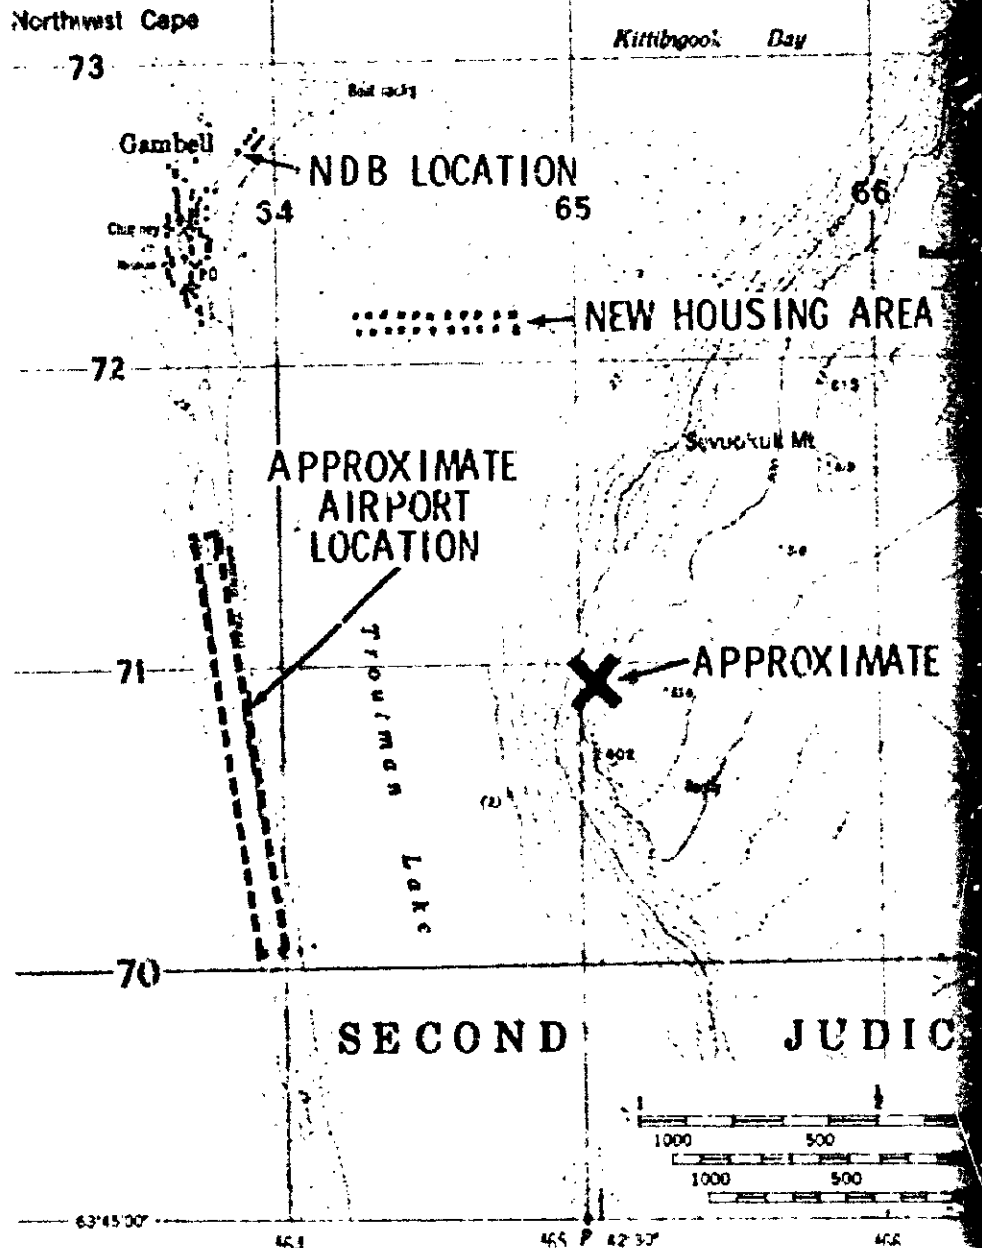
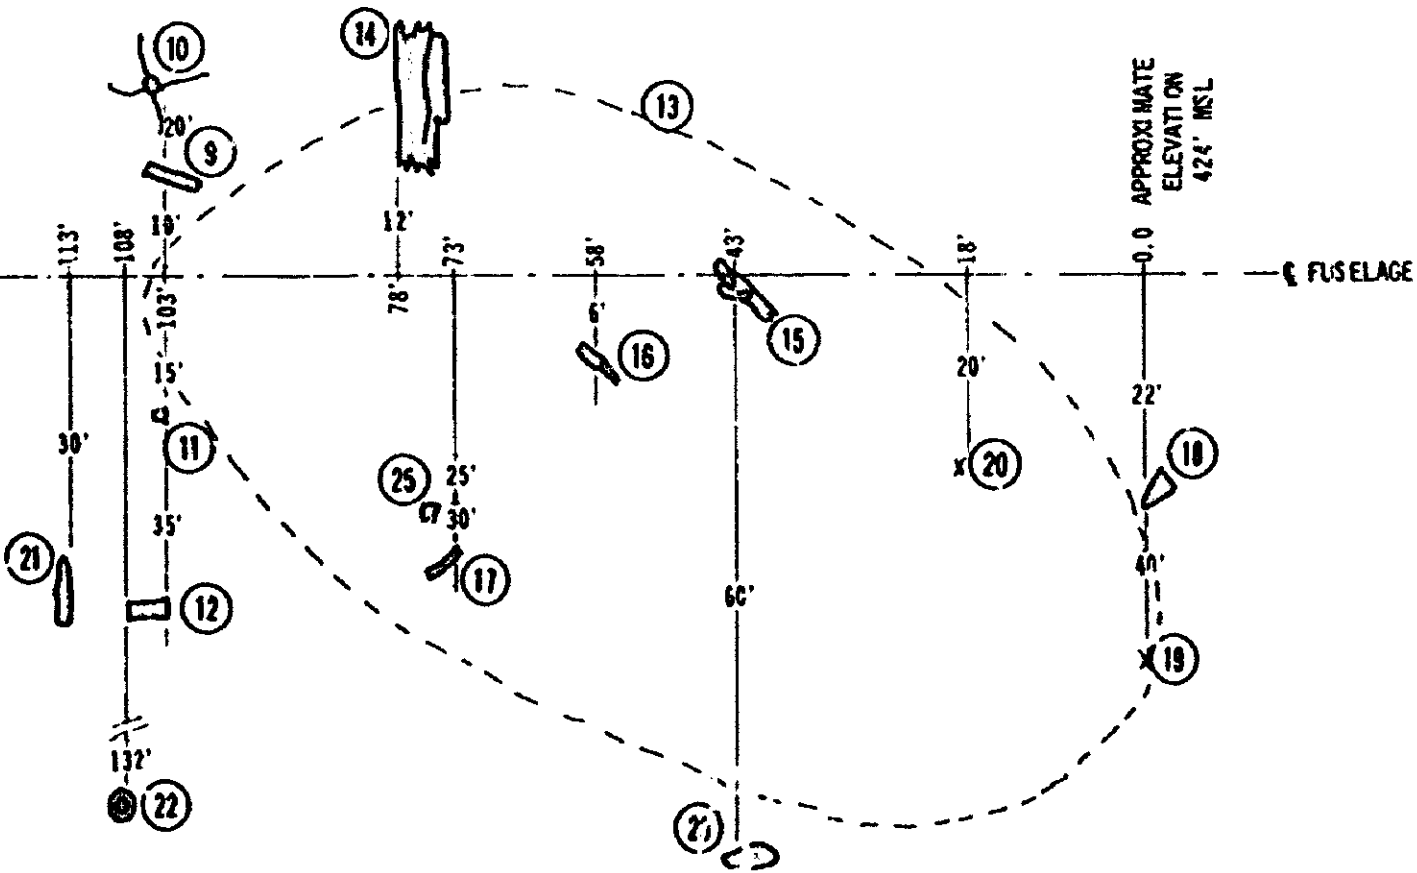
**WRECKAGE DISTRIBUTION CHART**  
**WIEN AIR ALASKA, INC.**  
**FAIRCHILD F-27B, N4904**  
**GAMBELL, ALASKA**  
**AUGUST 30, 1973**

19. Impact Mark
20. Impact Mark
21. Left Propeller Blade
22. Left Main Landing Gear Tire and Wheel Assembly
23. One-Foot Indentation in Ground, Small Pieces of Red Glass

24. Right Main Landing Gear Bogey
25. Gyrosyn Amplifier
