Aircraft Accident Report. American  
Airlines, Inc., Boeing 727-95, N1963  
St. Thomas, Virgin Islands, April 27, 1976

National Transportation Safety Board, Washington, D C

1. Report No. NTSB-AAR-77-1	2. Government Accession No.	3. Recipient's Catalog No.	
4. Title and Subtitle Aircraft Accident Report -- American Airlines, Inc., Boeing 727-95, N1963, St. Thomas, Virgin Islands, April 27, 1976		5. Report Date December 16, 1976	6. Performing Organization Code

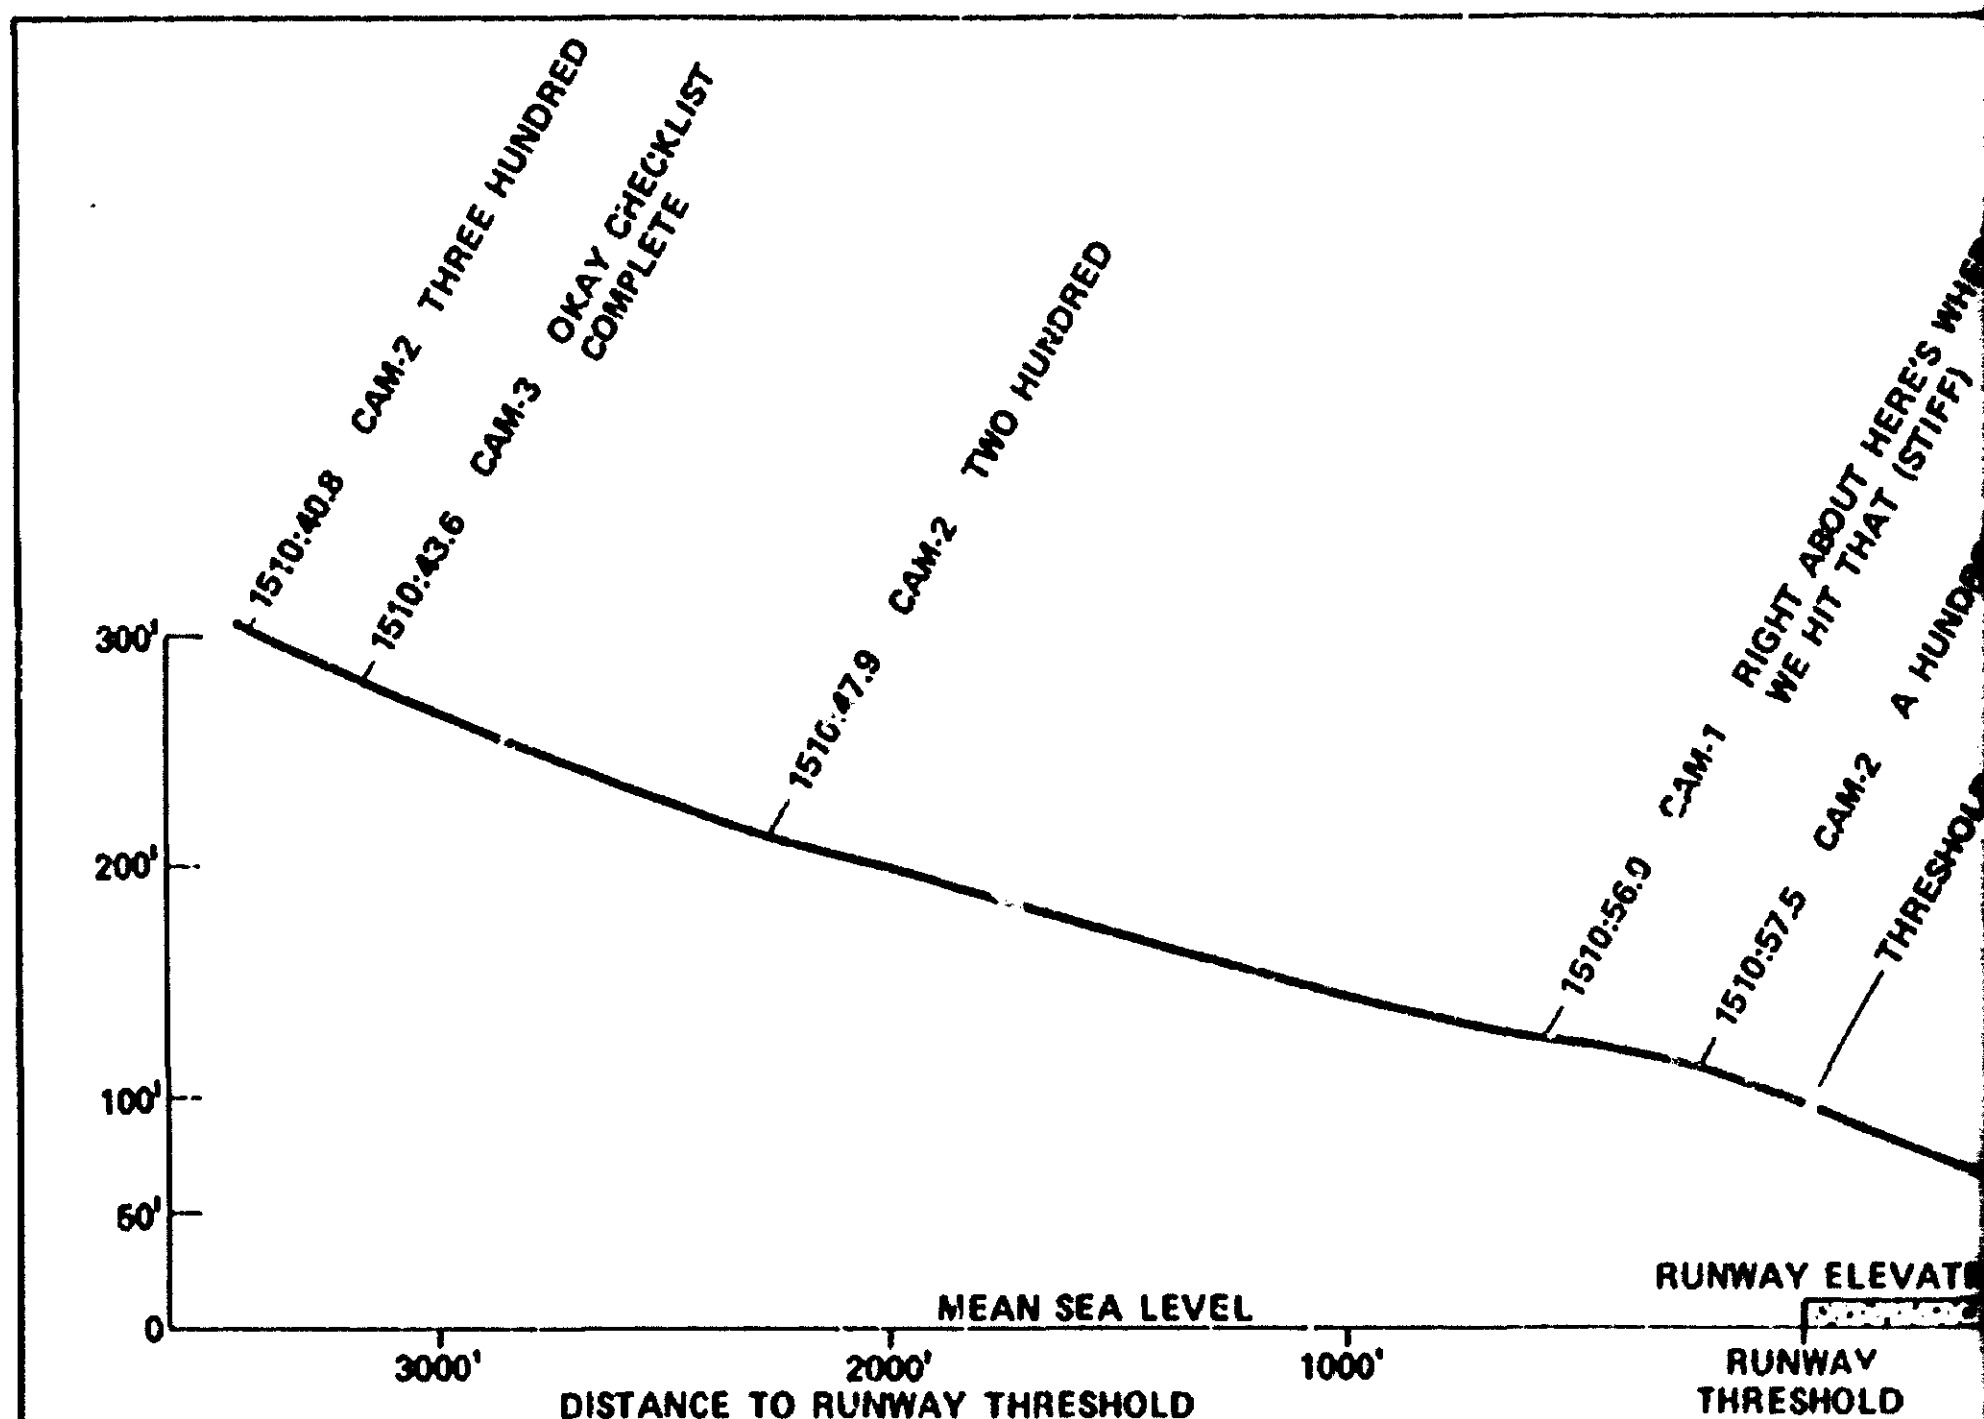
#### DERIVATION OF EXHIBIT

1. THE DISTANCE PLOT WAS DEVELOPED FROM THE F.D.R. AIRSPEED MEASUREMENT CORRECTED FOR DENSITY ALTITUDE AND WIND. THE FOLLOWING ASSUMPTIONS WERE USED:
  - SEA LEVEL BAROMETRIC PRESSURE - 30.01 IN. HG.
  - SEA LEVEL TEMPERATURE - 84° F.
  - WIND - CONSTANT - 120° TRUE/ 10 KNOTS
2. THE TIME CORRELATION BETWEEN THE FLIGHT RECORDER DATA AND THE C.V.R. TRANSCRIPT IS BASED UPON THE ASSUMPTION THAT A VERTICAL ACCELERATION PEAK THREE SECONDS BEFORE THE END OF THE F.D.R. TRACE CORRESPONDS WITH A SOUND OF THE INCREASING ROAR RECORDED ON THE C.V.R.
3. THE CORRELATION OF THE PLOT TO THE RUNWAY THRESHOLD IS BASED UPON THE ASSUMPTION THAT THE PREVIOUSLY MENTIONED ACCELERATION PEAK AND SOUND OF ROAR OCCURRED WHEN THE AIRCRAFT STRUCK AN EMBANKMENT 5369 FEET BEYOND THE RUNWAY THRESHOLD.

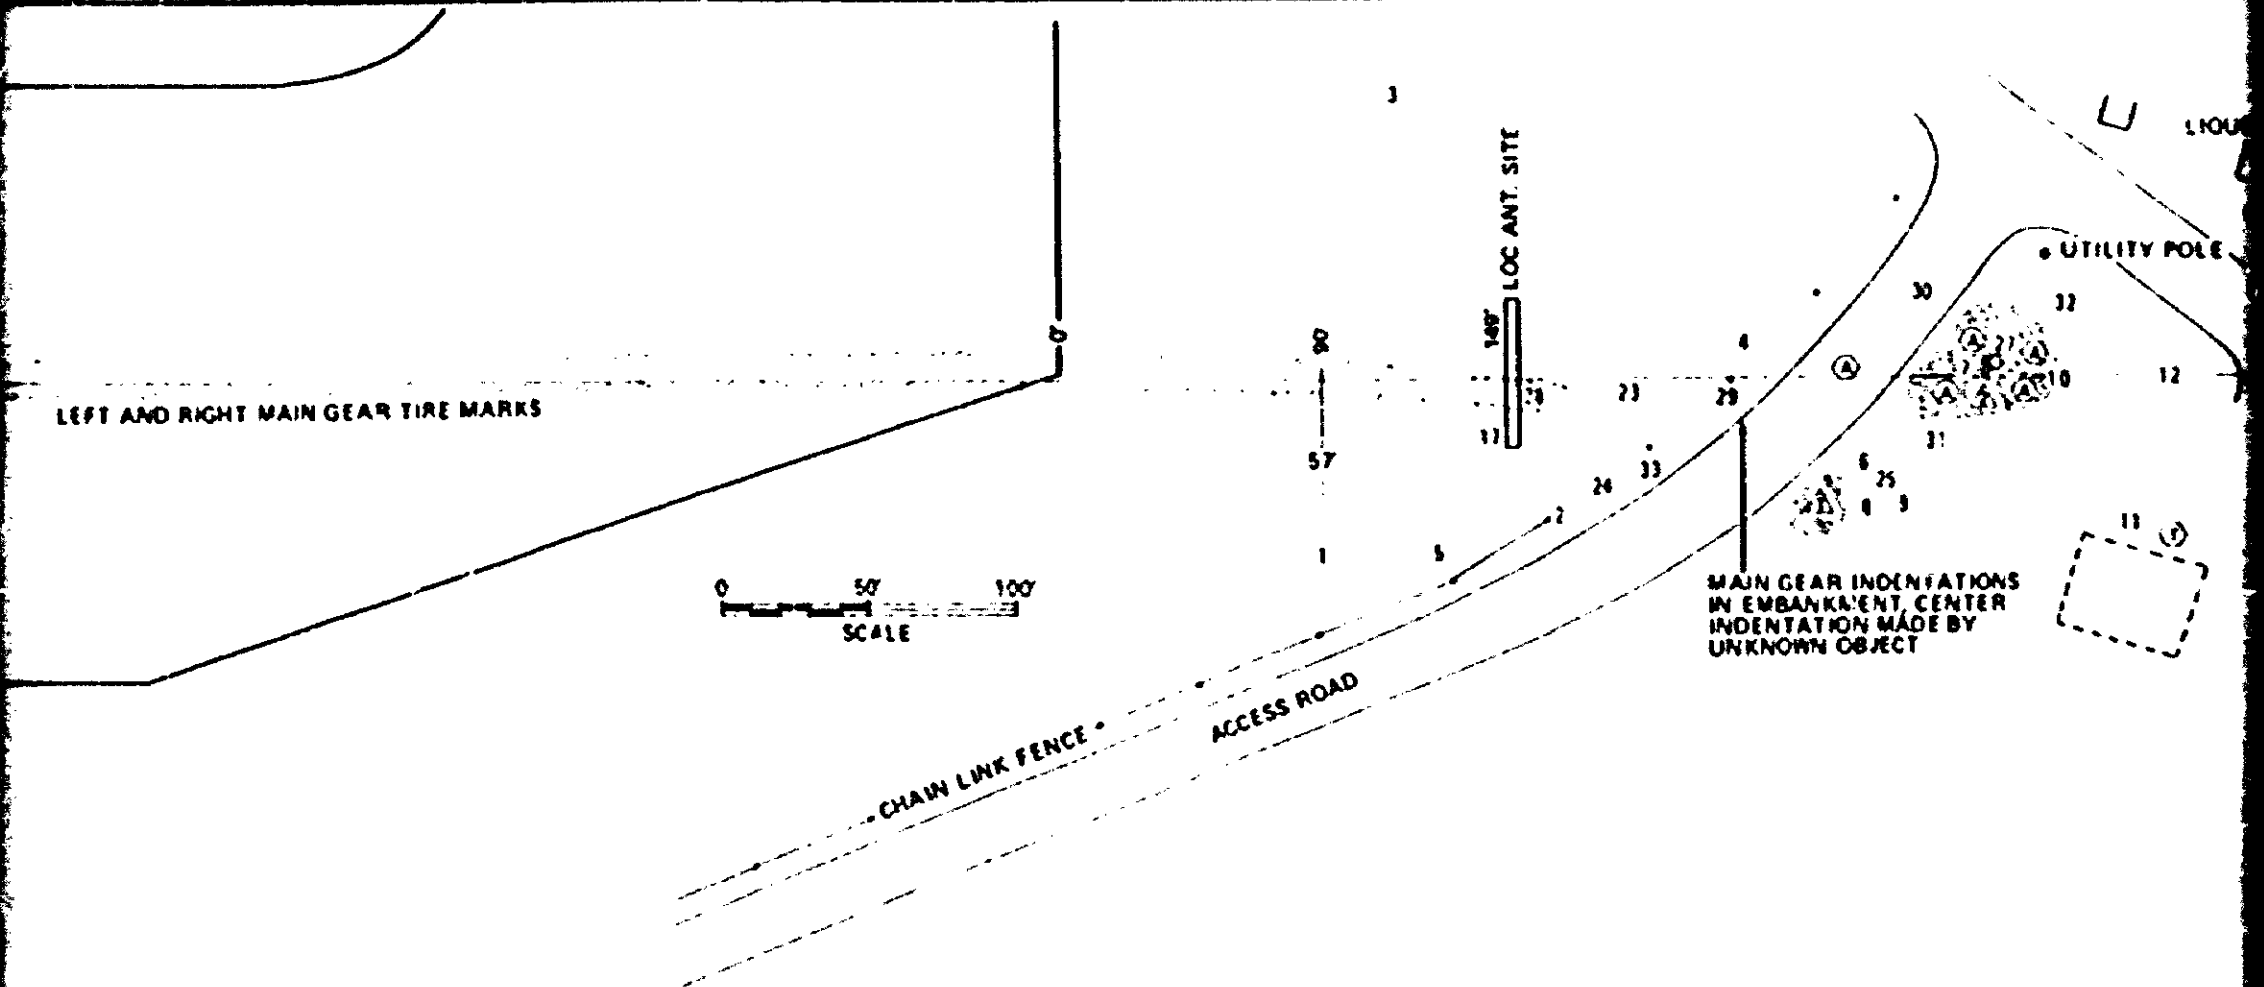
**RUNWAY EXAMINATION CHART**  
**AMERICAN AIRLINES, BOEING 727-95, N1963**  
**HARRY S TRUMAN AIRPORT**  
**CHARLOTTE AMALIE, ST. THOMAS, VIRGIN ISLANDS**  
**APRIL 27, 1976**

27. TREE BROKEN APPROX. 8 FEET ABOVE GROUND
28. HONEYCOMB FOUND IN LOCALIZER ANTENNA SUPPORT STRUCTURE
29. PIECES OF LEADING EDGE SLAT TRACK
30. LEFT MAIN LANDING GEAR AFT TRUNION BEARING SLEEVE

- (A) AUTOMOBILE
- (T) TRUCK
- (F) FIRST INDICATION OF FIRE
- (A) AREA OF FIRE DAMAGE (IN)
- (X) FIRE AREA

INDICATION OF FIRE LOCALIZED  
OF FIRE DAMAGE (INCLUDES 4 AUTOMOBILES AND 1 TREE)  
AREA
