# **NATIONAL TRANSPORTATION SAFETY BOARD**

## **AIRCRAFT ACCIDENT REPORT**

**SCANDINAVIAN AIRLINES SYSTEM  
FLIGHT 901**

**McDONNELL DOUGLAS DC-10-30  
JOHN F. KENNEDY**

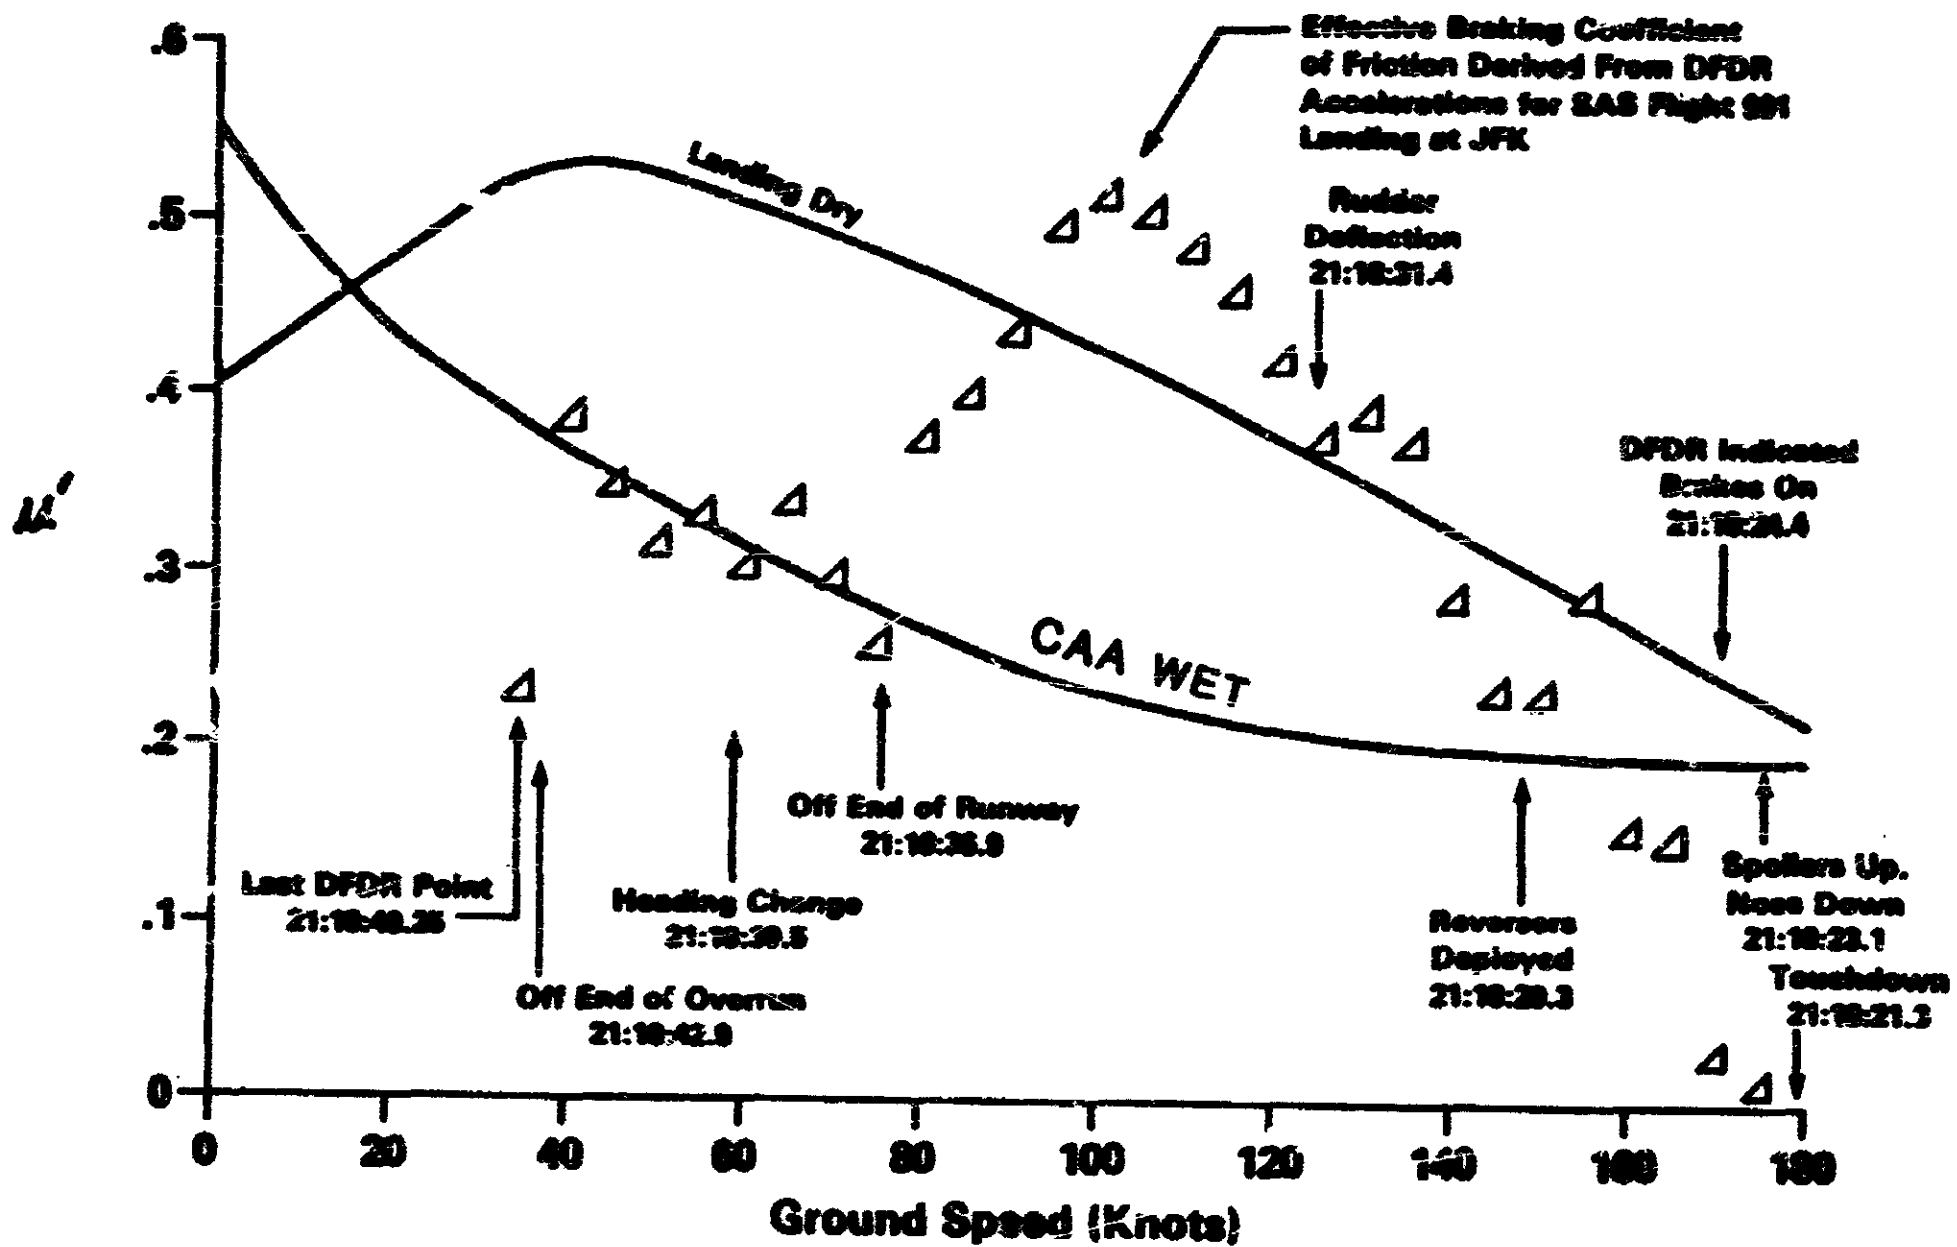
Figure 5.—Effective Braking Coefficient Derived from DFDR.

Calculations made by the Douglas Aircraft Company show calculated effective braking coefficient of friction (Mu prime) as a function of groundspeed for the landing ground roll. (See figure 5.) The force attributed to braking was derived using deceleration data from the DFDR and calculating the drag, lift, and thrust forces on the aircraft. (The effective braking coefficient cannot be directly equated to friction values as measured with the Saab equipment.)
