NATIONAL TRANSPORTATION SAFETY BOARD

AIRCRAFT ACCIDENT REPORT

**PIEDMONT AIRLINES FLIGHT 467
BOEING 737-222, N752N
CHARLOTTE DOUGLAS INTERNATIONAL AIRPORT
CHARLOTTE, NORTH CAROLINA
OCTOBER 26, 1986**

NTSB/AAR-87/08

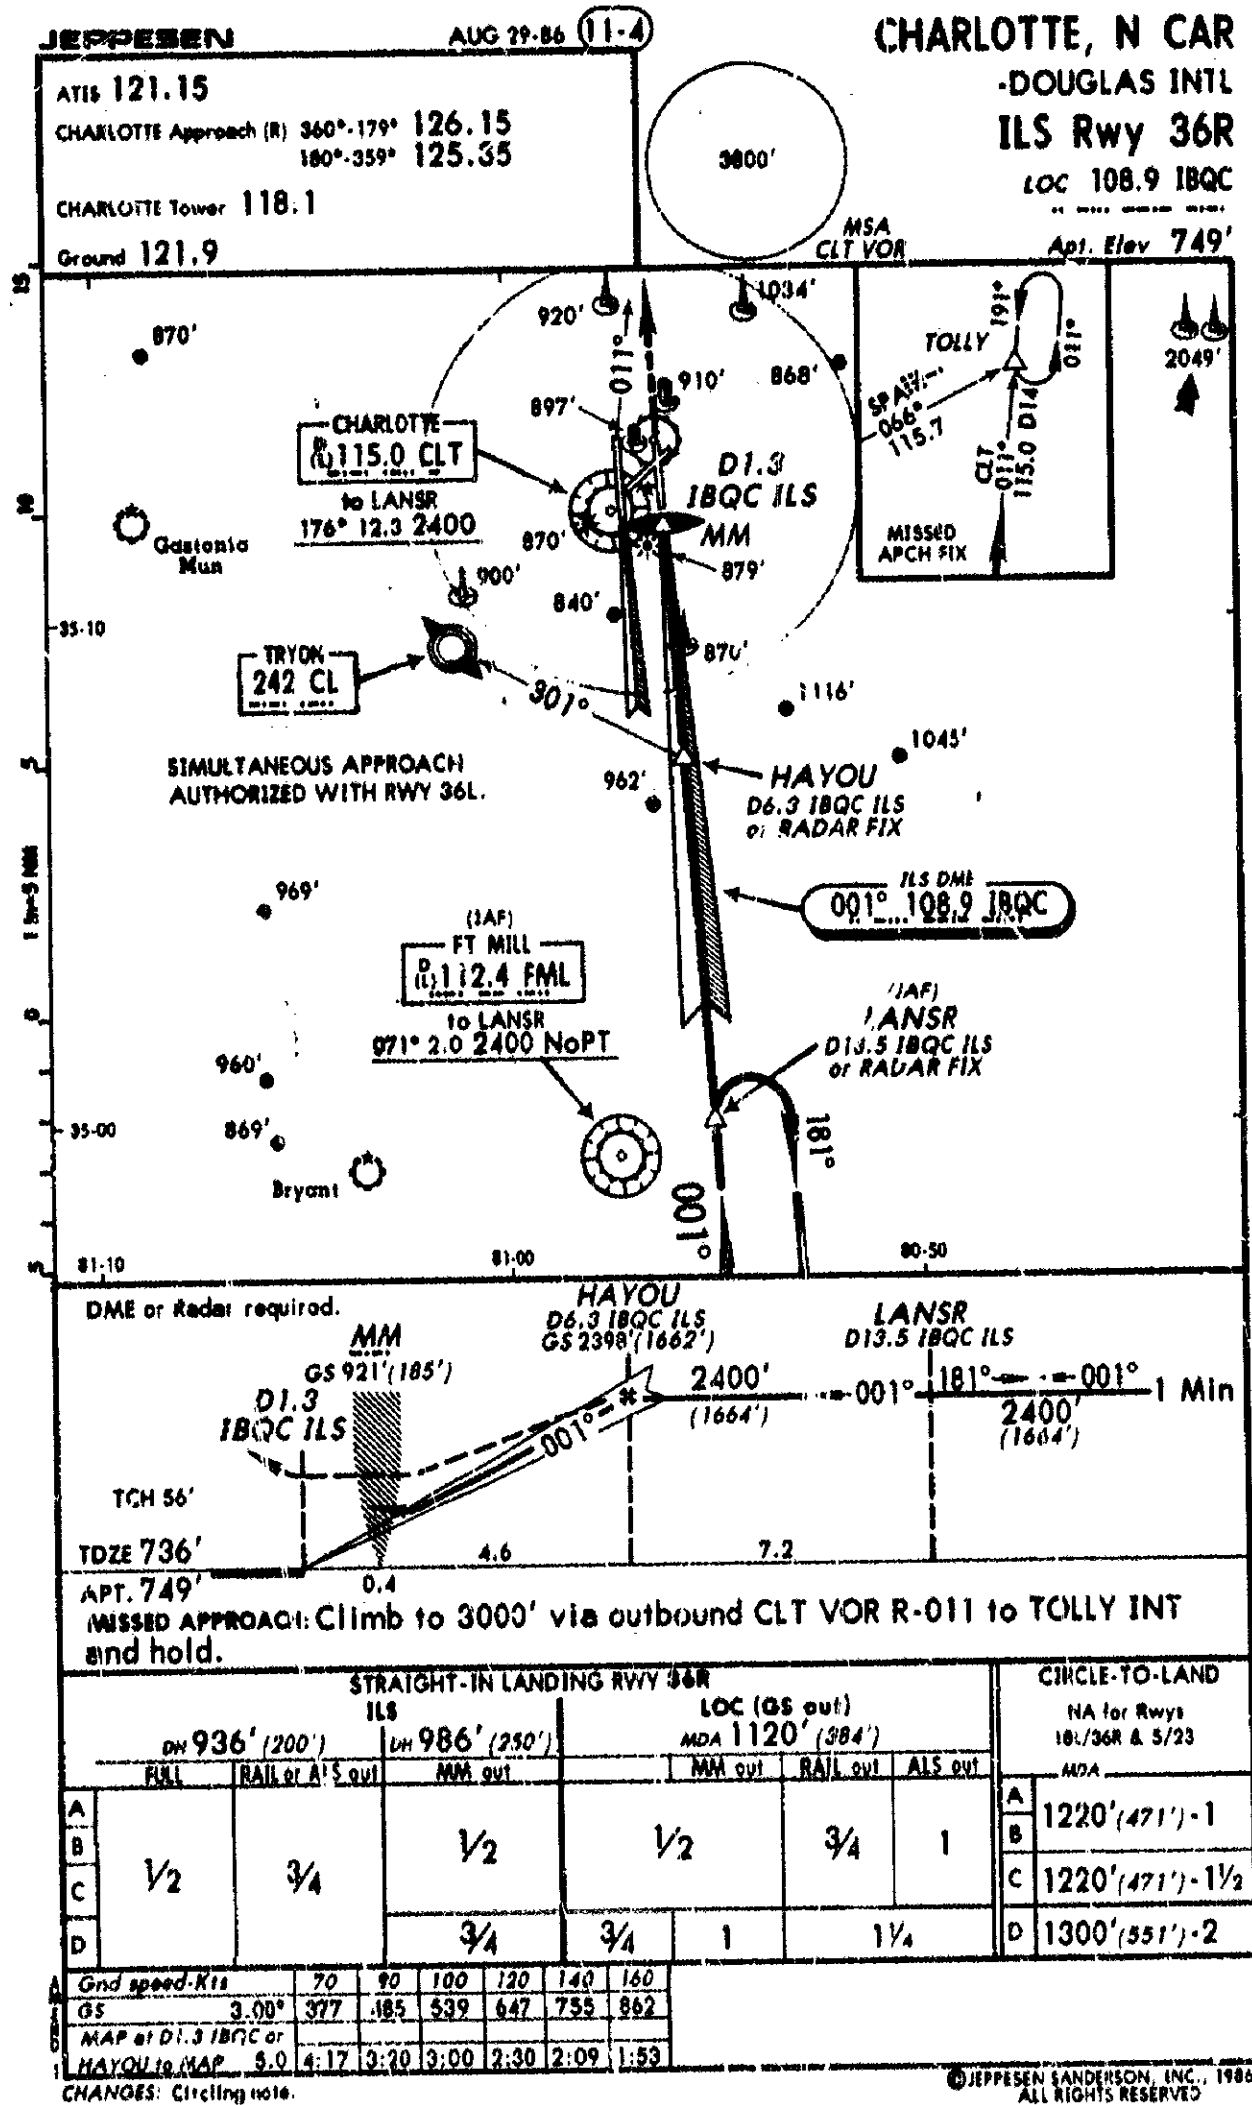
Figure 1.—ILS Approach to runway 36R—Charlotte Douglas International Airport.
 (Reprinted by permission of Jeppesen-Sanderson, Inc.
 Not to be used for navigation.)

Runway 36R at CLT is served by an ILS system. (See figure 1.) All navigation aids used in the ILS approach, except for the localizer, were found to be operational after the accident. An FAA flight check of the glide slope following the accident indicated that the glide slope was operating within prescribed tolerances. The localizer could not be flight checked since it was destroyed in the accident; however, no problems with the localizer were reported by the flightcrews who landed on the runway before PI 467.

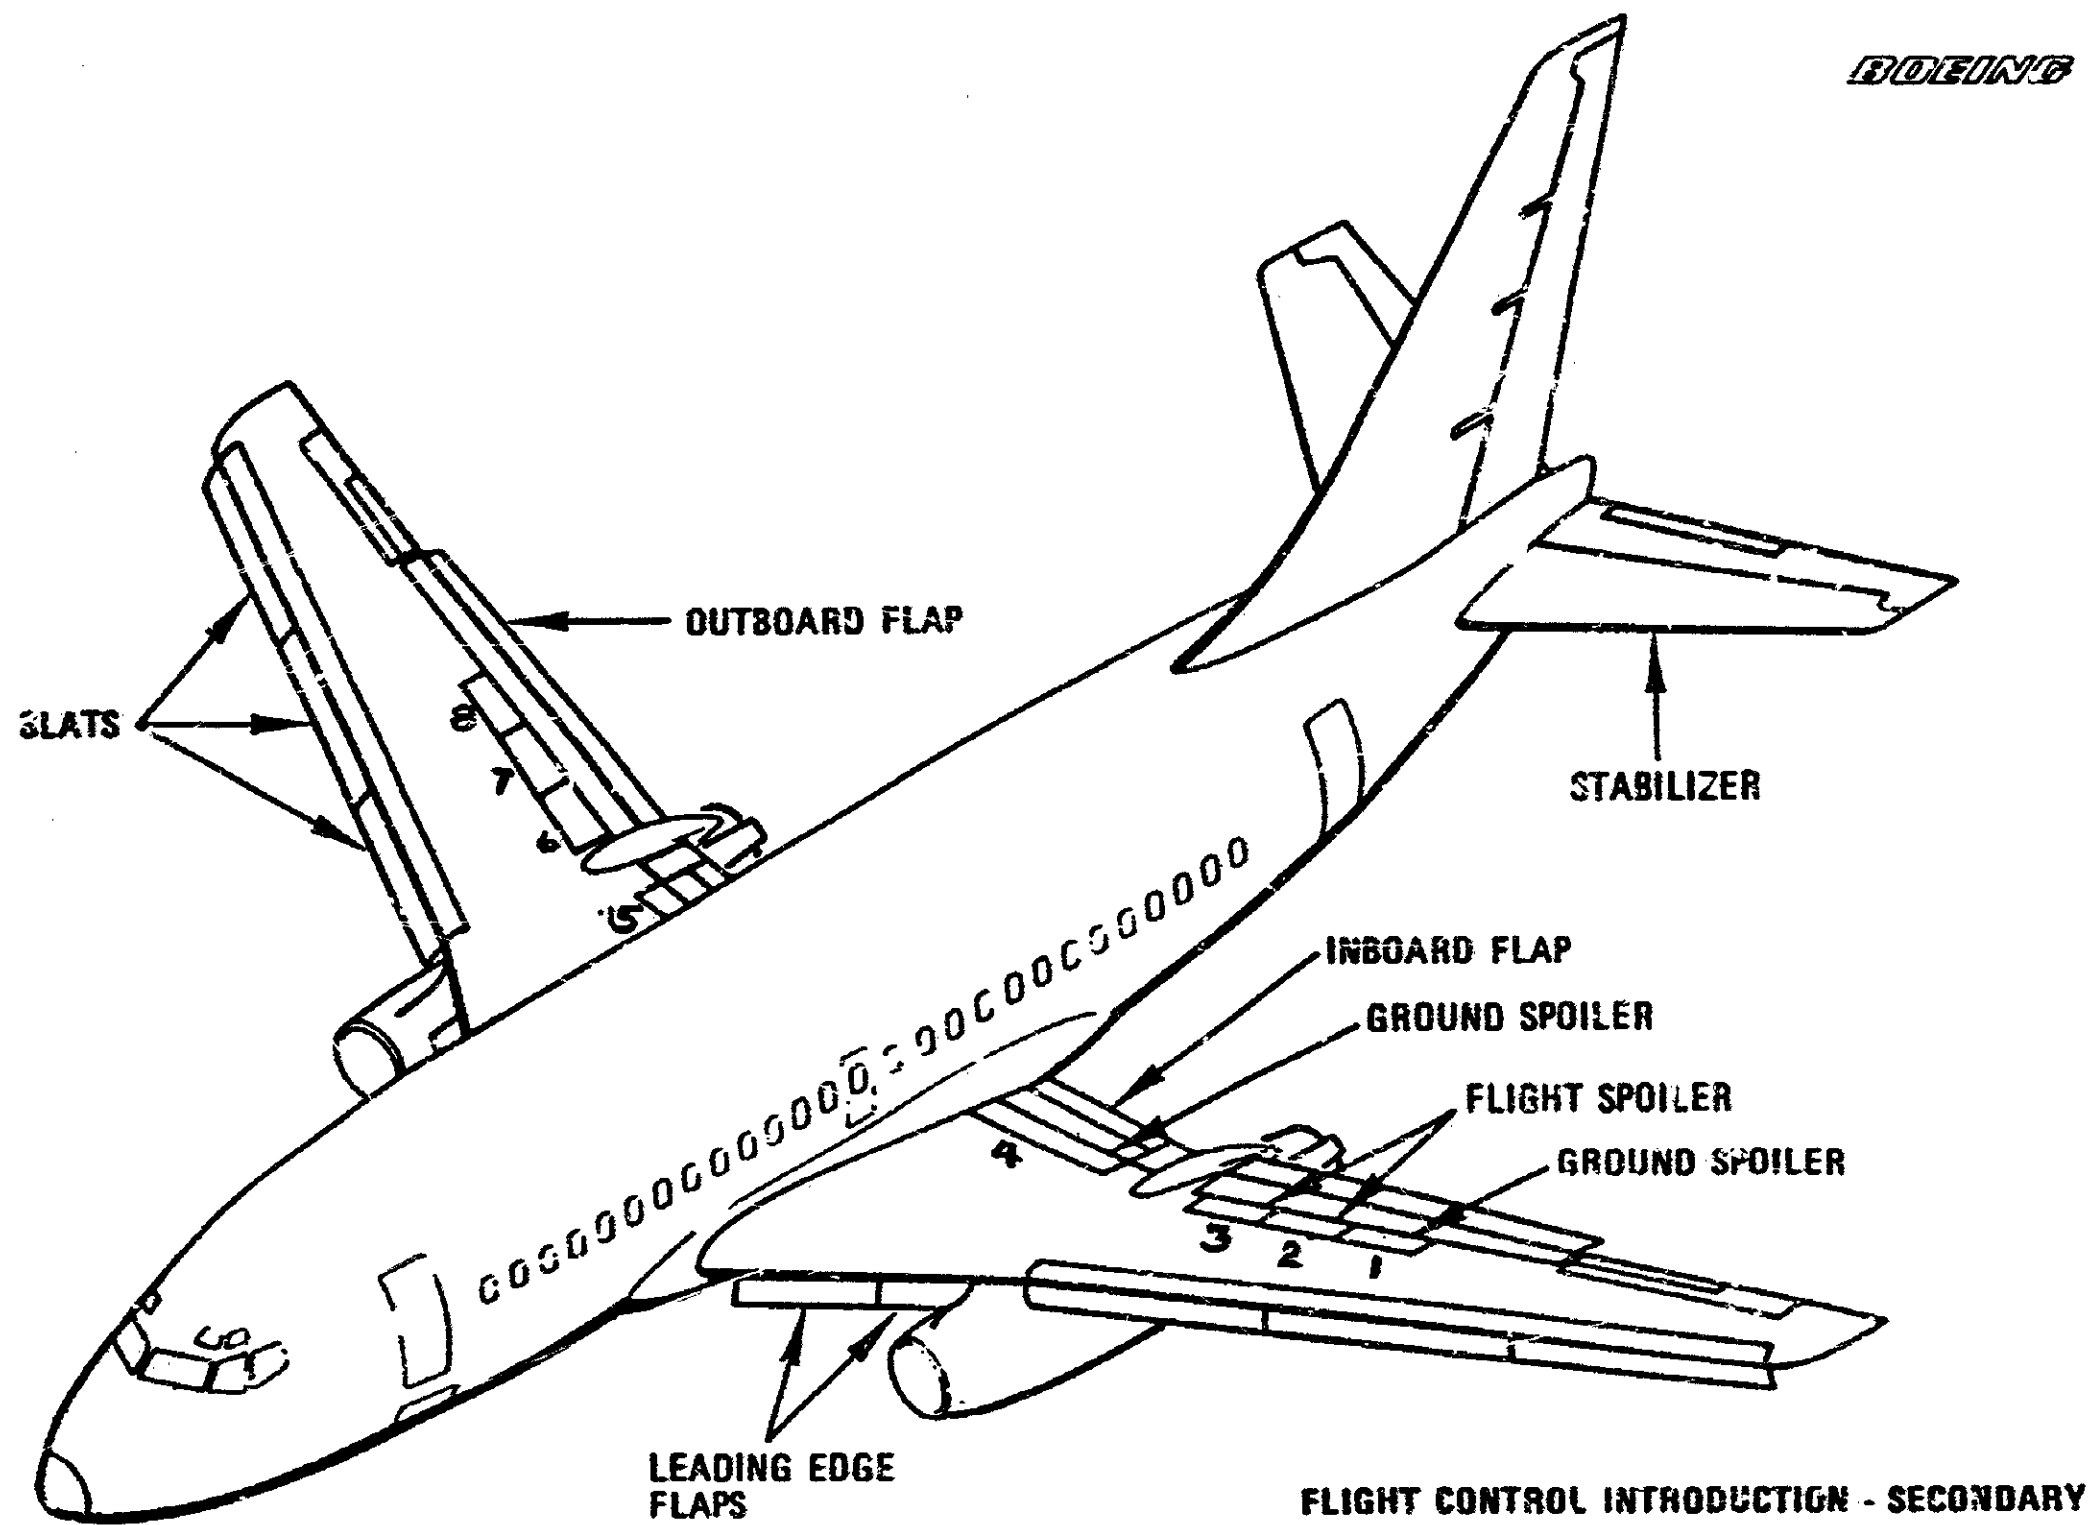
On the Boeing 737, the spoilers are composed of eight spoiler panels, four on each wing. (See figure 4.) The outboard and inboard panels on each wing can only be activated on the ground to a maximum deflection of 40° and 60° up, respectively. The

Figure 4.--Boeing 737-222.

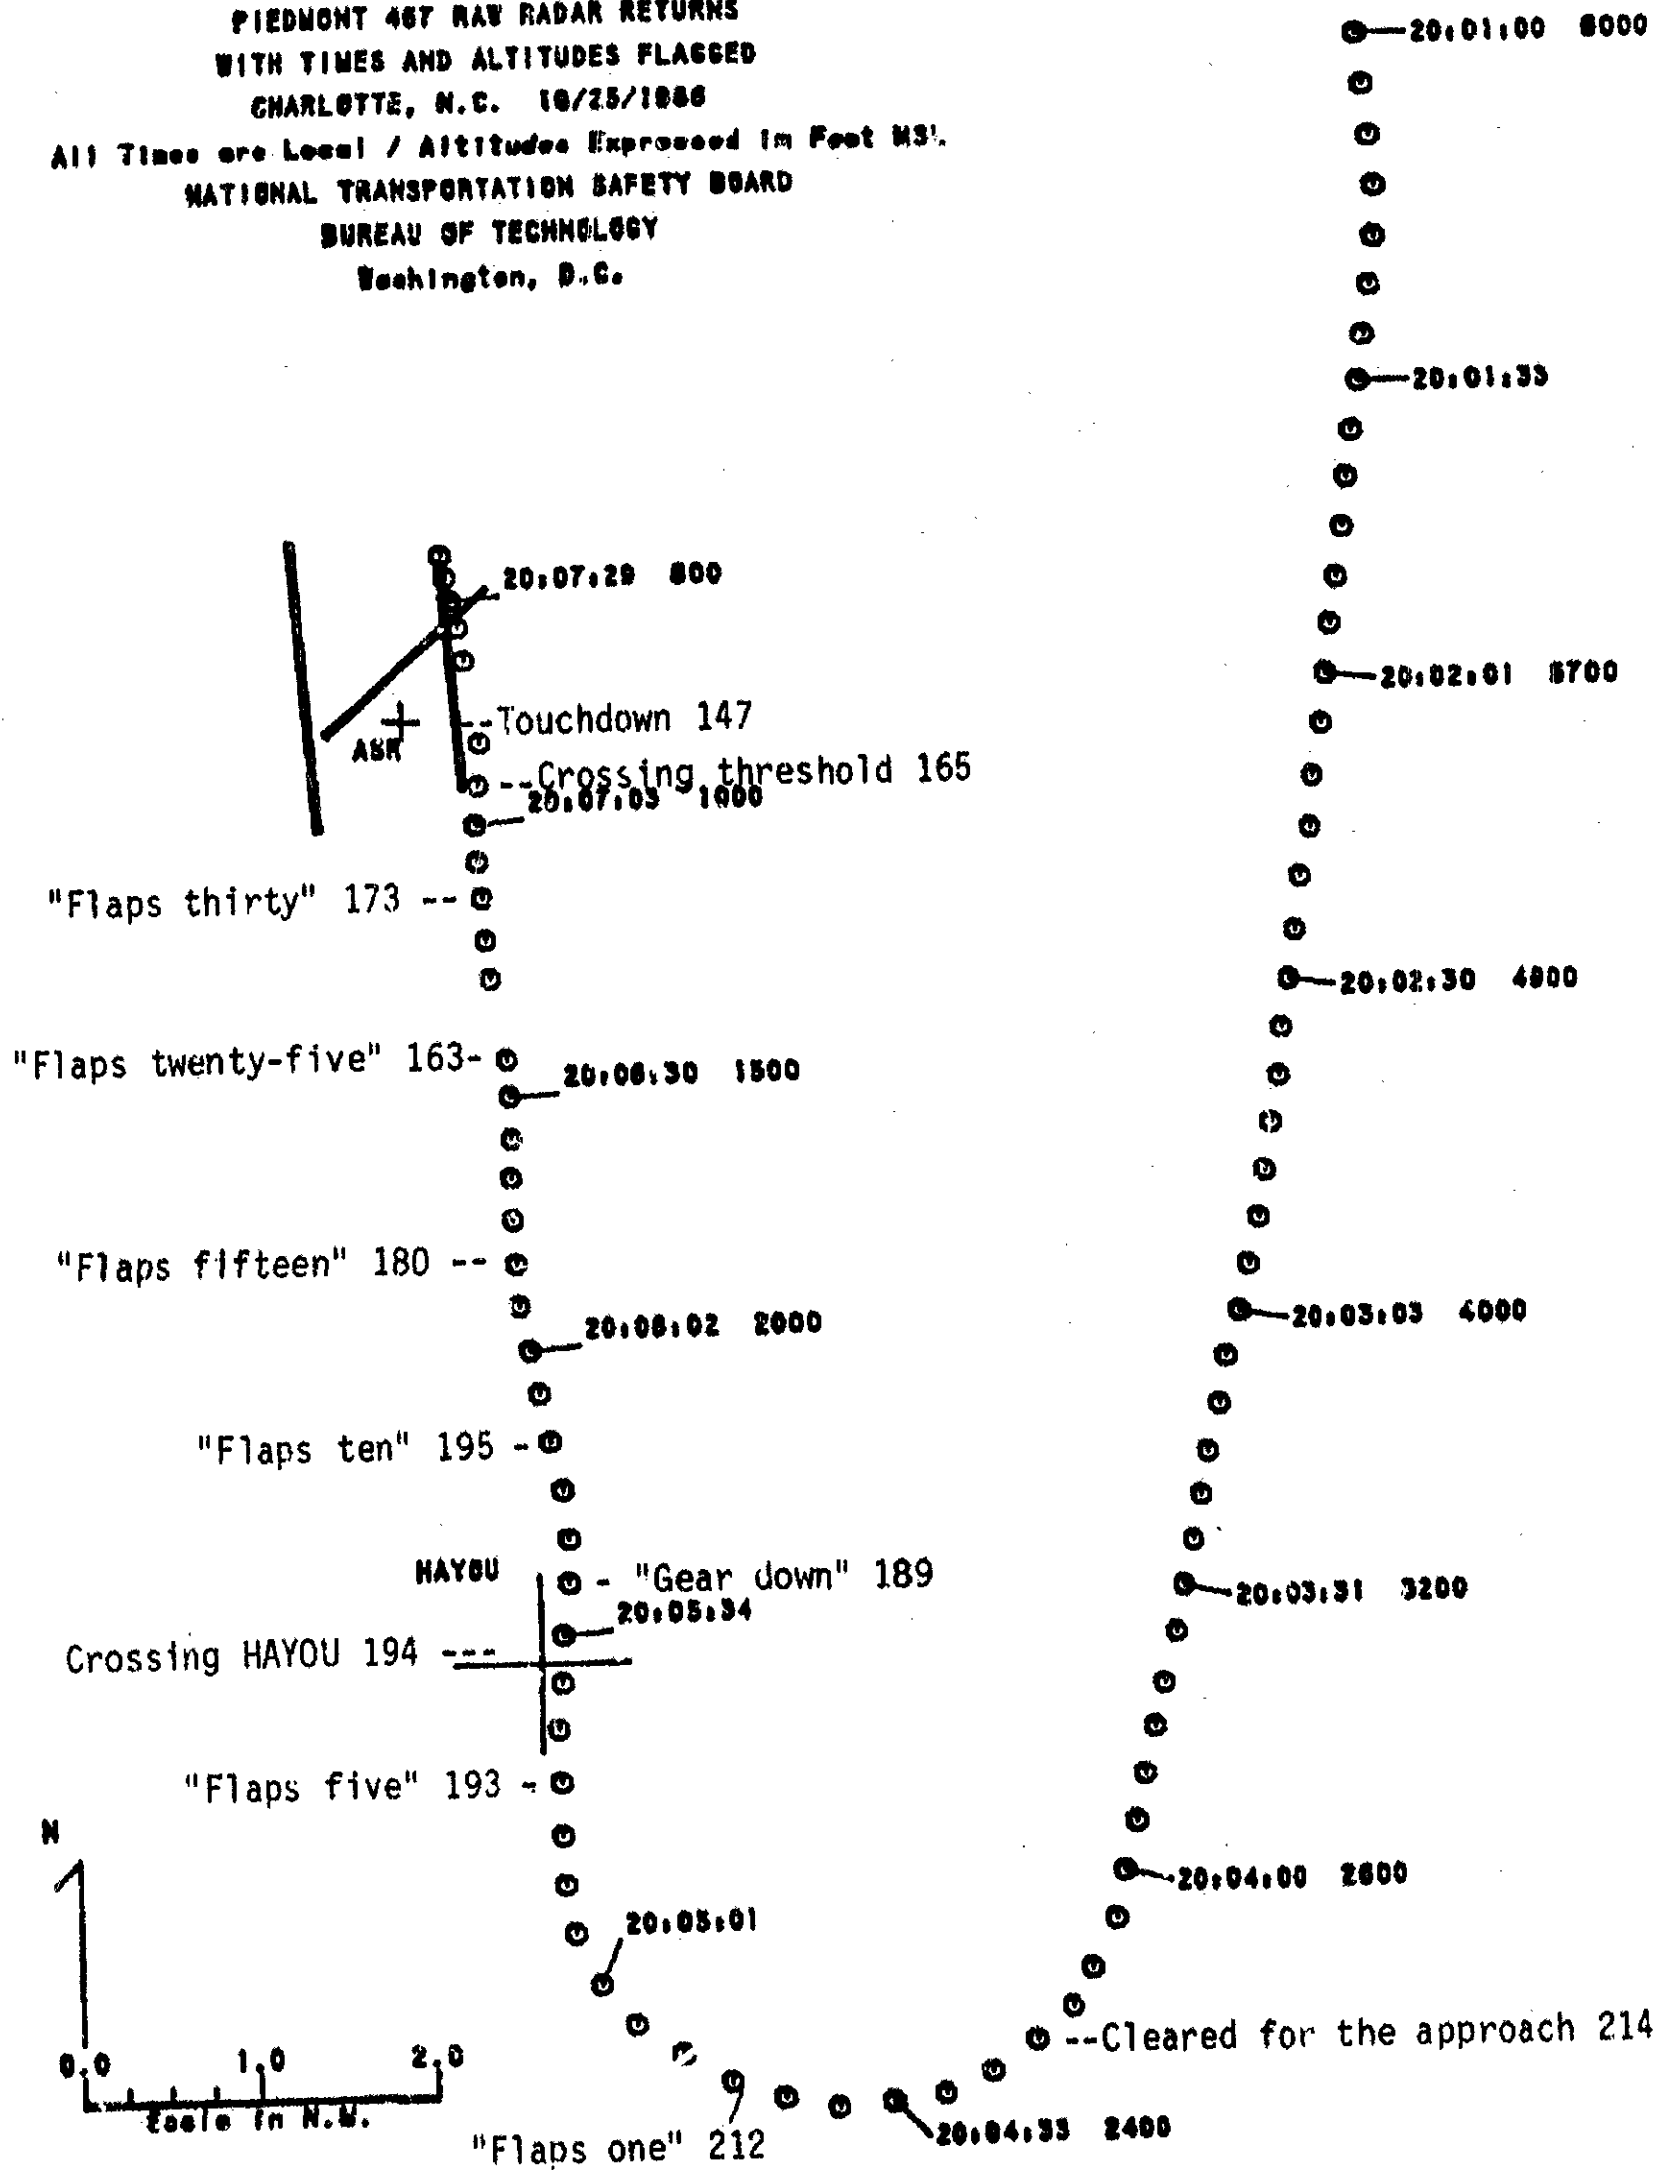
Due to the corrections that were applied to the DFR, as well as the lack of complete precision in measuring airspeed, the derived airspeeds contain an approximate 5-knot error. That is, the actual airspeed could be as much as 5 knots higher or 5 knots lower than the derived airspeed. The examination of the DFR indicates that the derived airspeed of PI 467 was about 214 knots when it was cleared for the approach. (See figure 7.) The airspeed was about 194 knots crossing HAYOU. When PI 467 crossed the threshold, the airspeed was about 165 knots, and at touchdown, it was about 147 knots. The airspeed was about 72 knots when the airplane departed the runway.

Figure 7.—Airspeeds and airplane configuration at selected points in the approach of PI 467.

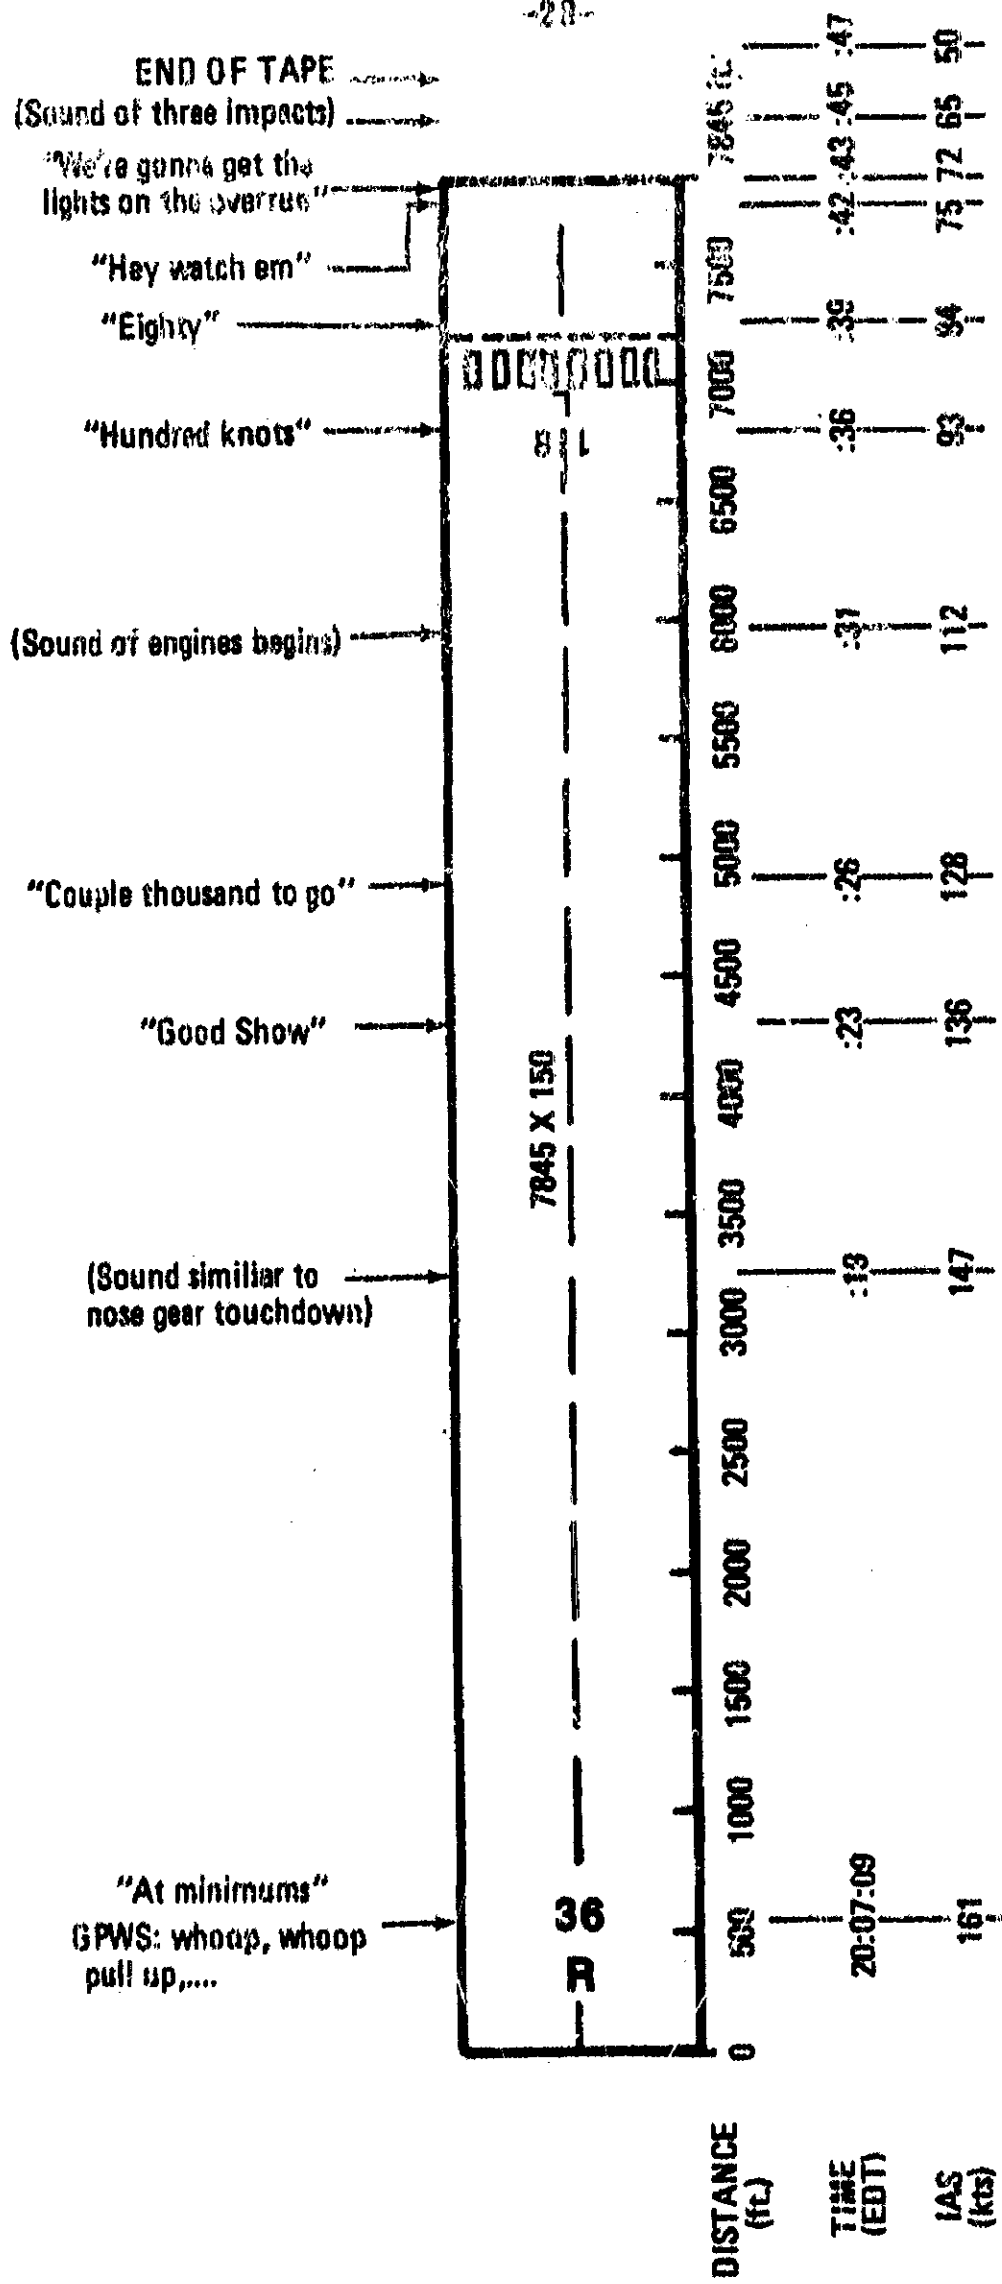
According to data supplied by Boeing, on a wet, grooved runway without spoiler extension, the airplane could have been stopped in about 3,500 feet provided full reverse thrust was obtained within 3 seconds of touchdown. However, significant reverse thrust was not obtained until about 12 seconds after touchdown when the airplane had slowed to about 112 KIAS, at which time less than 1,900 feet of runway remained. (See figure 8.) Consequently, although the frictional qualities of the last 1,500 feet of

Figure 8.--Speeds of PI 467 at selected points on the runway.

runway 36R were substandard, the lack of any spoiler extension could account for the delay in obtaining reverse thrust, the airplane poor stopping performance with the last 1,900 feet of runway, and its departure from the runway at a speed in excess of J KIAS.

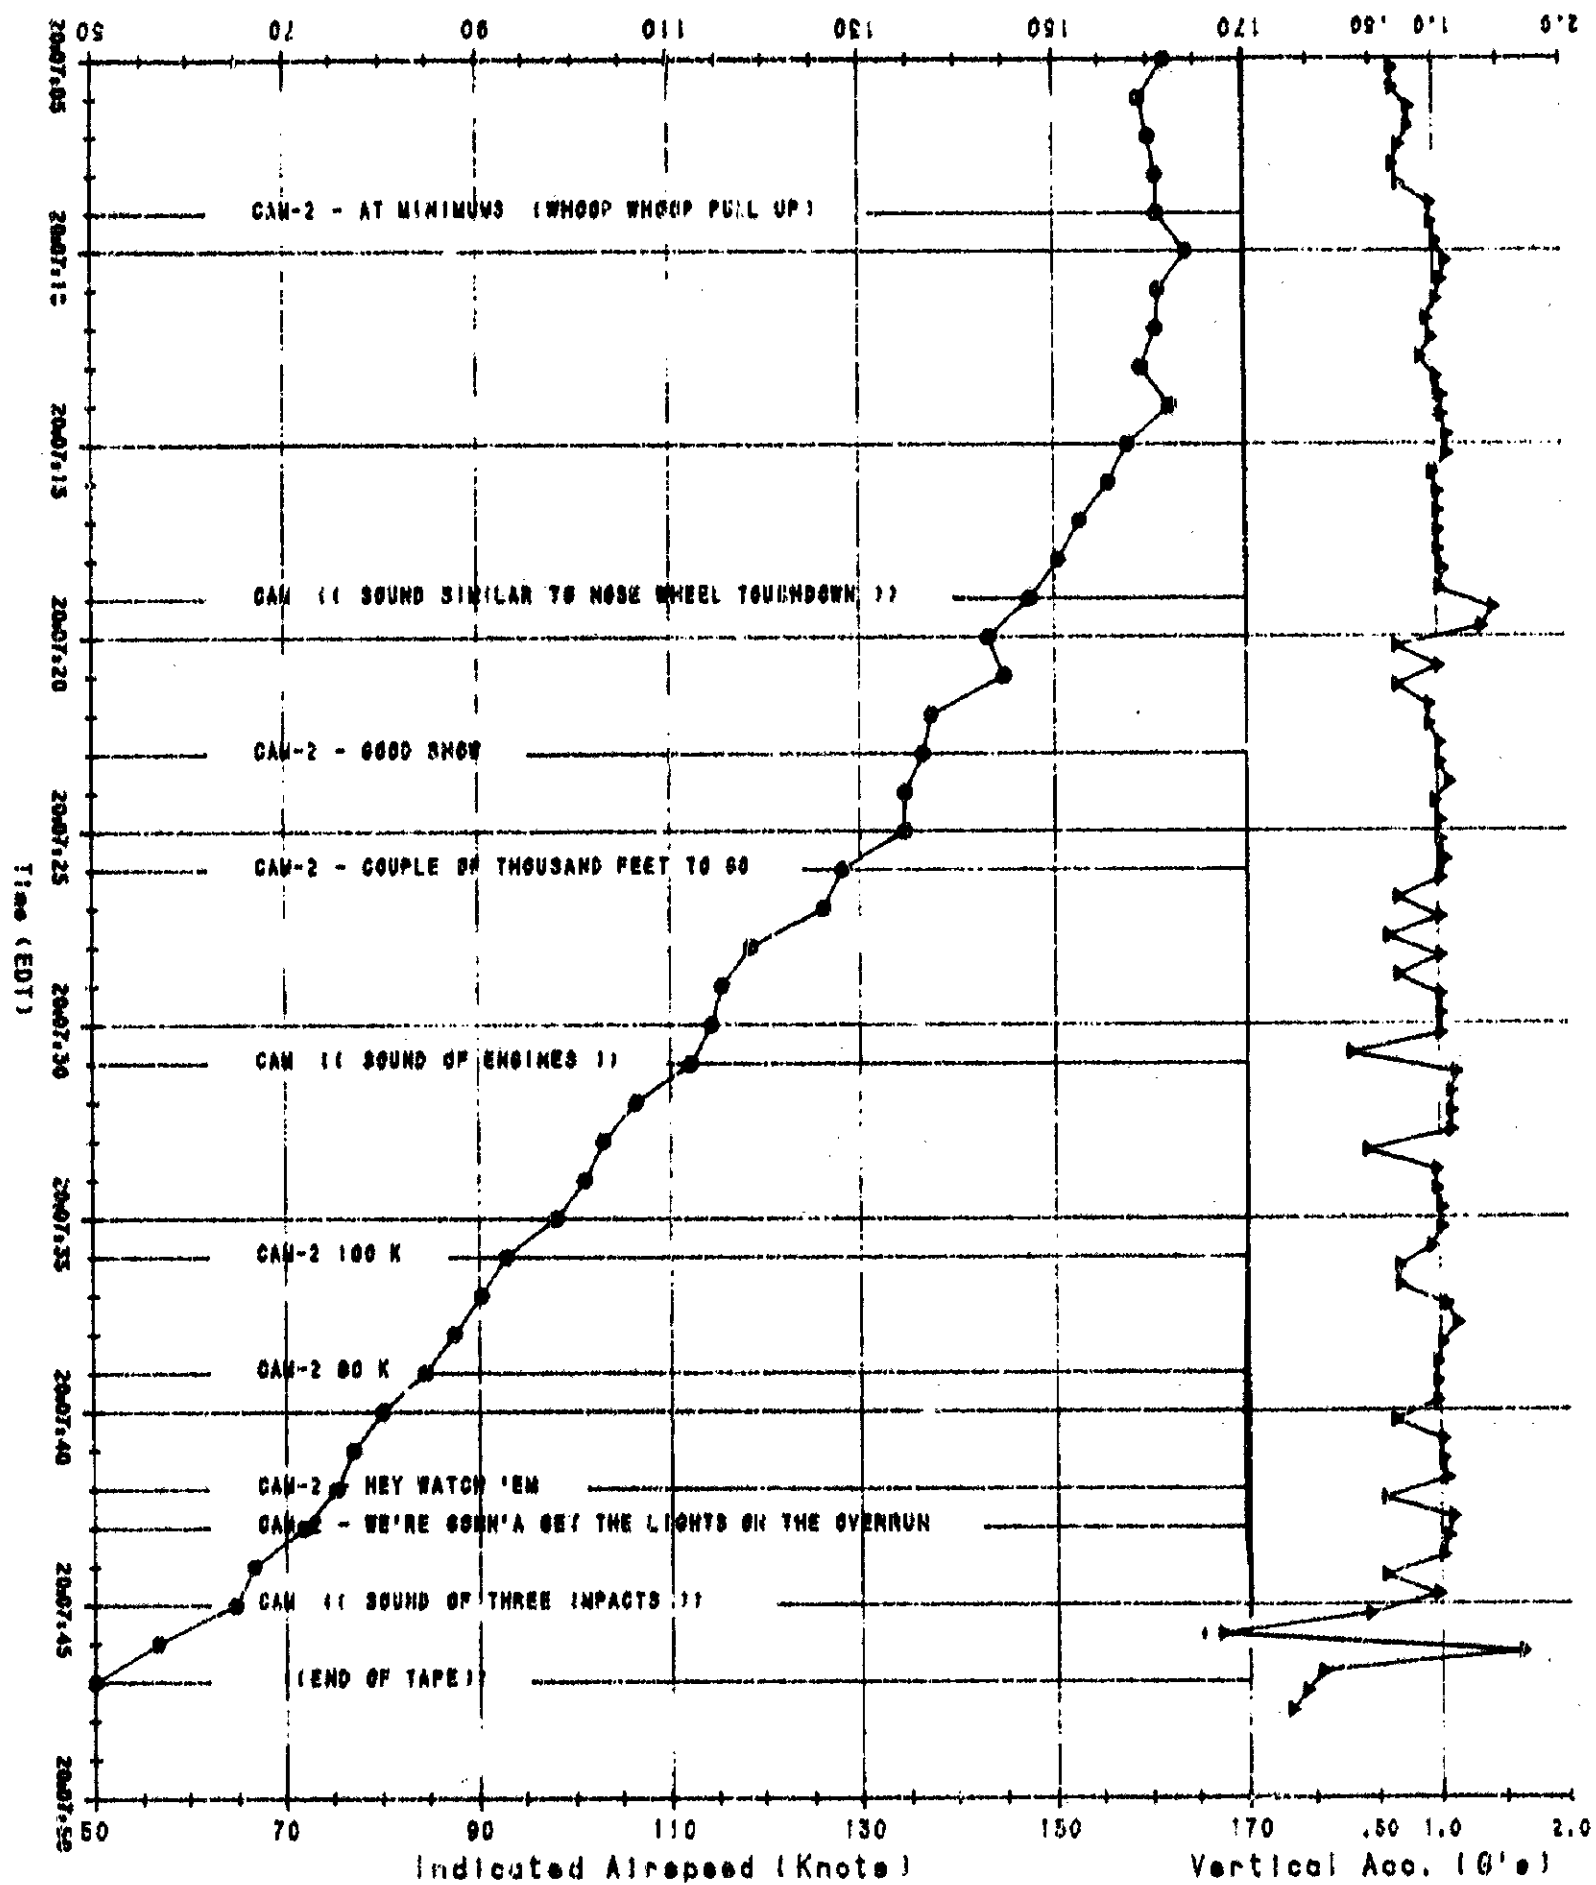
As shown in figure 9, the almost simultaneous sounds of nose wheel contact, with an increase in the G-trace to about 1.43 G, indicate that the airplane nose wheel and the wheels of one or both main gear struts contacted the runway almost simultaneously. The main gear contact was followed by about 3 seconds of oscillation in vertical acceleration, at slightly less than 1.0 G. Thus, following touchdown, very little of the airplane weight transferred to the main gear struts. This situation would have been exacerbated by the captain's stated application of forward pressure on the control column following touchdown, in order to hold the nose wheel on the runway. Boeing Company data indicate that at an increased airspeed of 15 knots above Vref, the lift generated by PI 467, while in a 3-point ground attitude was approximately equal to the airplane weight. Thus, there would have been little or no weight on the main gear wheels following initial touchdown, a condition which could have been maintained for 4 to 6 seconds with forward displacement of the control column. Since the airplane touched down in heavy rain on a runway that had been exposed to over 2/3 inch of rain during the day, it is possible that initially there would have been insufficient friction between the tires and the runway to obtain a wheel speed of 60 knots or more (the speed required by combination of any two wheels to cause automatic spoiler deployment and automatic movement of the speed brake lever actuator to the "Up" position). Further, the lack of any significant weight on the main gear struts would have prevented the strut compression needed to close the air/ground safety sensor switches which would have precluded the immediate selection of reverse thrust. This condition would be consistent with the captain's stated difficulty in deploying reverse thrust.

During the 6 seconds after touchdown, the airplane slowed from about 147 knots to about 135 knots, a deceleration of about 2 ft/sec². Since the brakes on the inboard wheels would not have been available immediately due to locked wheel protection, the performance of PI 467 in the first 6 seconds after touchdown suggests that the outboard wheels may have locked up within 3 to 4 seconds after touchdown, most likely due to the captain's application of wheel brakes before synchronous speed was achieved.

Figure 9.--Vertical acceleration and speeds of PI 467 following touchdown.
